**Agreement No. CE 30/2018 (EP)  
Environmental Team for Kai Tak Sports Park –  
Design and Construction**

Monthly EM&A Report for April 2021

**Agreement No. CE 30/2018 (EP)**  
**Environmental Team for Kai Tak Sports Park –**  
**Design and Construction**

This is the 25<sup>th</sup> Monthly EM&A Report for the construction phase of the Project which summaries findings of the EM&A programme during the reporting period from 1 to 30 April 2021.

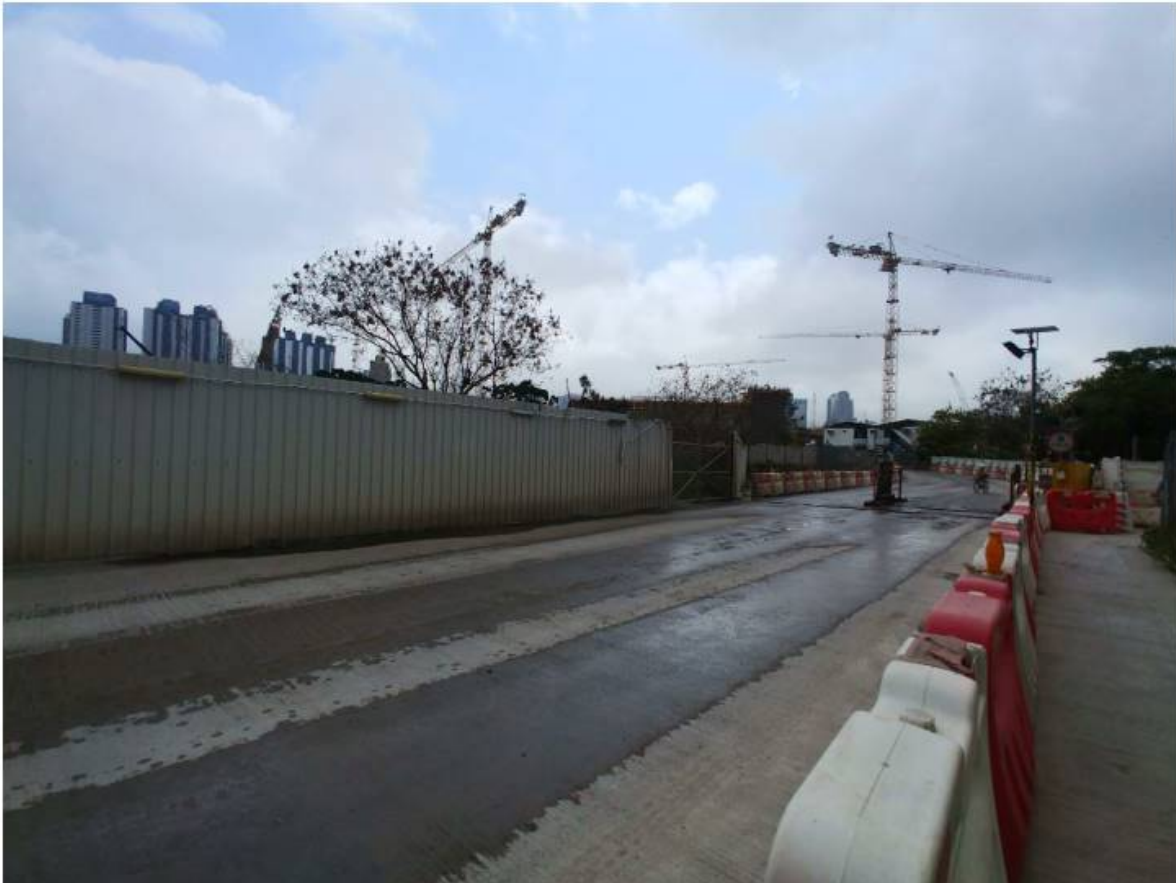
Date of Notification from EPD	Date of Complaint	Description of Complaint	Recommendations / Actions	Close-Out Date / Status
16 Apr 2021	13 Apr 2021 14 Apr 2021	- Complaint of dusty environment of the exit of road 3C at To Kwa Wan Road, and silt contamination on nearby pavement and road surface. - Please ensure the work fulfill the relevant environmental legislations and their subsidiary regulations. Please take necessary measures to minimize the environmental nuisance arising from the construction site.	1. Water truck has been provided regularly at road 3C to remove all dusty material. 2. Worker has been arranged to regularly maintain the tidiness at road 3C. 3. Wheel wash facility has been implemented at road 3C	23 Apr 2021

Photo 1: No dust emission at the road surface of the road 3C was observed and wet surface was maintained along the road 3C. (14 April 2021)

RECOMMENDATIONS / MITIGATION MEASURES / ACTIONS			
Environmental mitigation measures have been maintained as follow:			
<ol style="list-style-type: none"> <li>1. Water truck has been provided regularly at road 3C to remove all dusty material. (photo 3)</li> <li>2. Worker has been arranged to regularly maintain the tidiness at road 3C. (photo 4)</li> <li>3. Wheel wash facility has been implemented at road 3C (photo 5)</li> </ol>			
Prepared by:	Sunny Chan	Title:	Environmental Team Leader
Signature:

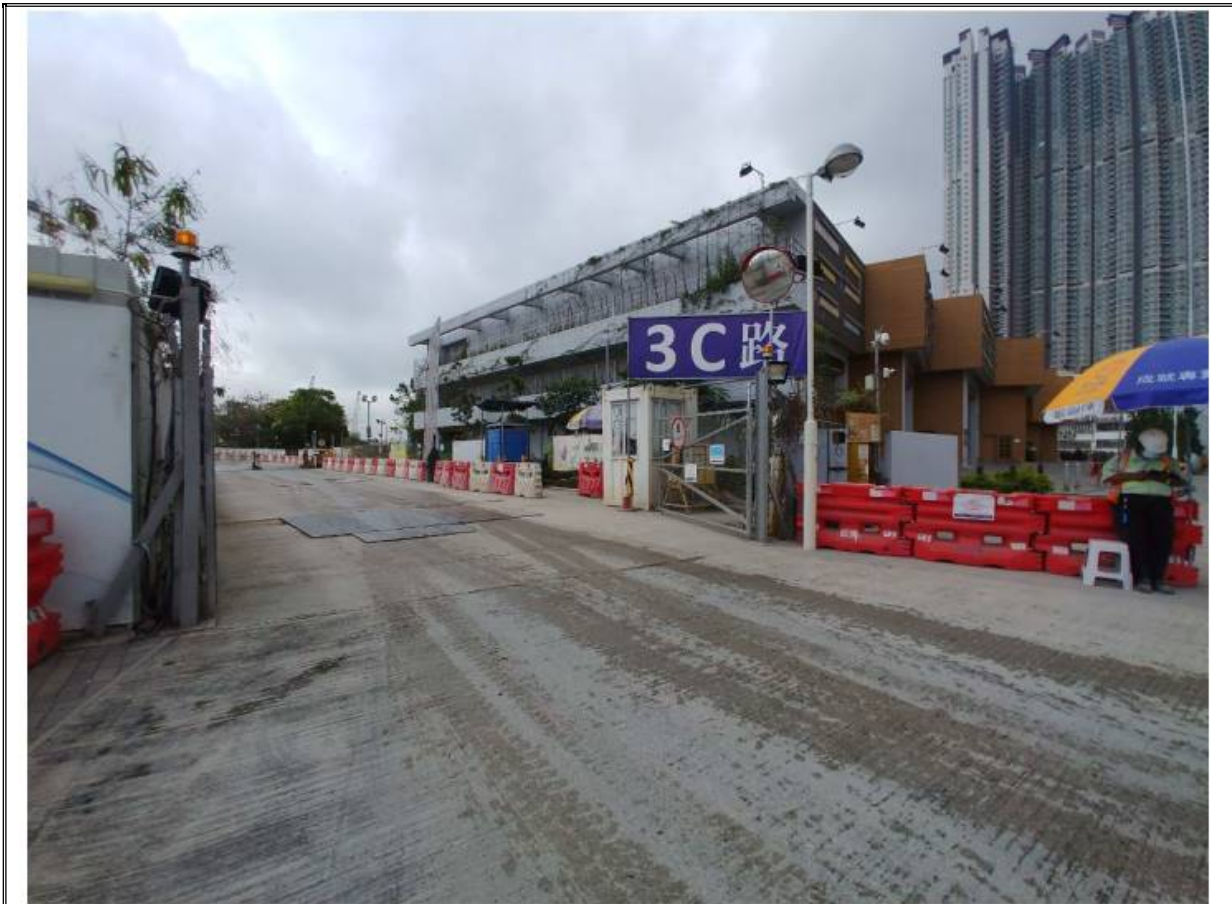
Photo 2: No slit contamination on nearby pavement road surface was observed. (14 April 2021)

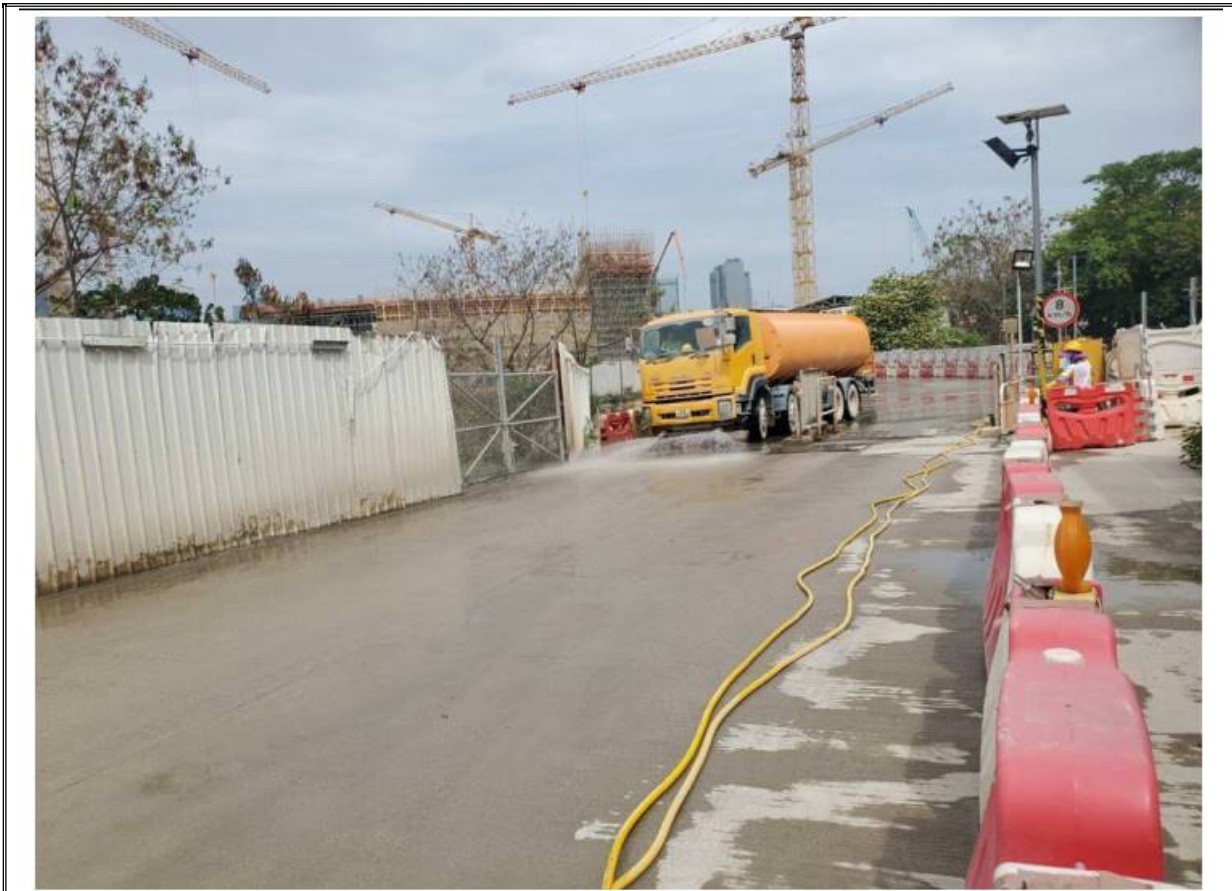
Photo 3: Water truck has been provided regularly at road 3C to remove all dusty material. (16 April 2021)

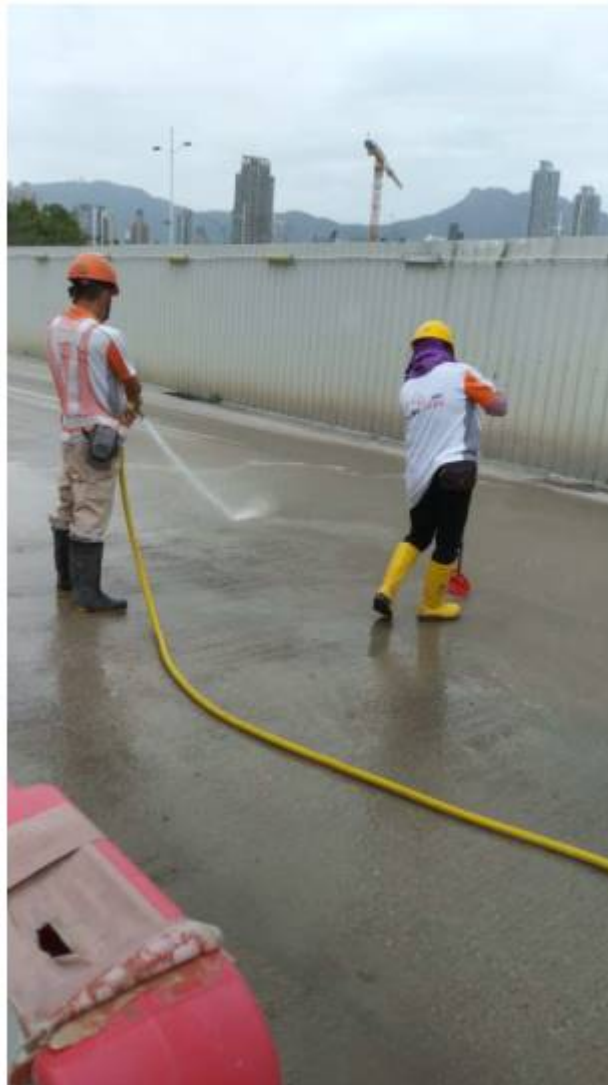
Photo 4: Worker has been arranged to regularly maintain the tidiness at road 3C (16 April 2021)

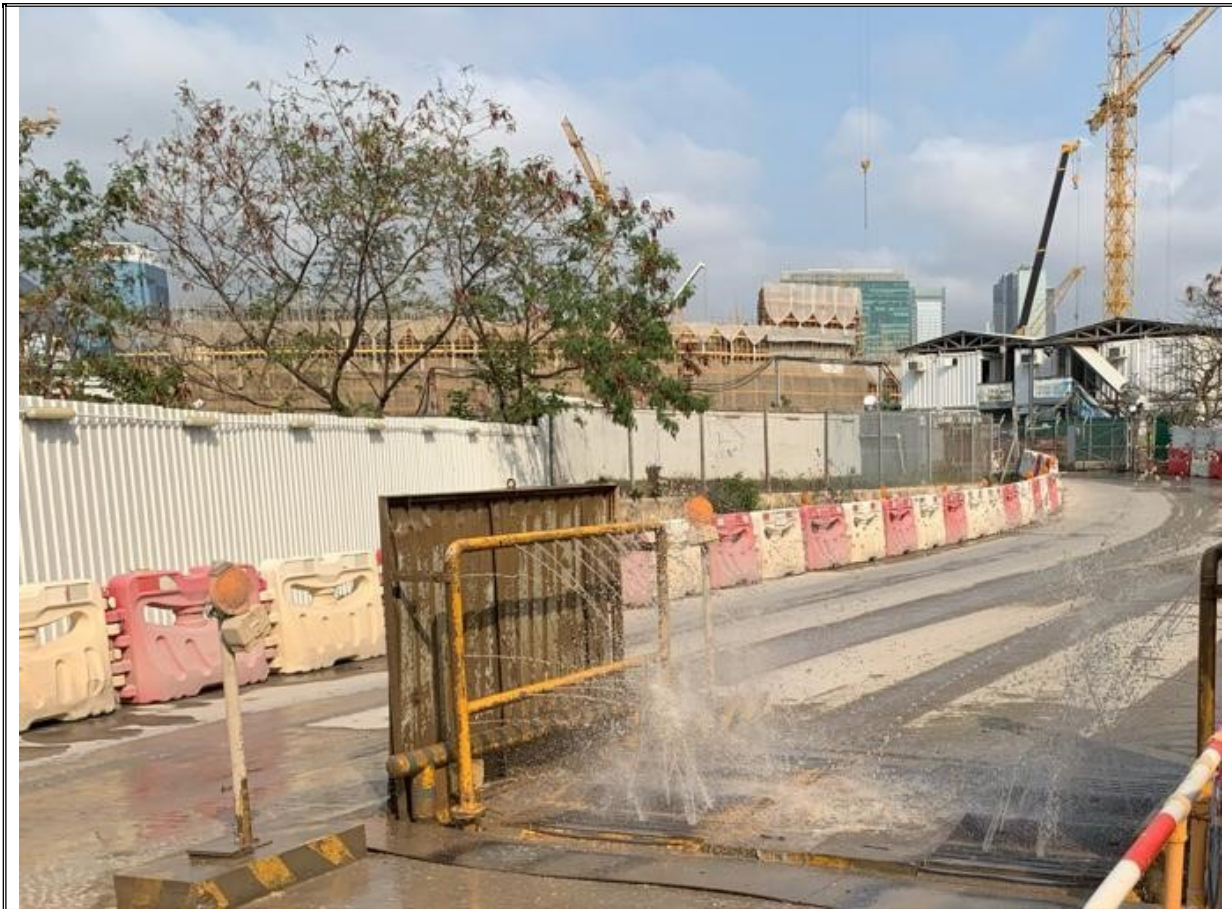
Photo 5. Wheel wash facility has been implemented at road 3C (19 April 2021)
