Agreement No. CE 30/2018 (EP) Environmental Team for Kai Tak Sports Park – Design and Construction

Monthly EM&A Report for July 2021

August 2021

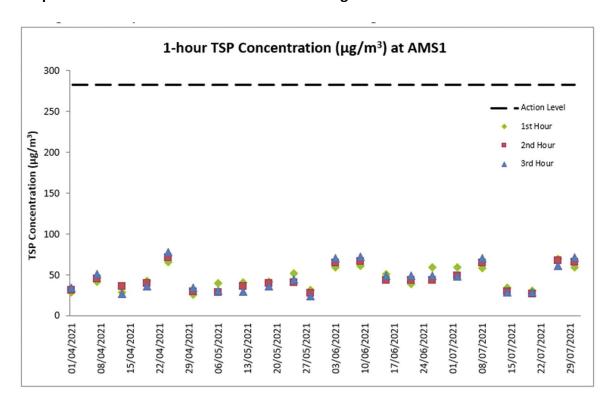
Graphical Presentation for 1-hour TSP Monitoring at AMS1

Date	Start Time	Finish Time	Weather	Wind Speed (m/s)	Wind Direction (deg)	1-hour TSP (μg/m³)
2-Jul-21	9:07	10:07	Cloudy	2.8	171	60
2-Jul-21	10:07	11:07	Cloudy	2.8	206	49
2-Jul-21	11:07	12:07	Cloudy	4.2	219	48
8-Jul-21	9:57	10:57	Fine	5.3	112	59
8-Jul-21	10:57	11:57	Fine	4.4	120	65
8-Jul-21	11:57	12:57	Fine	4.4	115	71
14-Jul-21	9:08	10:08	Sunny	1.4	120	35
14-Jul-21	10:08	11:08	Sunny	2.8	139	30
14-Jul-21	11:08	12:08	Sunny	3.3	126	29
20-Jul-21	9:27	10:27	Fine	1.1	172	31
20-Jul-21	10:27	11:27	Fine	5.3	67	27
20-Jul-21	11:27	12:27	Fine	1.1	131	29
26-Jul-21	9:10	10:10	Sunny	2.8	242	70
26-Jul-21	10:10	11:10	Sunny	2.8	234	68
26-Jul-21	11:10	12:10	Sunny	1.4	241	61
30-Jul-21	9:05	10:05	Cloudy	0.3	328	60
30-Jul-21	10:05	11:05	Cloudy	0.0	Variable	66
30-Jul-21	11:05	12:05	Cloudy	0.3	213	72

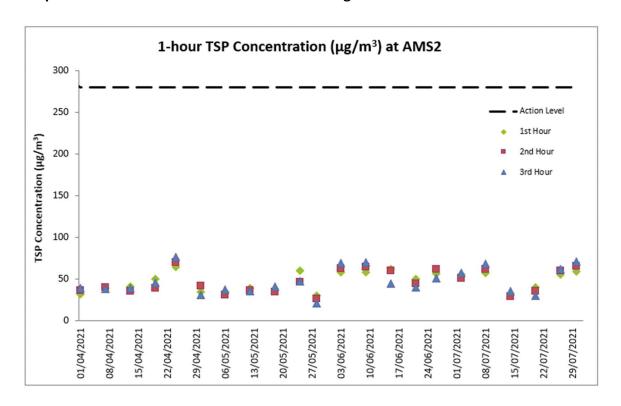
Graphical Presentation for 1-hour TSP Monitoring at AMS2

Date	Start Time	Finish Time	Weather	Wind Speed (m/s)	Wind Direction (deg)	1-hour TSP (μg/m³)
2-Jul-21	8:19	9:19	Fine	2.2	181	55
2-Jul-21	9:19	10:19	Fine	1.9	178	51
2-Jul-21	10:19	11:19	Fine	3.9	233	57
8-Jul-21	9:05	10:05	Cloudy	1.1	169	57
8-Jul-21	10:05	11:05	Cloudy	1.7	160	62
8-Jul-21	11:05	12:05	Cloudy	2.2	185	68
14-Jul-21	8:25	9:25	Sunny	1.1	105	31
14-Jul-21	9:25	10:25	Sunny	1.7	135	29
14-Jul-21	10:25	11:25	Sunny	3.1	131	35
20-Jul-21	8:43	9:43	Cloudy	5.8	82	40
20-Jul-21	9:43	10:43	Cloudy	1.7	153	35
20-Jul-21	10:43	11:43	Cloudy	3.3	48	30
26-Jul-21	8:22	9:22	Sunny	2.5	248	55
26-Jul-21	9:22	10:22	Sunny	3.1	239	60
26-Jul-21	10:22	11:22	Sunny	2.8	230	62
30-Jul-21	8:45	9:45	Cloudy	2.5	296	59
30-Jul-21	9:45	10:45	Cloudy	0.8	278	65
30-Jul-21	10:45	11:45	Cloudy	0.0	Variable	71

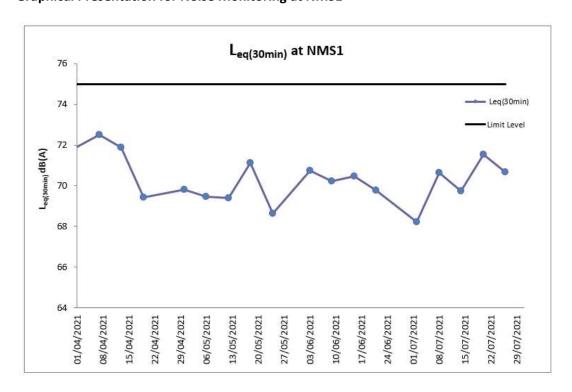
Graphical Presentation for Noise Monitoring at NMS1

Date	Time	Weather	L _{eq(5min)}	L ₁₀	L ₉₀	Measured L _{eq(30min)}
2-Jul-21	9:10	Cloudy	68.7	70.9	66.8	
2-Jul-21	9:15	Cloudy	69.2	71.0	67.7	
2-Jul-21	9:20	Cloudy	67.1	69.2	65.3	68.2
2-Jul-21	9:25	Cloudy	67.4	69.3	65.5	00.2
2-Jul-21	9:30	Cloudy	68.4	70.5	66.6	
2-Jul-21	9:35	Cloudy	68.2	70.4	66.6	
8-Jul-21	9:55	Fine	69.3	72.4	64.5	
8-Jul-21	10:00	Fine	71.3	73.8	65.3	
8-Jul-21	10:05	Fine	70.7	73.3	64.9	70.7
8-Jul-21	10:10	Fine	70.3	73.3	65.5	70.7
8-Jul-21	10:15	Fine	71.9	73.4	64.2	
8-Jul-21	10:20	Fine	69.9	72.4	66.0	
14-Jul-21	9:10	Sunny	69.6	71.4	67.5	
14-Jul-21	9:15	Sunny	68.7	70.4	66.3	
14-Jul-21	9:20	Sunny	70.6	72.4	68.2	60.7
14-Jul-21	9:25	Sunny	70.8	72.1	68.5	69.7
14-Jul-21	9:30	Sunny	69.0	71.9	67.3	
14-Jul-21	9:35	Sunny	69.2	71.4	67.6	
20-Jul-21	9:30	Cloudy	71.6	73.7	68.8	
20-Jul-21	9:35	Cloudy	72.9	74.6	69.5	
20-Jul-21	9:40	Cloudy	70.3	72.4	67.2	74.5
20-Jul-21	9:45	Cloudy	70.4	72.5	67.6	71.5
20-Jul-21	9:50	Cloudy	72.2	74.1	69.0

20-Jul-21	9:55	Cloudy	71.2	73.4	68.7	
26-Jul-21	9:12	Sunny	69.5	71.3	67.1	
26-Jul-21	9:17	Sunny	70.2	72.6	68.4	
26-Jul-21	9:22	Sunny	71.1	73.0	69.5	70.7
26-Jul-21	9:27	Sunny	71.5	73.1	69.9	70.7
26-Jul-21	9:32	Sunny	70.6	72.7	68.6	
26-Jul-21	9:37	Sunny	70.8	72.0	68.6

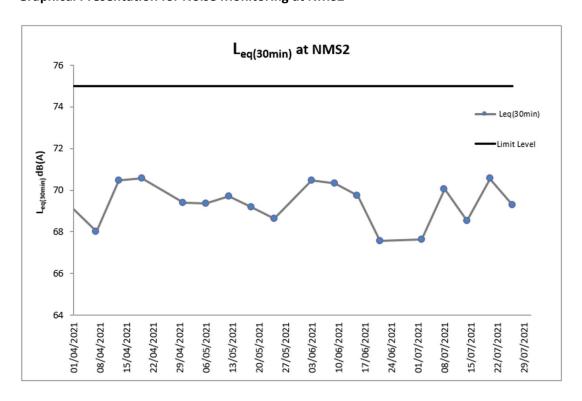
Graphical Presentation for Noise Monitoring at NMS2

Date	Time	Weather	L _{eq(5min)}	L ₁₀	L ₉₀	Measured L _{eq(30min)}
2-Jul-21	8:22	Cloudy	67.5	69.7	65.4	
2-Jul-21	8:27	Cloudy	68.6	70.5	66.3	
2-Jul-21	8:32	Cloudy	67.1	69.2	65.4	67.6
2-Jul-21	8:37	Cloudy	66.4	68.2	64.8	07.0
2-Jul-21	8:42	Cloudy	67.7	69.0	65.9	
2-Jul-21	8:47	Cloudy	68.1	70.6	66.5	
8-Jul-21	9:08	Fine	70.0	72.3	66.2	
8-Jul-21	9:13	Fine	70.3	72.2	66.6	
8-Jul-21	9:18	Fine	70.5	72.4	67.0	70.1
8-Jul-21	9:23	Fine	70.2	71.7	66.5	70.1
8-Jul-21	9:28	Fine	69.4	72.0	65.8	
8-Jul-21	9:33	Fine	69.9	72.6	66.6	
14-Jul-21	8:28	Sunny	68.7	70.0	66.6	
14-Jul-21	8:33	Sunny	67.1	69.2	65.4	
14-Jul-21	8:38	Sunny	68.1	70.2	66.3	68.5
14-Jul-21	8:43	Sunny	69.3	71.9	67.8	68.5
14-Jul-21	8:48	Sunny	69.2	71.4	67.3	
14-Jul-21	8:53	Sunny	68.5	70.6	66.7	
20-Jul-21	8:45	Cloudy	70.7	72.5	67.3	
20-Jul-21	8:50	Cloudy	71.6	73.5	68.4	
20-Jul-21	8:55	Cloudy	69.1	71.3	66.7	70.6
20-Jul-21	9:00	Cloudy	70.2	72.8	67.4	70.6
20-Jul-21	9:05	Cloudy	70.2	72.0	67.9

20-Jul-21	9:10	Cloudy	71.1	73.5	68.6	
26-Jul-21	8:25	Sunny	67.6	69.7	65.8	
26-Jul-21	8:30	Sunny	68.6	70.5	66.9	
26-Jul-21	8:35	Sunny	69.4	71.5	67.6	60.2
26-Jul-21	8:40	Sunny	69.4	71.3	67.2	69.3
26-Jul-21	8:45	Sunny	70.2	72.1	68.9	
26-Jul-21	8:50	Sunny	70.1	72.0	68.2
