**Agreement No. CE 30/2018 (EP)  
Environmental Team for Kai Tak Sports Park –  
Design and Construction**

Monthly EM&A Report for June 2022

This is the 39<sup>th</sup> Monthly EM&A Report for the construction phase of the Project which summaries findings of the EM&A programme during the reporting period from 1 to 30 June 2022.

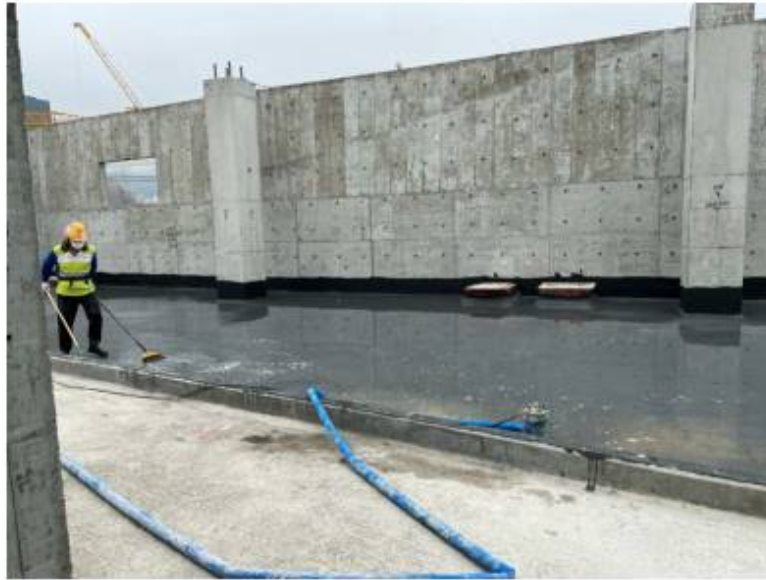
Photo 1: Clear the stagnant water regularly throughout the site.

<b>RECOMMENDATIONS / MITIGATION MEASURES / ACTIONS</b>			
Environmental mitigation measures have been maintained as follow: 1. Maintain good site practices to keep the construction site dry and tidy. 2. Conduct regular checking to clear stagnant water on site.			
Prepared by:	Sunny Chan	Title:	Environmental Team Leader
Signature:

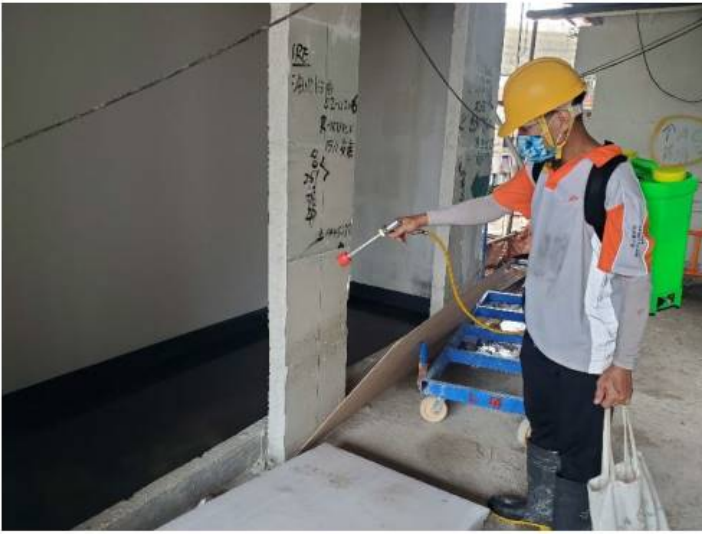
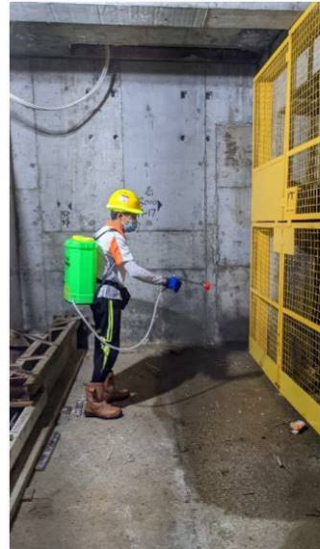
Photos 3a and 3b: Apply mosquito pesticides every two days throughout the site.

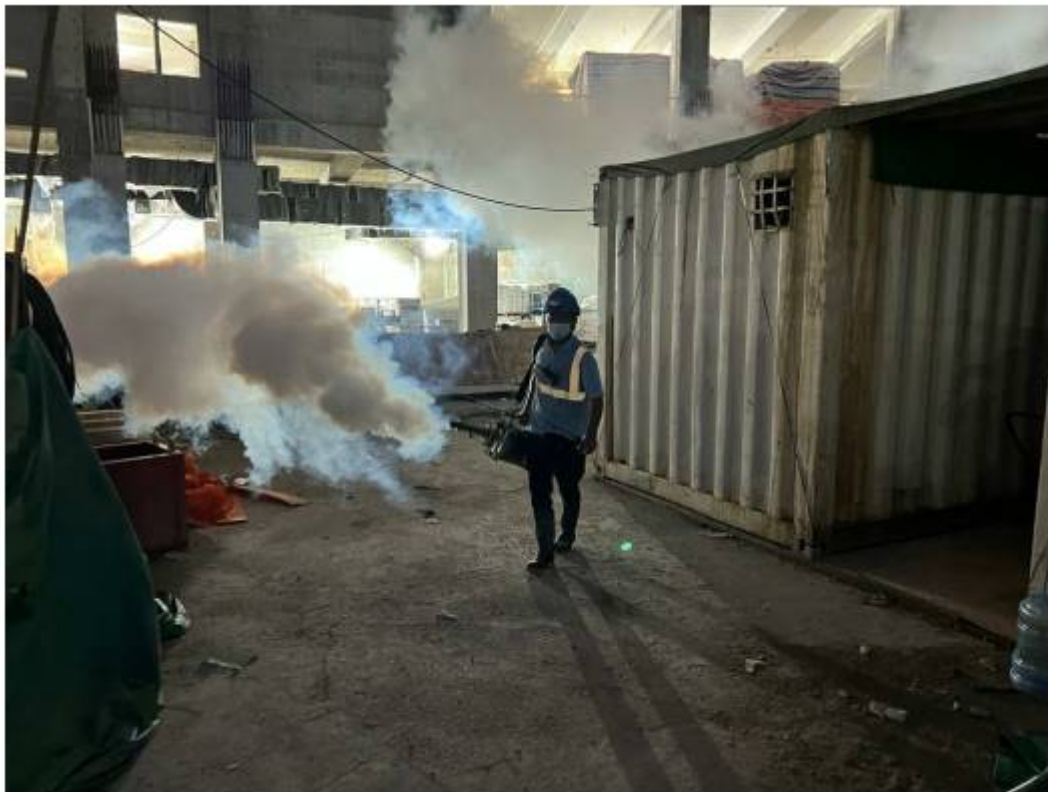
Photo 4: Apply mosquito killing hot mist twice a week.
