**Agreement No. CE 30/2018 (EP)
Environmental Team for Kai Tak Sports Park –
Design and Construction**

Monthly EM&A Report for October 2022

Document/ Plan to be Certified / Verified:	Monthly EM&A Report No. 43 (October 2022)
Date of Report:	7 November 2022
Date received by IEC:	7 November 2022

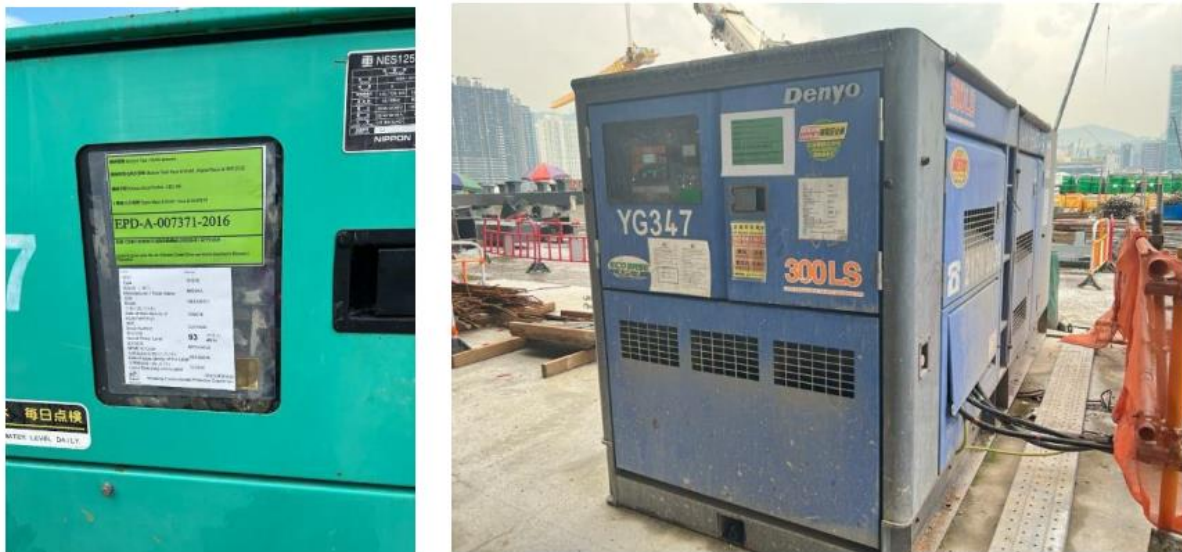
Photo 2a and 2b: Power Mechanical Equipment with Quality Power Mechanical Equipment (QPME) labels were used at site to lower the noise nuisance to the nearby residents.

1. Power Mechanical Equipment with Quality Power Mechanical Equipment (QPME) labels were used at site to lower the noise nuisance to the nearby residents (photos 2a and 2b).
2. Site Frontline Staffs (photo 3a) and subcontractors (photo 3b) had been encouraged to start any powered mechanical equipment at 07:15 and only if necessary.
3. Notice was provided to all subcontractors to follow the latest Construction Noise Permit Requirement. (photo 4).
4. Implementation of noise mitigation measures recommended in EIA's Environmental Mitigation Implementation Schedule

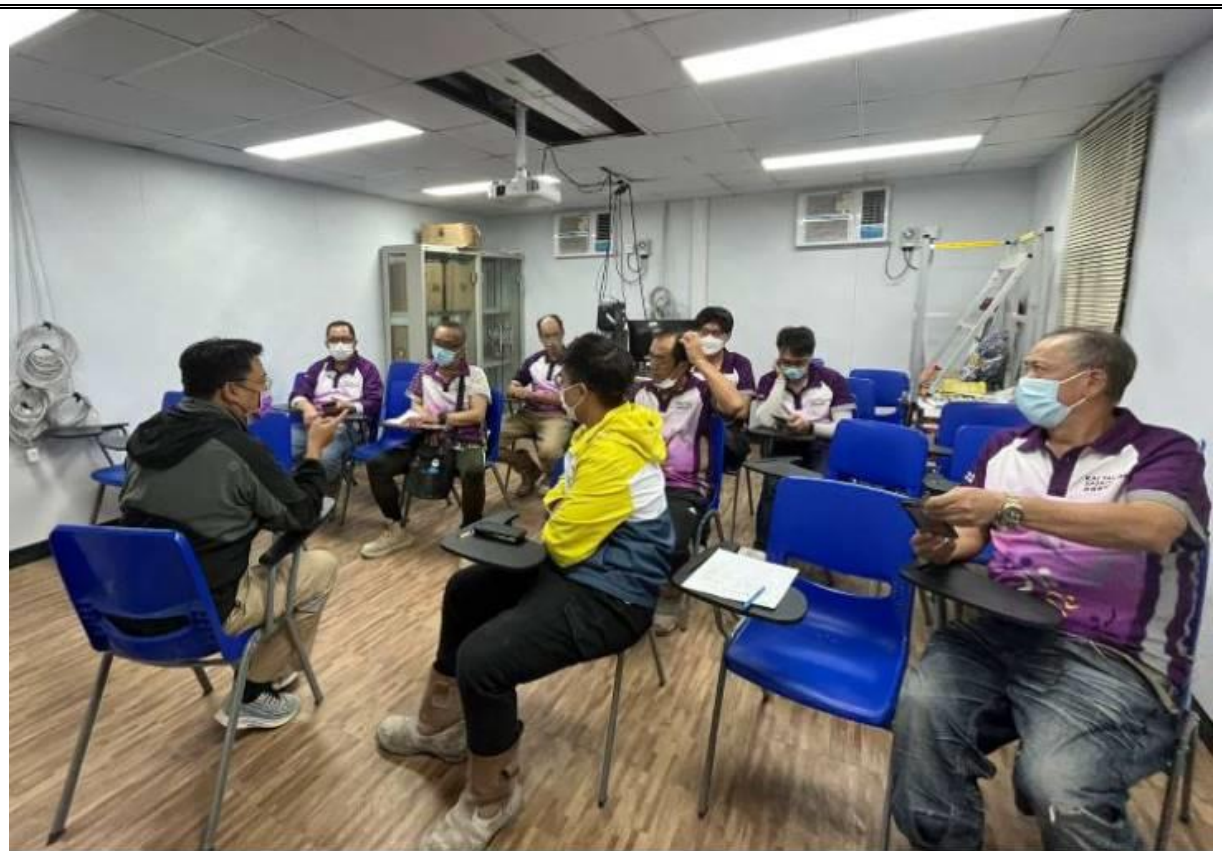
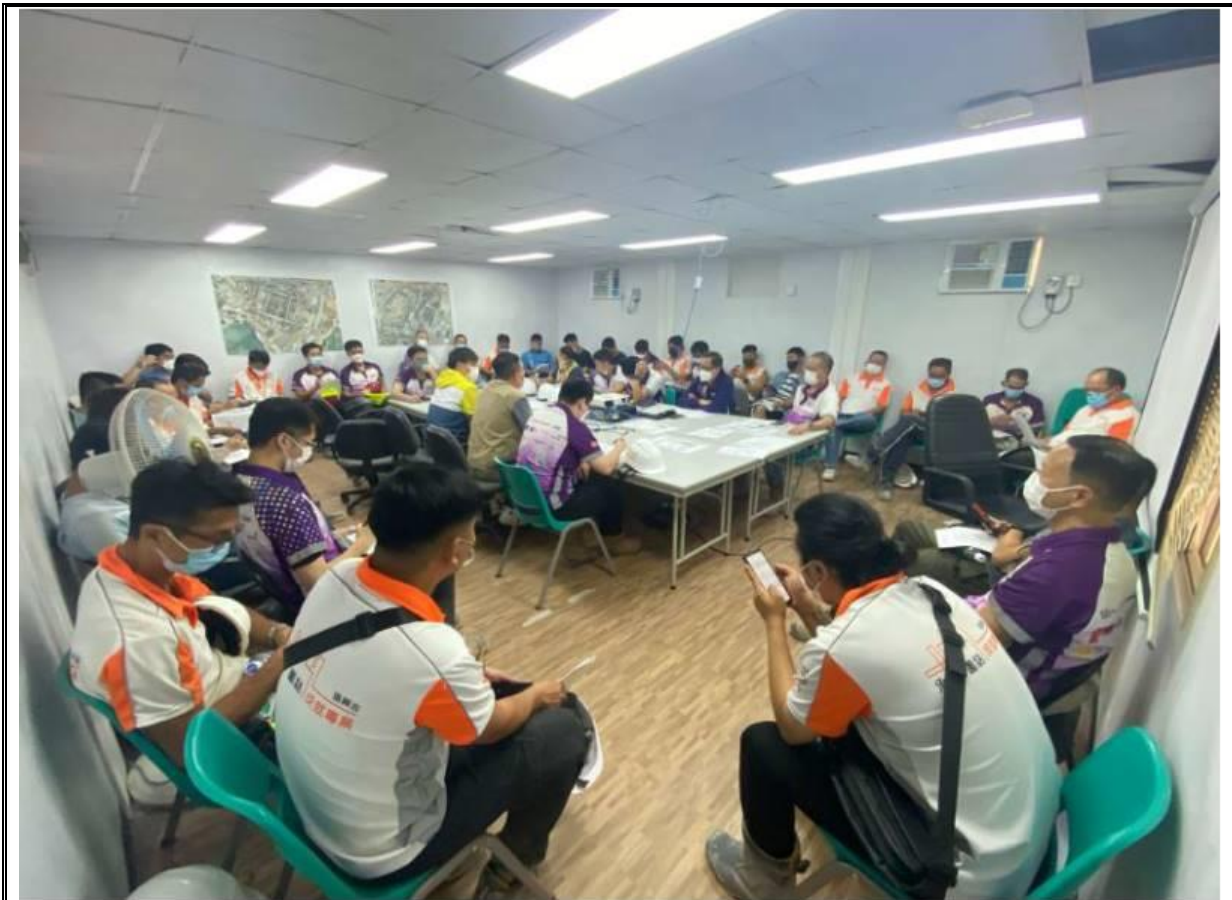
Photo 3a and 3b : Site Frontline Staffs (photo 3a) and subcontractors (photo 3b) had been encouraged to start any powered mechanical equipment at 07:15 and only if necessary.
