**Agreement No. CE 30/2018 (EP)  
Environmental Team for Kai Tak Sports Park –  
Design and Construction**

Monthly EM&A Report for August 2023

### Kai Tak Sports Park - Investigation

This is the 53<sup>rd</sup> Monthly EM&A Report for the construction phase of the Project which summarizes findings of the EM&A programme during the reporting period from 1 to 31 August 2023.

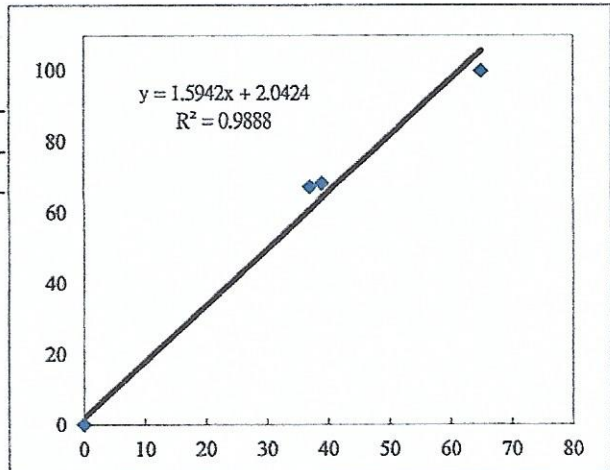
Linear Regression of Y or X

Slope (K-factor): 1.5942(µg/m³)/CPM  
Correlation Coefficient (R): 0.9944  
Date of Issue: 29-Mar-2023

- 1. Strong Correlation (>0.8)
- 2. Factor 1.5942 (µg/m³)/CPM should be applied for TSP monitoring

\*If R<0.5, repair or verification is required for the equipment

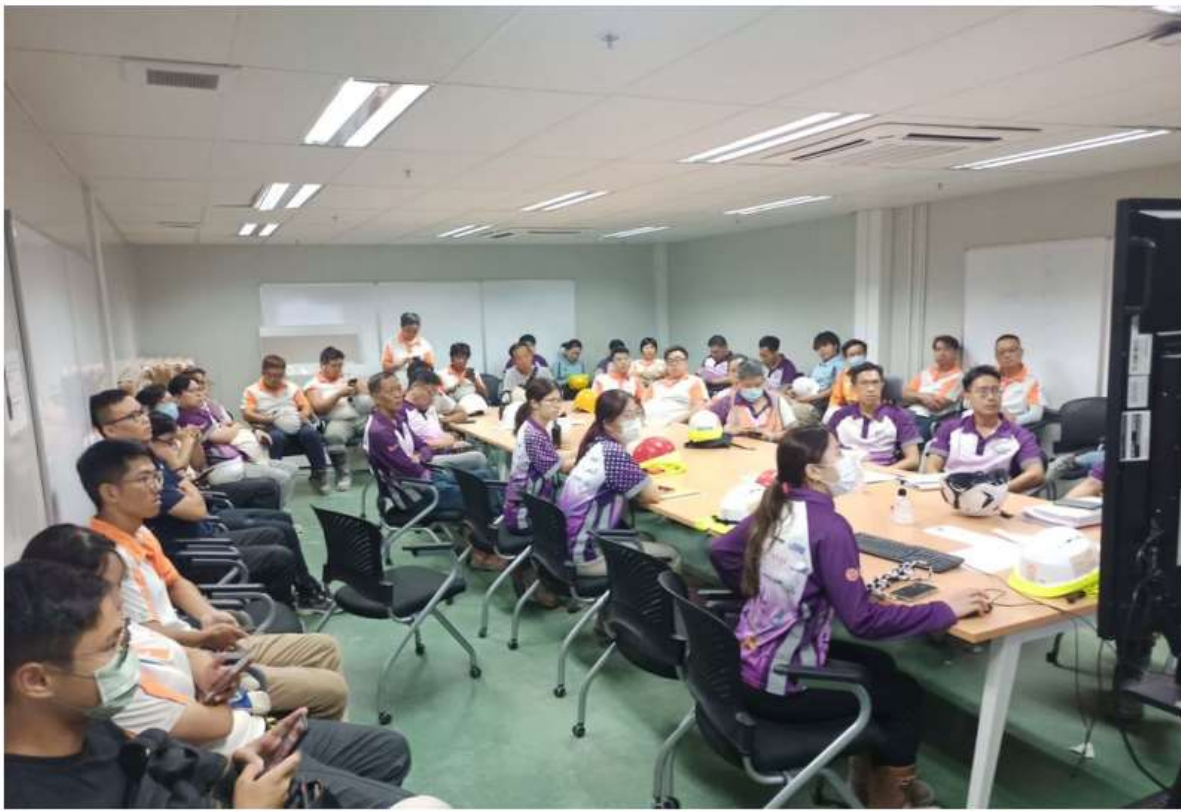
**Photo 1:** All subcontractors are reminded to read and follow the latest Construction Noise Permit Requirement..

RECOMMENDATIONS / MITIGATION MEASURES / ACTIONS			
Environmental mitigation measures have been maintained as follow:			
1. All subcontractors are reminded to read and follow the latest Construction Noise Permit Requirement. (Photo 1).
