**Agreement No. CE 30/2018 (EP)
Environmental Team for Kai Tak Sports Park –
Design and Construction**

Monthly EM&A Report for February 2024

March 2024

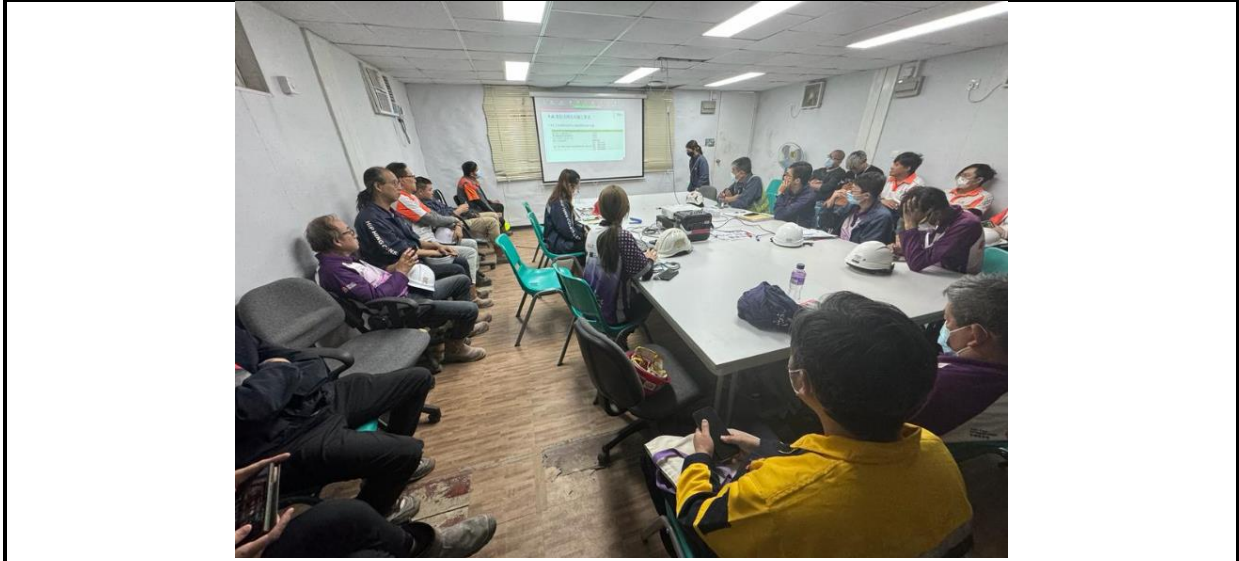
Photo 5a and 5b: A memo has been issued and subcontractors are reminded to properly cover the stockpile and duty materials on site.
