**Agreement No. CE 30/2018 (EP)
Environmental Team for Kai Tak Sports Park –
Design and Construction**

Quarterly EM&A Report (Jul 2019 – Sep 2019)

November 2019

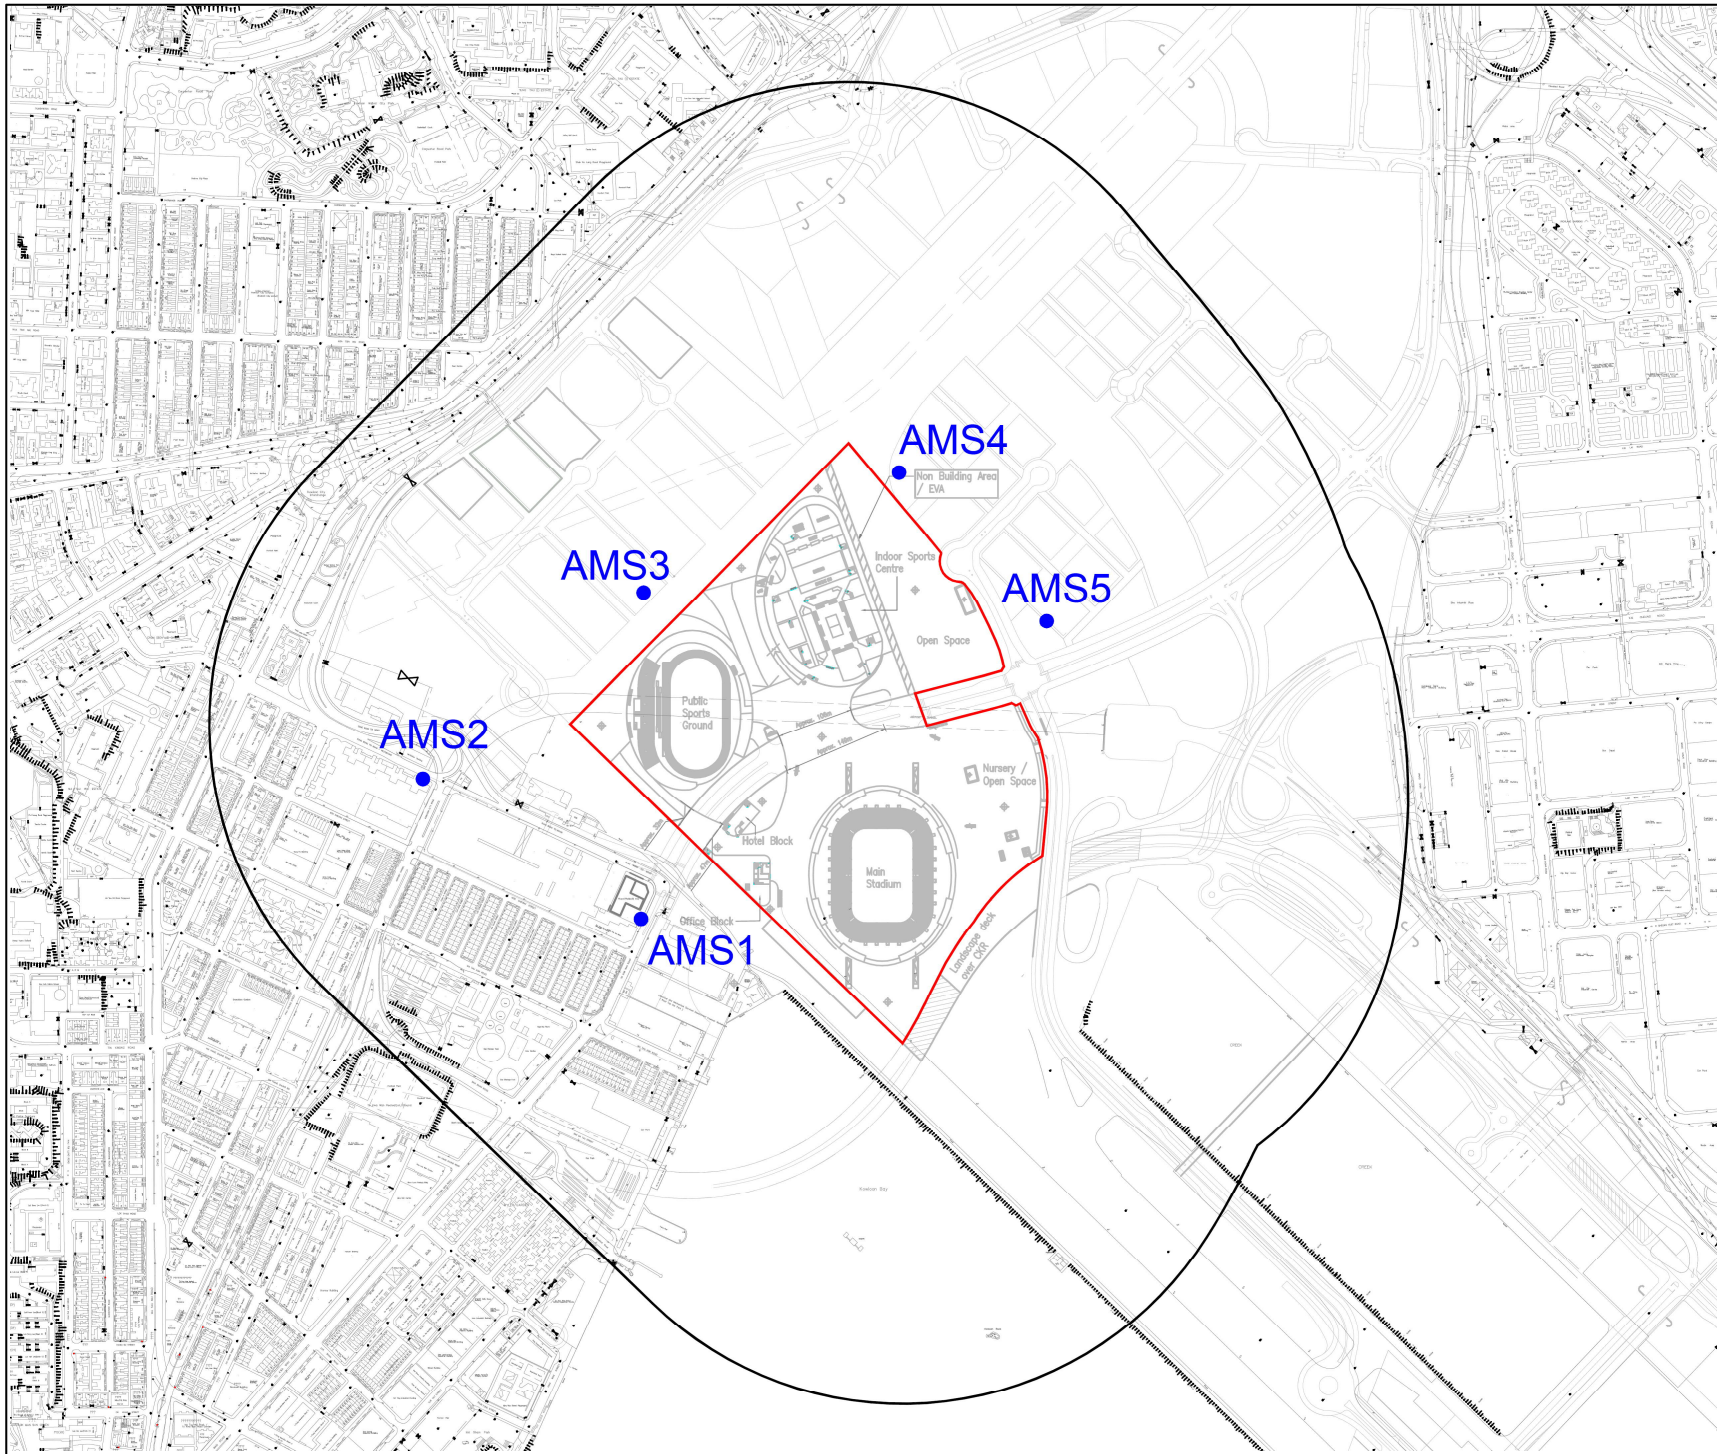
Title:
**Figure 2.1
Location of Air Quality
Monitoring Stations**

Table 2.2 describes the impact air quality monitoring stations and **Figure 2.1** shows their locations.

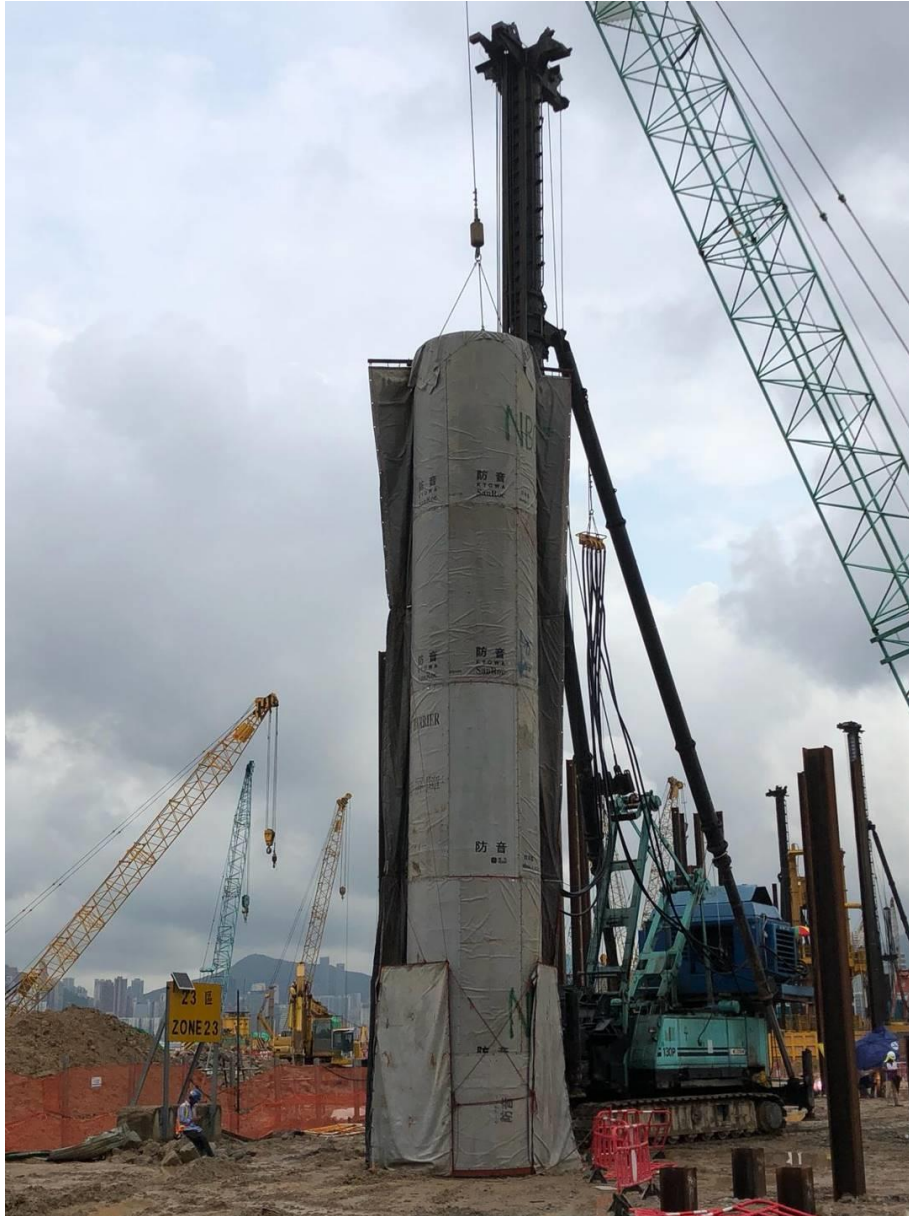
1) Photos of noise barrier on 4 September 2019

Date of Notification from EPD	Date of Complaint	Description of Complaint	Recommendations / Actions	Close-Out Date / Status
18 Sep 2019	4 Sep 2019	-Complaint of daytime percussive piling noise from the construction site of Kai Tak Sports Park. -Complainant would like percussive piling to be carried out later in the morning, i.e. after 8:30 hrs. -Please ensure the work fulfill the relevant environmental legislation and conditions stipulated in the construction noise permit	1. Conduct regular checking to ensure the implementation of noise barrier for all percussive piling works. 2. Consider to reschedule the percussive piling works activities to reduce the noise nuisance to nearby sensitive receivers during the 8:00 a.m. to 9:30a.m. session.	24 Sep 2019

RECOMMENDATIONS / MITIGATION MEASURES / ACTIONS			
<p>1. Conduct regular checking to ensure the implementation of noise barrier for all percussive piling works.</p> <p>2. Consider to reschedule the percussive piling works activities to be carried out later in the morning, e.g. after 8:30 a.m. as far as possible to reduce the noise nuisance to nearby sensitive receivers during the morning session.</p> <p>3. Consider to revise the CNP so as to start the piling works at 0830 with total daily piling duration unchanged.</p>			
Prepared by:	Sunny Chan	Title:	Environmental Team Leader
Signature:

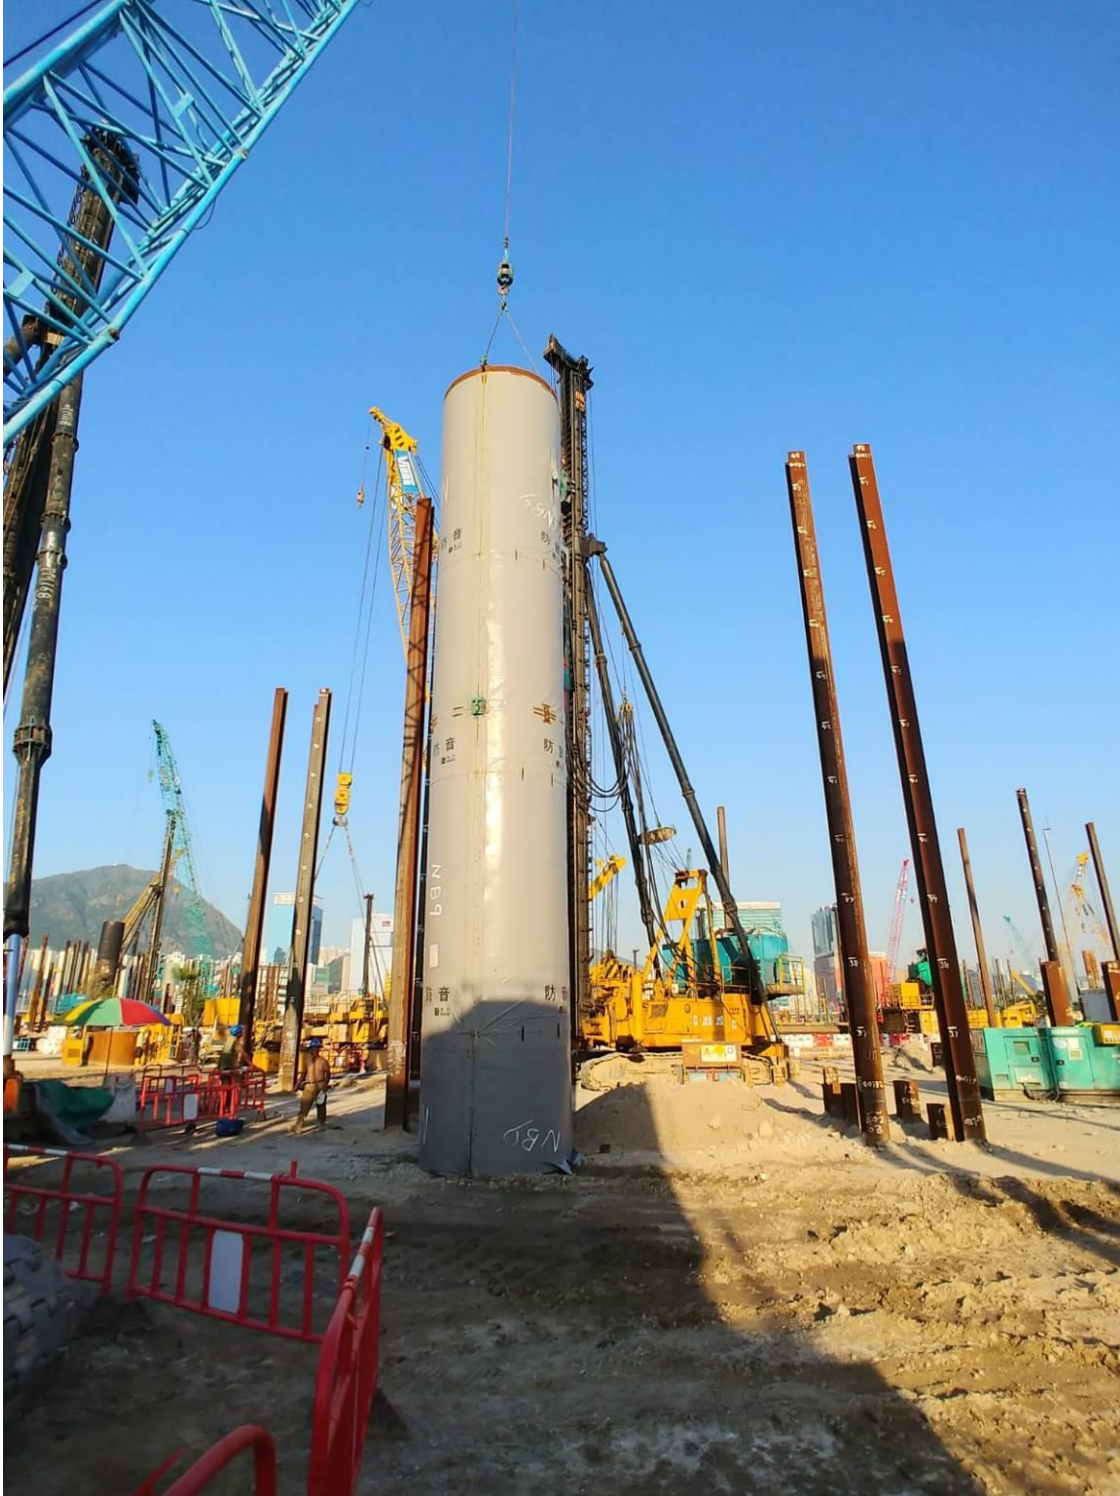
Photo of Investigation Record

1. Noise barrier for percussive piling had been used to reduce the noise nuisance to sensitive receivers.
