Agreement No. CE 30/2018 (EP) Environmental Team for Kai Tak Sports Park – Design and Construction

Quarterly EM&A Report (Apr 2020 – Jun 2020)

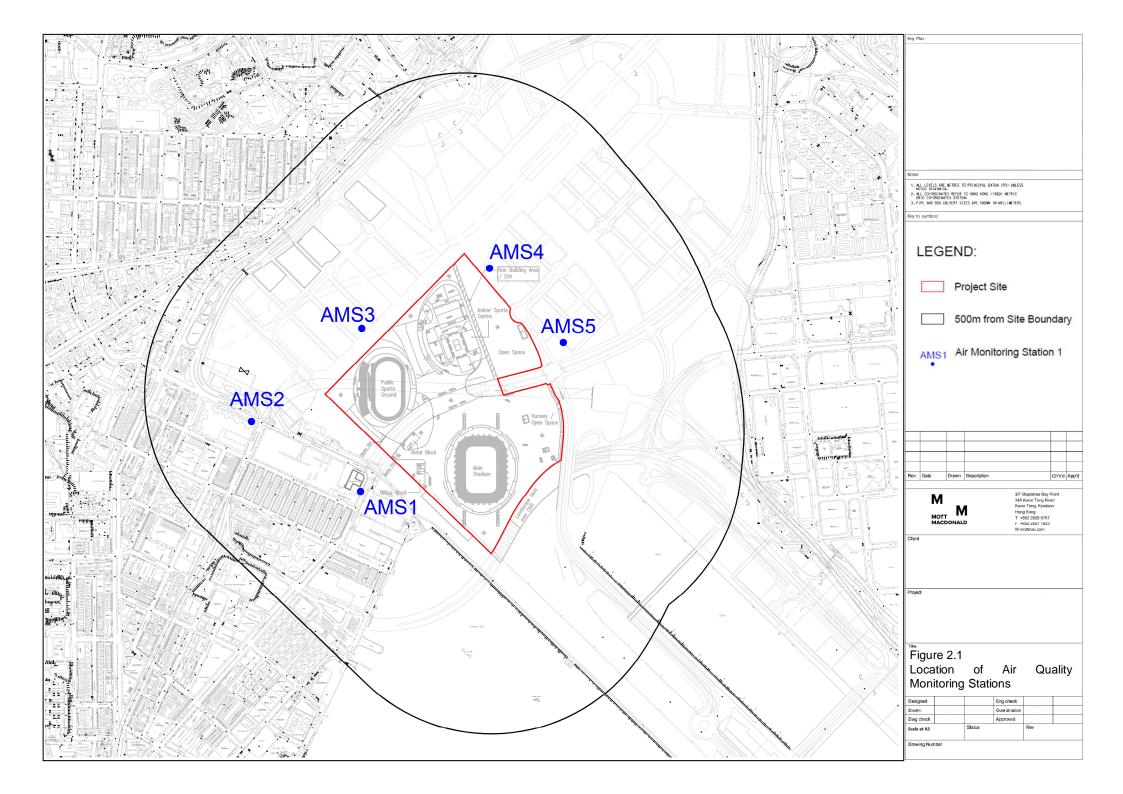
Figure 2.1: Location of Air Quality Monitoring Stations

Table 2.2 describes the impact air quality monitoring stations and <u>Figure 2.1</u> shows their locations.

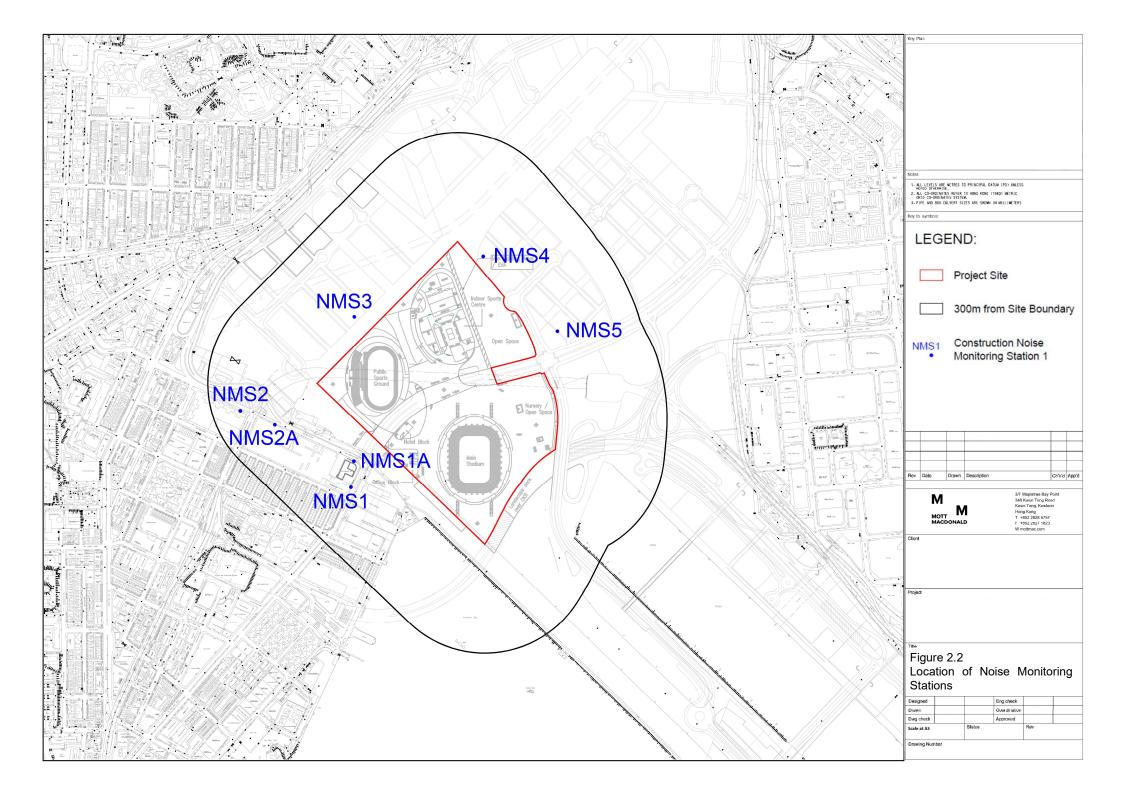
Figure 2.2: Location of Noise Monitoring Stations

Table 2.5 describes the details of the monitoring stations and <u>Figure 2.2</u> shows the locations of noise monitoring stations.

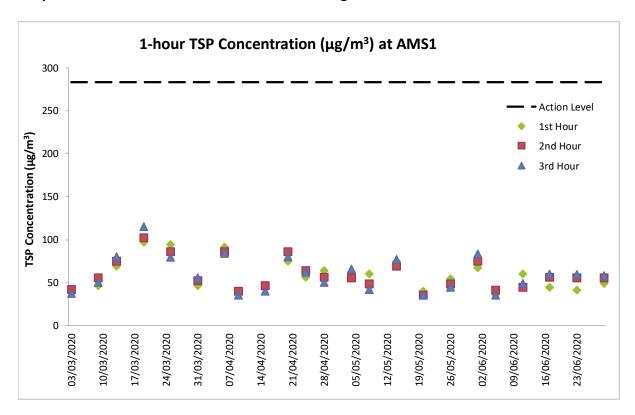
Graphical Presentation for 1-hour TSP Monitoring at AMS1

No Action and Limit Level exceedances of 1-hour TSP level was recorded at AMS1 and AMS2 during the reporting period.

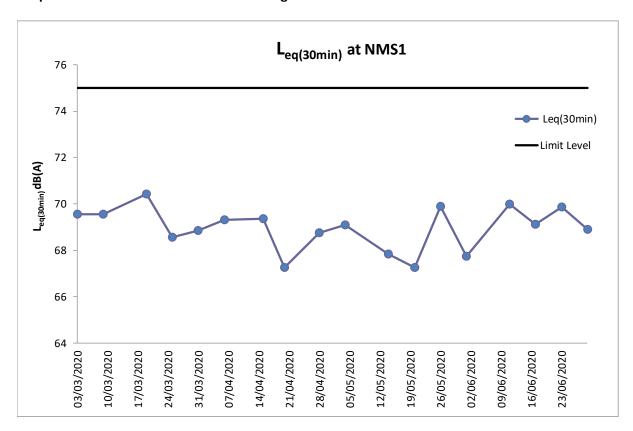
Graphical Presentation for Noise Monitoring at NMS1

No Action and Limit Level exceedances of noise at NMS1 and NMS2 was recorded during the reporting period.
