Agreement No.: PI 3/2020  
Independent Environmental Checker for  
Lei Yue Mun Waterfront Enhancement Project  
Verification of Monthly Environmental Monitoring and Audit Report (February 2022)

**Environmental Monitoring Works for**  
**Lei Yue Mun Waterfront Enhancement Project**

**Monthly EM&A Report (February 2022)**

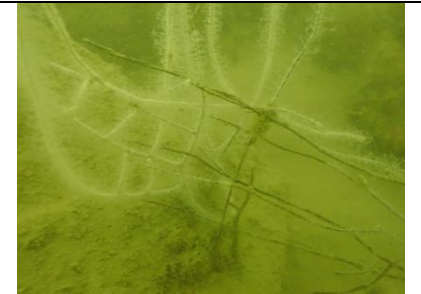
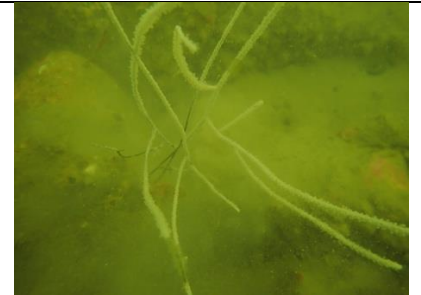
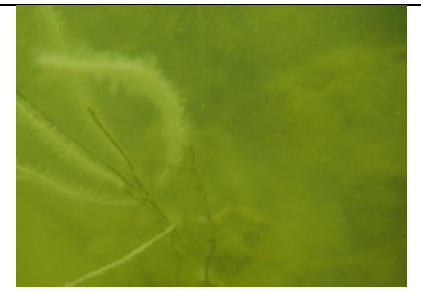
**Photo Plate 1**

The third post-translocation coral monitoring was carried out on 24 February 2022. Ten (10) selected translocated coral colonies were monitored at the recipient site. Besides the missing branches recorded in coral no. T8 and T9 during November 2021 monitoring, coral mortality was recorded in coral no. T3 (25%) and no. T7 (20%). The health condition of other translocated coral colonies were good in general. No increased mortality was recorded during the survey.

Tagged Translocated Corals at Recipient Site

Besides the recorded partial mortality, no sediment and bleaching in the general condition of coral colonies were observed during the monitoring period. No deterioration of the coral community was observed in the ecological monitoring results when compared with the baseline ecological monitoring results. There is no AL/LL exceedance during the monitoring period. Photos of each tagged translocated and natural corals were taken and shown in Photo Plates 1 and 2.

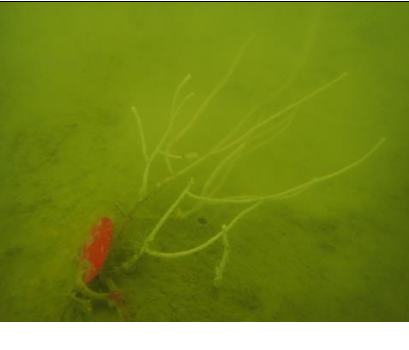
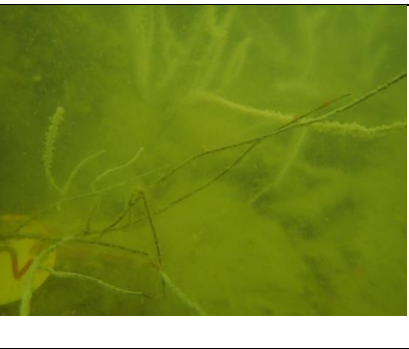
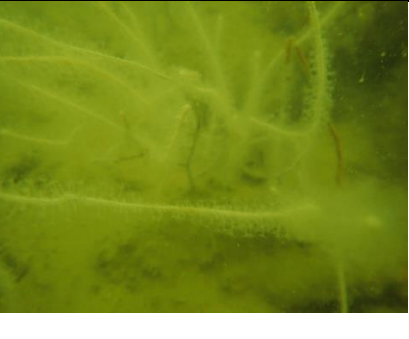
**Photo Plate 2**

Ten (10) natural hard coral colonies were also monitoring at the recipient site as control and similar to the baseline result, half of the tagged corals (R2: 40%, R3:20%, R4:30%, R5:20% and R8: 20%) showed partial mortality during the February 2022 monitoring. Other tagged natural coral colonies are all in good condition.

Tagged Natural Corals at Recipient Site
