Agreement No.: PI 3/2020
Independent Environmental Checker for
Lei Yue Mun Waterfront Enhancement Project
Verification of Monthly Environmental Monitoring and Audit Report (March 2023) (Revision 1)

**Environmental Monitoring Works for
Lei Yue Mun Waterfront Enhancement Project**

Monthly EM&A Report (March 2023)

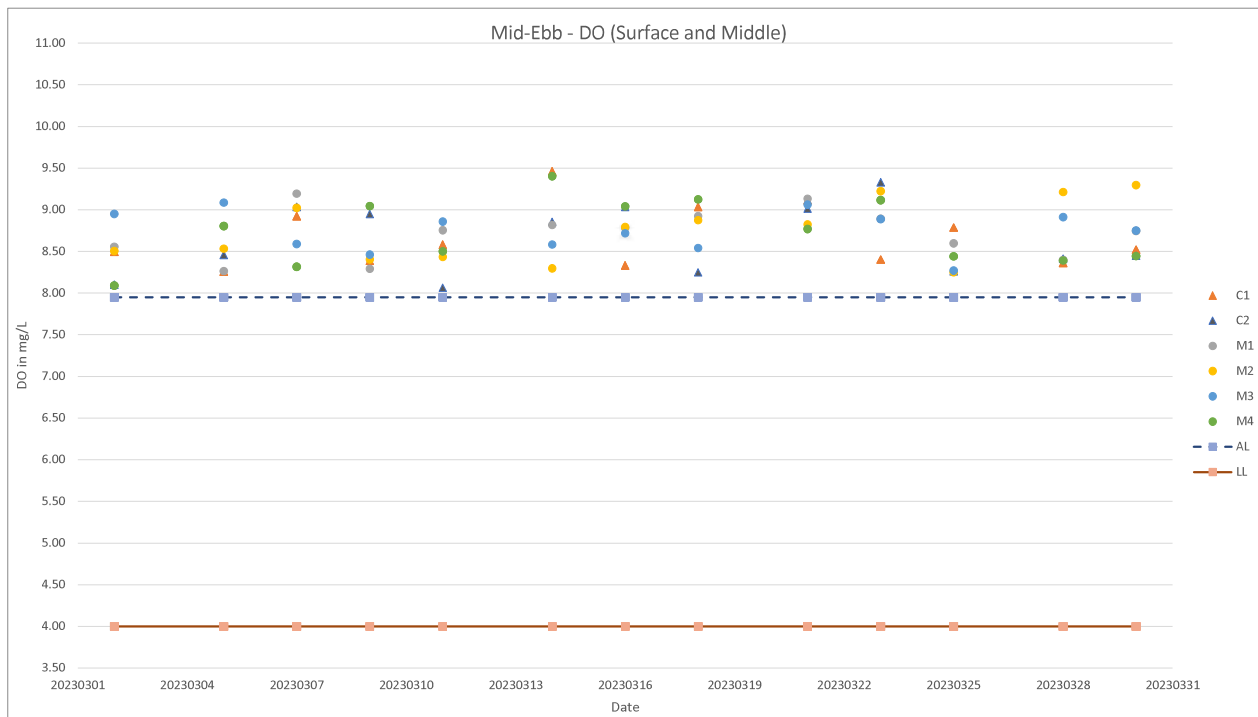
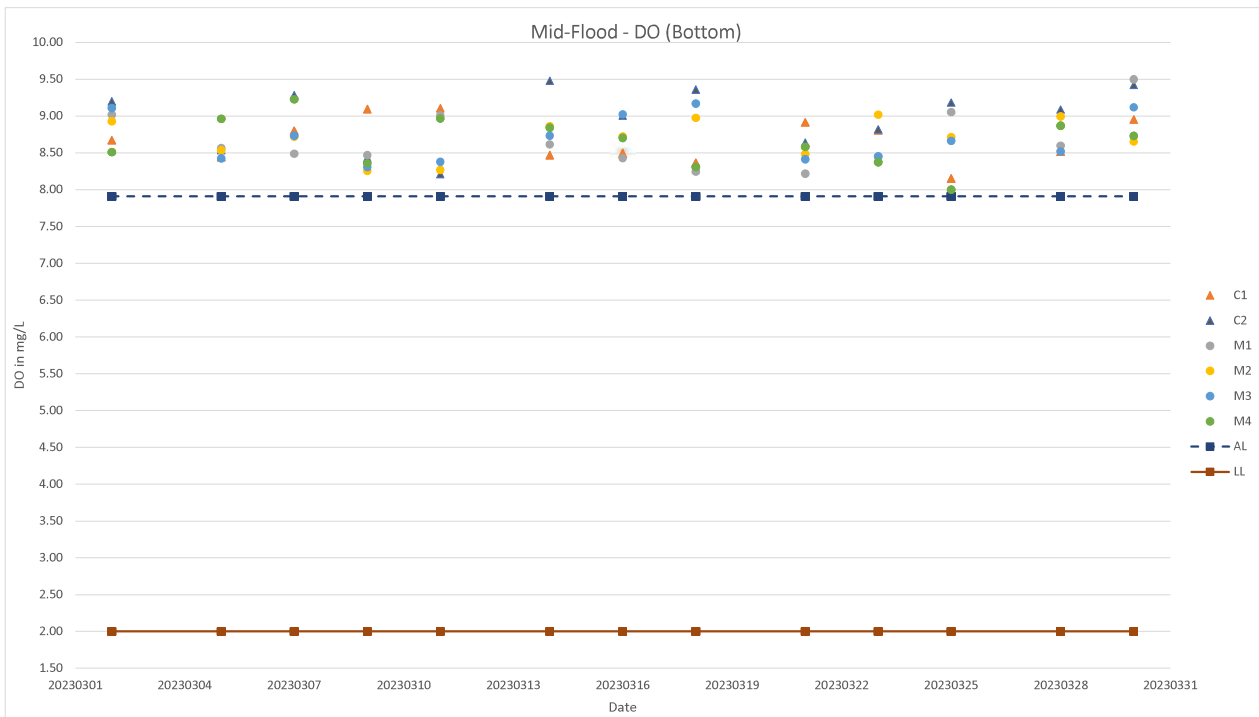
Water Quality Monitoring Results

In this reporting period, water quality monitoring exceedances were recorded and summarized below. According to the field observation by sampling team during sampling event, no silt plume was observed in the Project site; site record showed no marine construction on that day. Weekly inspection on the silt curtain by the contractor on 1, 8, 15, 22 and 29 March 2023, the silt curtain conditions were found in order. Based on the above, it is no substantial evident that the SS exceedance is caused this project.
