Contract No. SPW 02/2023 Environmental Team for Construction of Yuen Long Effluent Polishing Plant Stage 1

Monthly EM&A Report (November 2023) **Drainage Services Department**

EP Condition 3.4 - Monthly EM&A Report for November 2023

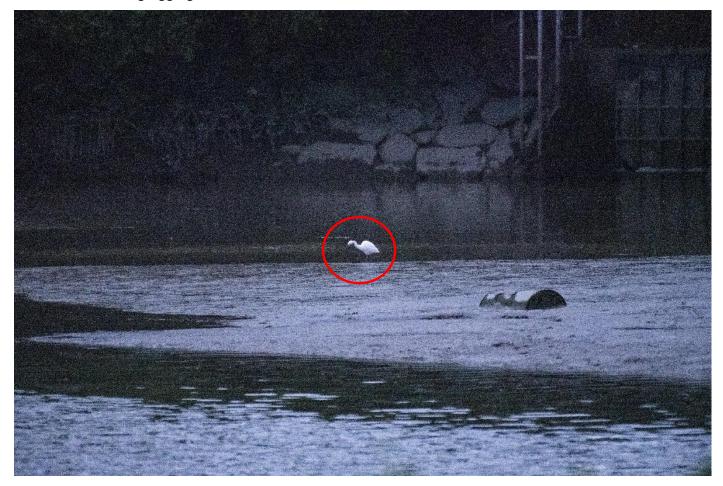
Appendix O.2.1a: Pre-roost aggregate of Little Egret Chinese Pond Heron *Egretta garzetta* in the mudflat area east of the Project boundary observed on 17 October 2023 around 18:12

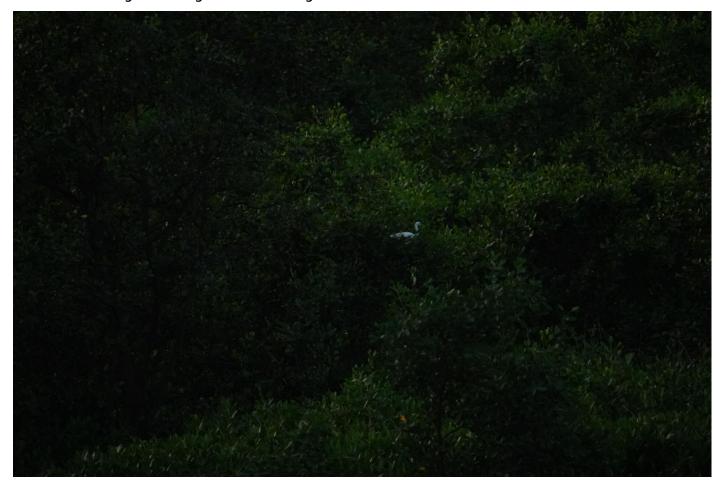
Appendix O.2.2a: Active night roost on *Sonneratia apetala* and *S. caseolaris* mangrove roosting substrate located northeast of the Project boundary observed on 17 October 2023 around 18:30.

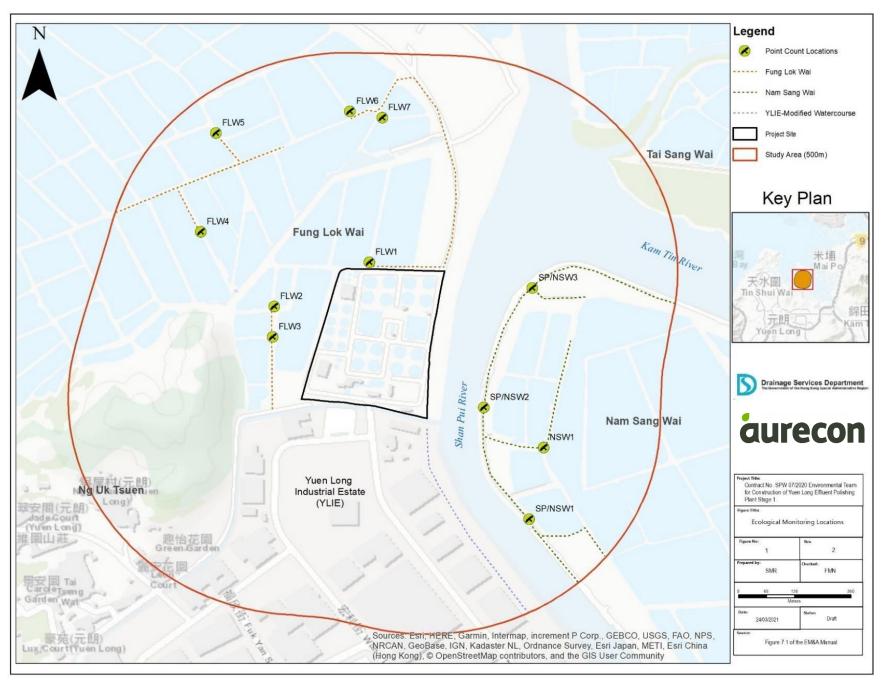
Appendix P
Ecological Bird Monitoring Area with Locations of Point
Count Sites and Transect Route

Appendix P: Ecological bird monitoring area with the locations of point count sites and transect routes
