**Contract No. SPW 02/2023
Environmental Team for
Construction of Yuen Long
Effluent Polishing Plant
Stage 1**

**Monthly EM&A Report (December 2023)
Drainage Services Department**

EP Condition 3.4 – Monthly EM&A Report for December 2023

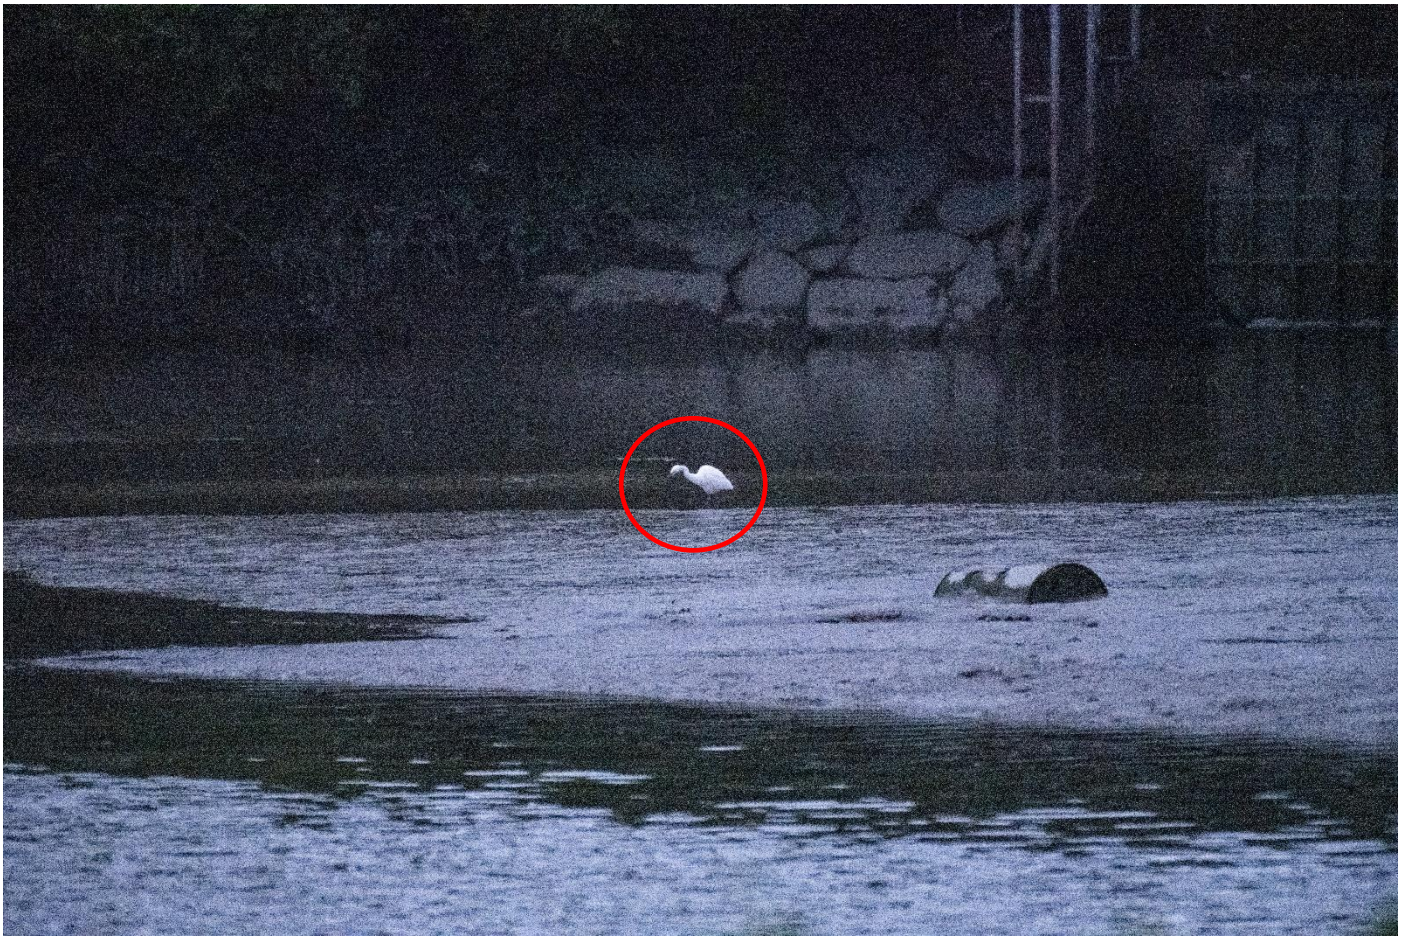
Appendix O.2.1a: Pre-roost aggregate of Little Egret Chinese Pond Heron *Egretta garzetta* in the mudflat area east of the Project boundary observed on 17 October 2023 around 18:12

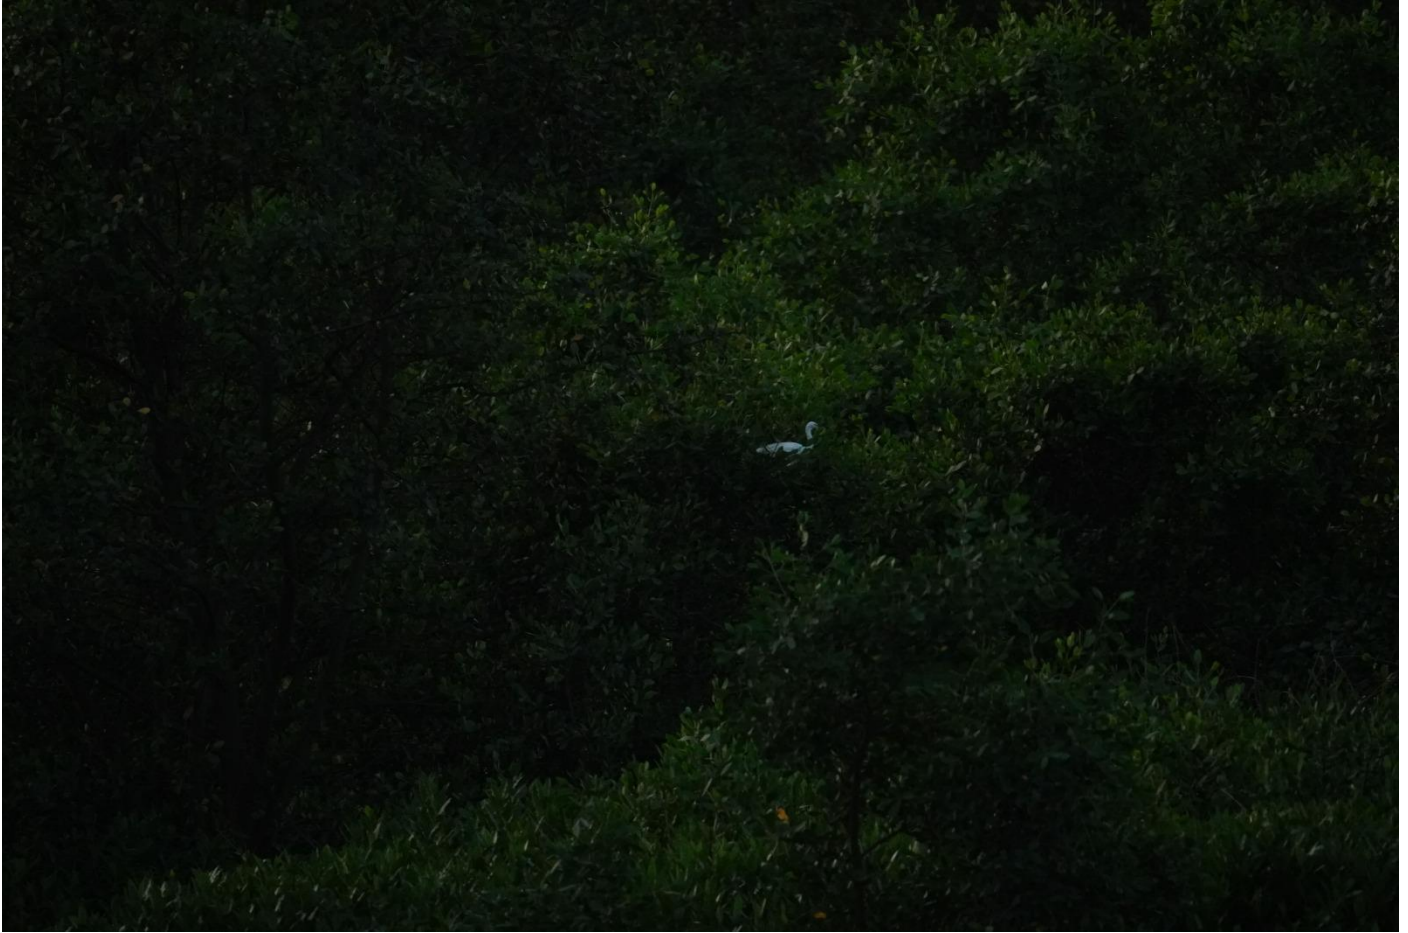
Appendix O.2.2a: Active night roost on *Sonneratia apetala* and *S. caseolaris* mangrove roosting substrate located northeast of the Project boundary observed on 17 October 2023 around 18:30.

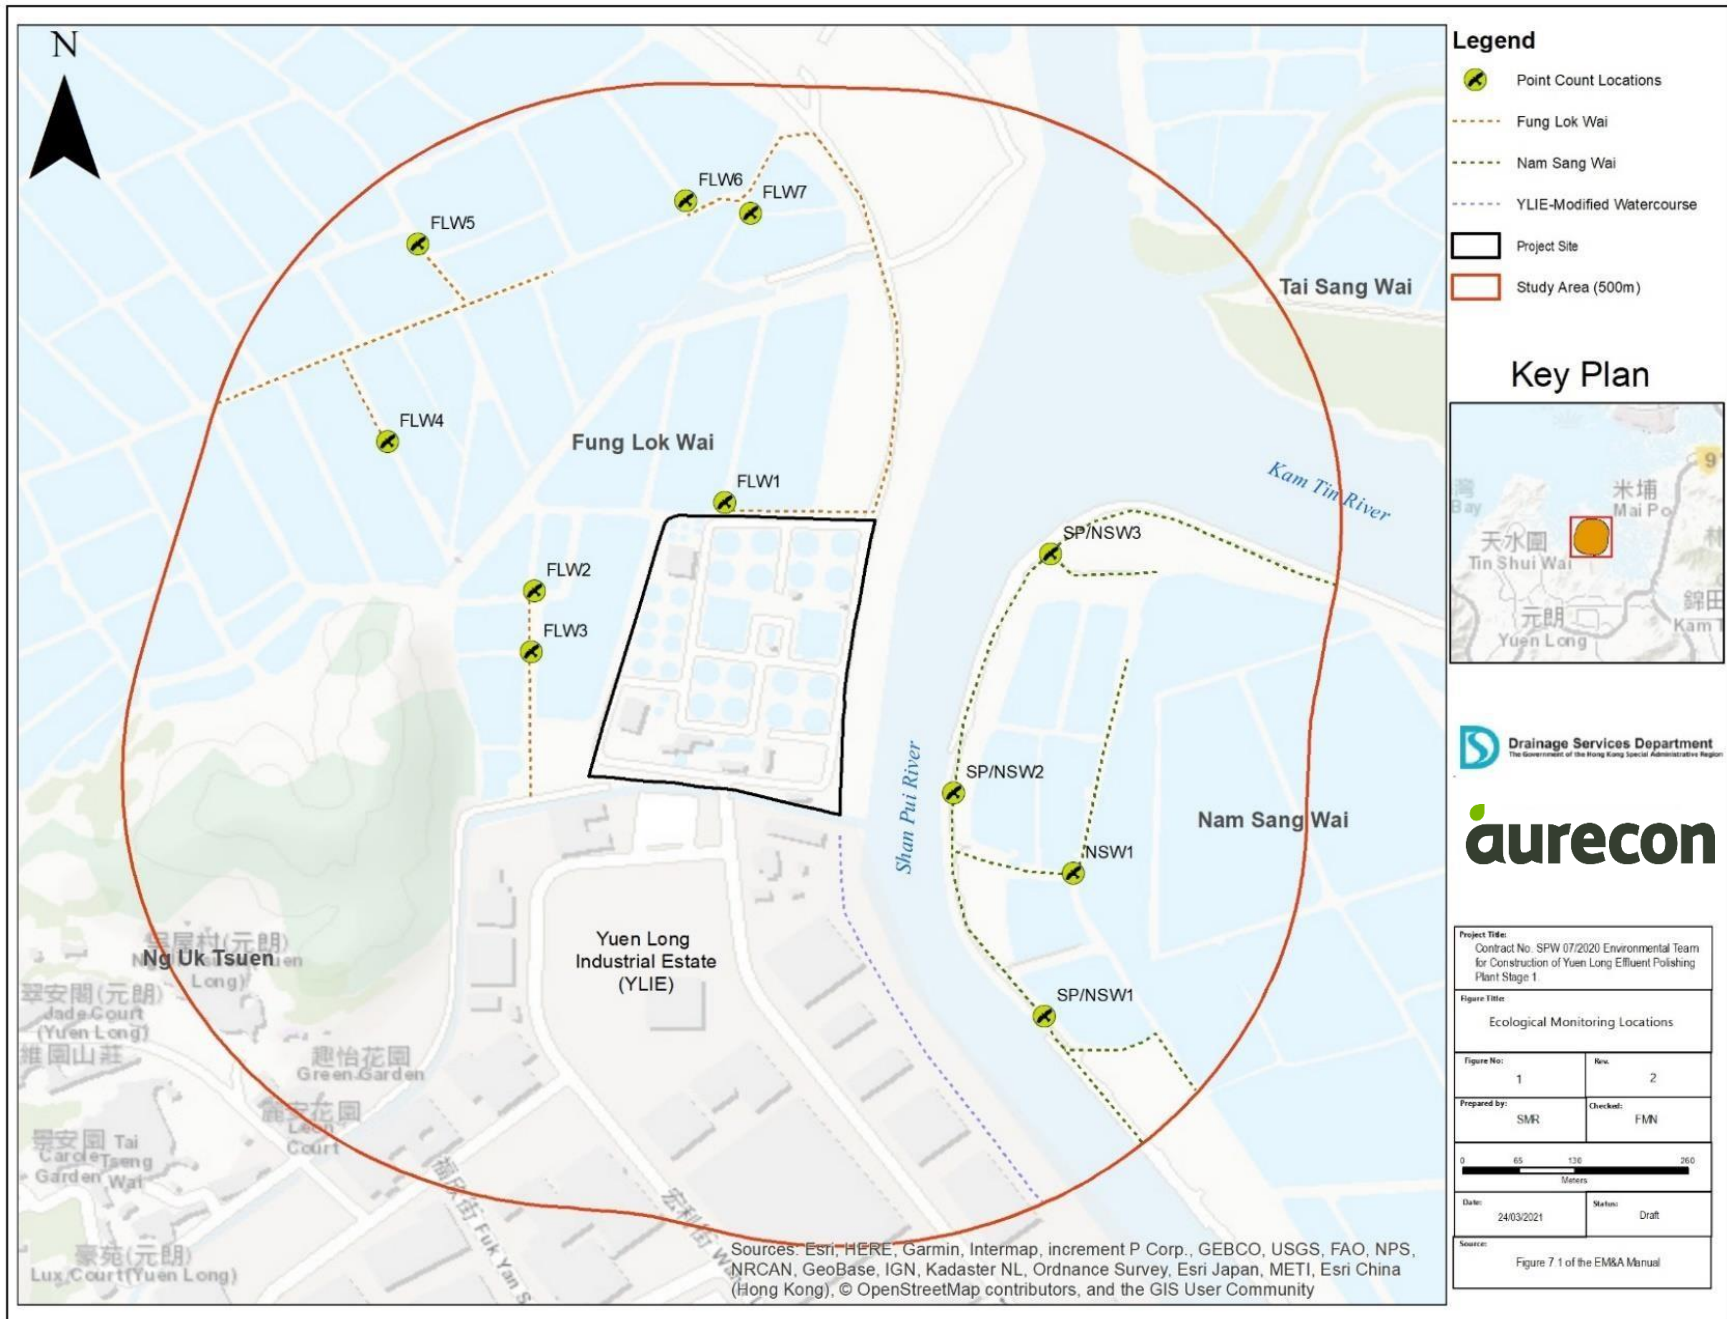
Appendix P: Ecological bird monitoring area with the locations of point count sites and transect routes
