Agreement No. CE 32/2021 (CE)
Improvement Works at Lai Chi Wo Pier and
Tung Ping Chau Public Pier
- Design and Construction

Monthly EM&A Report No. 3 for Lai Chi Wo Pier
(5207869-OR102c-00)

Monthly EM&A Report No. 3 for Lai Chi Wo Pier

[Period from 1 to 30 April 2022]

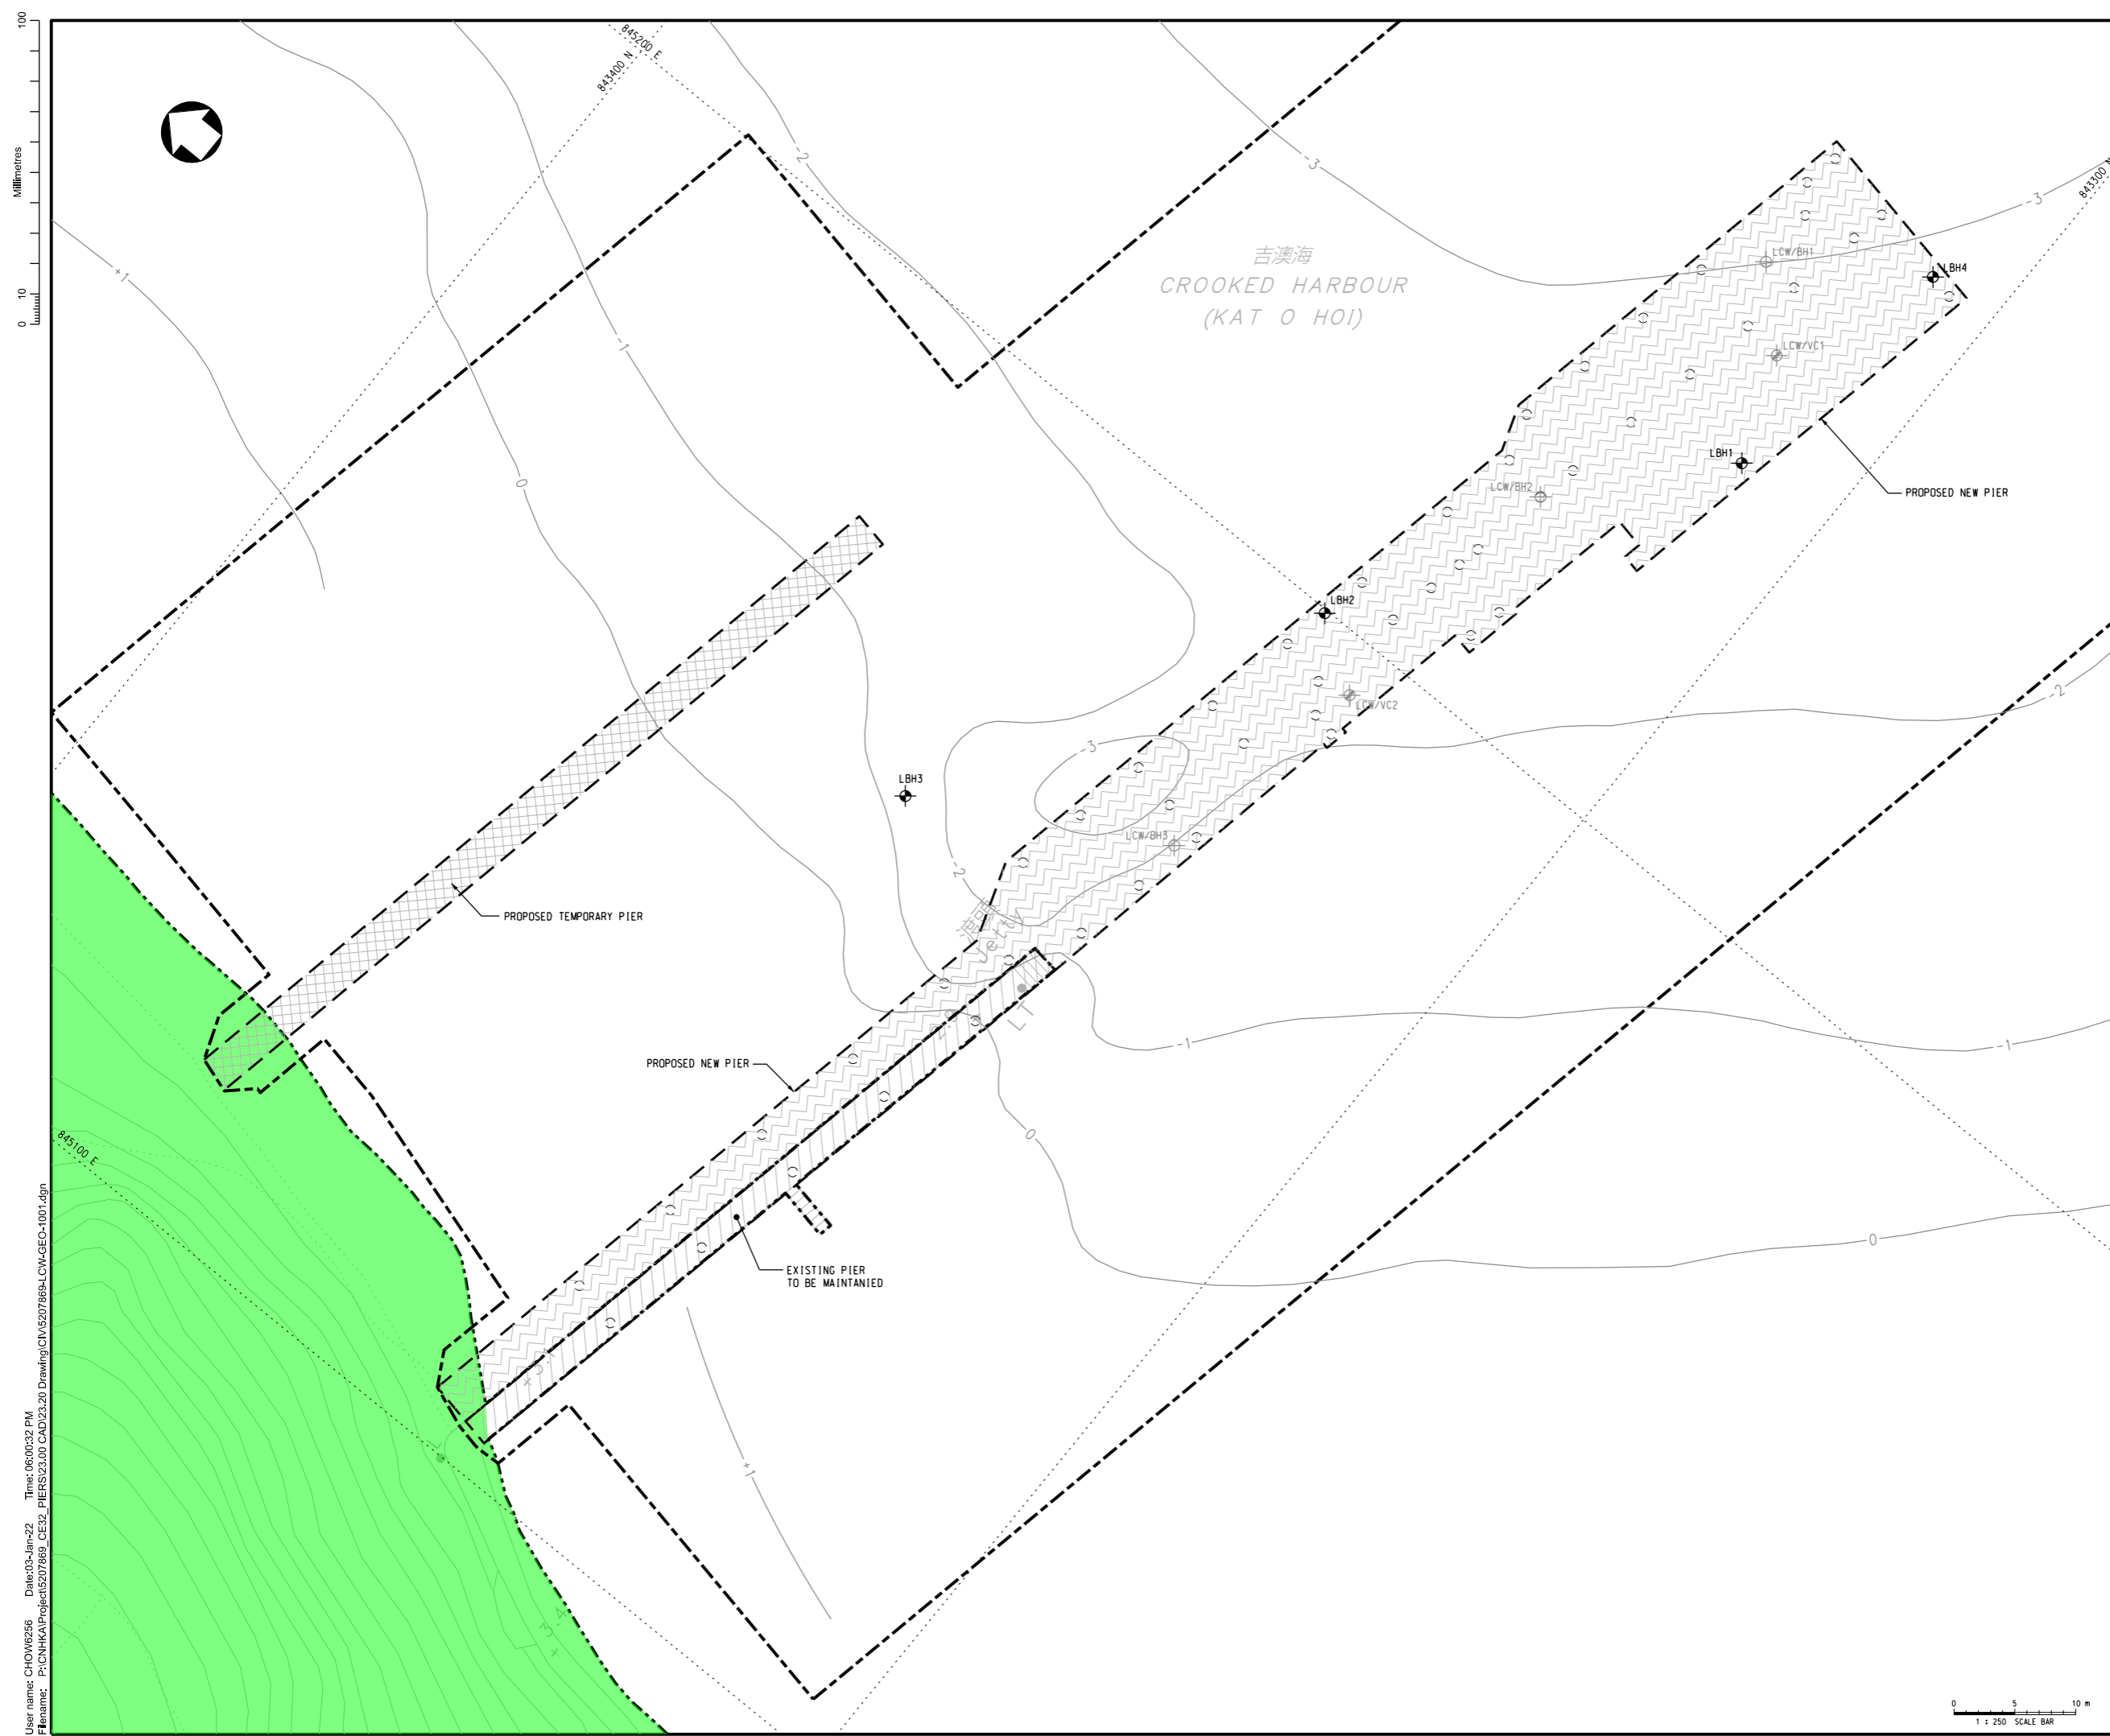
Figure 2 Water Quality Monitoring Locations Designated in the EIA Report

2.1.2.1. Water quality impact monitoring will be carried out at four locations at Yan Chau Tong Marine Park near the hard coral community and seagrass and mangrove at Lai Chi Wo Beach SSSI. The water quality monitoring locations are presented in **Figure 2**. The coordinates and description of monitoring stations are summarised in **Table 2.1**.

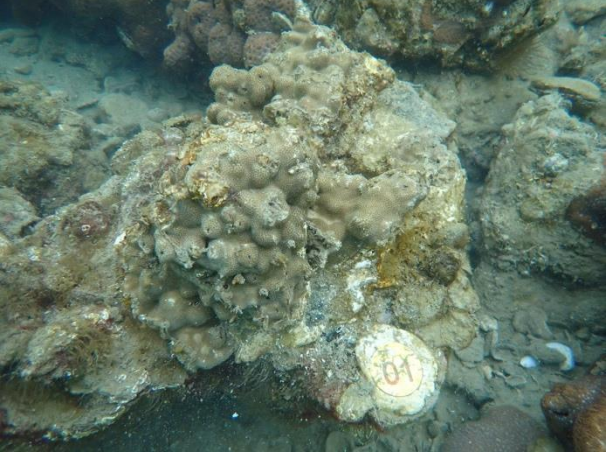
Coral No.	Translocated Coral Colonies
1

An underwater photograph showing a coral colony with a yellow circular tag labeled '01' attached to its base. The coral has a porous, brownish structure and is situated on a sandy seabed with other coral fragments nearby.
2

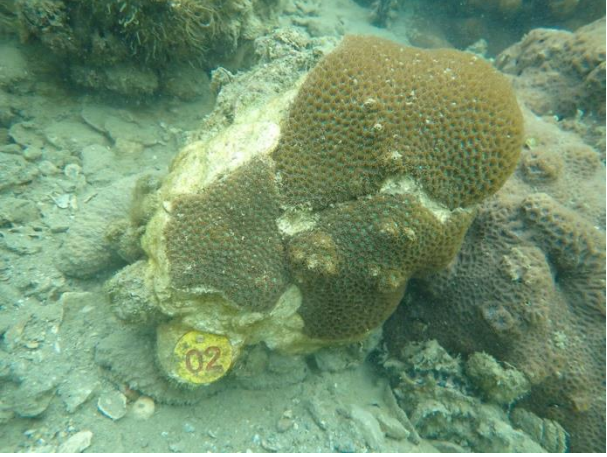
An underwater photograph of a coral colony with a yellow circular tag labeled '02'. The coral is a large, rounded, brownish structure with a distinct porous texture, resting on a sandy bottom.
3

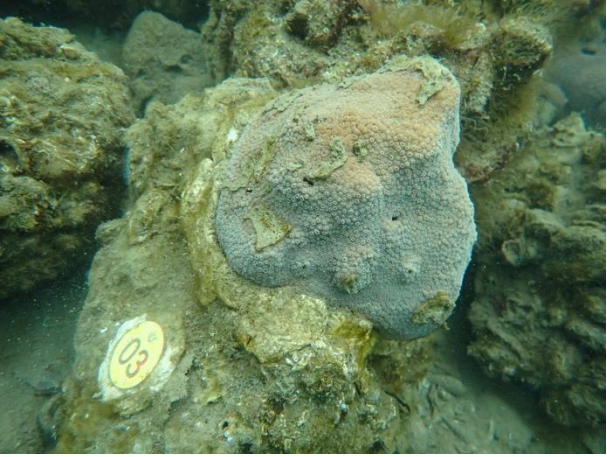
An underwater photograph of a coral colony with a yellow circular tag labeled '03'. The coral is a large, rounded, light-colored structure with a porous texture, resting on a sandy seabed.

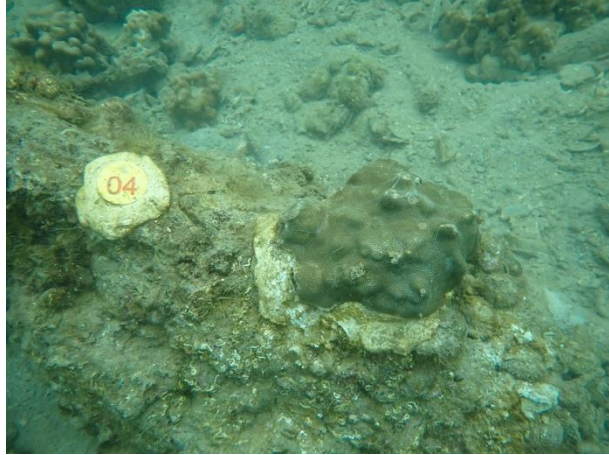
4

2.2.7.5. All translocated hard coral colonies were monitored and each coral colony were photographed. The health condition of all the translocated coral colonies were good. In addition, the 10 existing natural hard coral colonies monitored at the recipient site are all in good condition.

2.2.7.6. No partial mortality, sediment and bleaching in the general condition of translocated coral colonies were observed during the monitoring period. No deterioration of the coral community was observed during the monitoring period when compared with the baseline survey results. There is no Action / Limit Level exceedance during the monitoring period.
