Monthly EM&A Report (August 2022)

Sai O Trunk Sewer Sewage Pumping Station

**Re: Sai O Trunk Sewer Sewage Pumping Station
Environmental Permit No. EP-597/2021
Monthly EM&A Report (August 2022)**

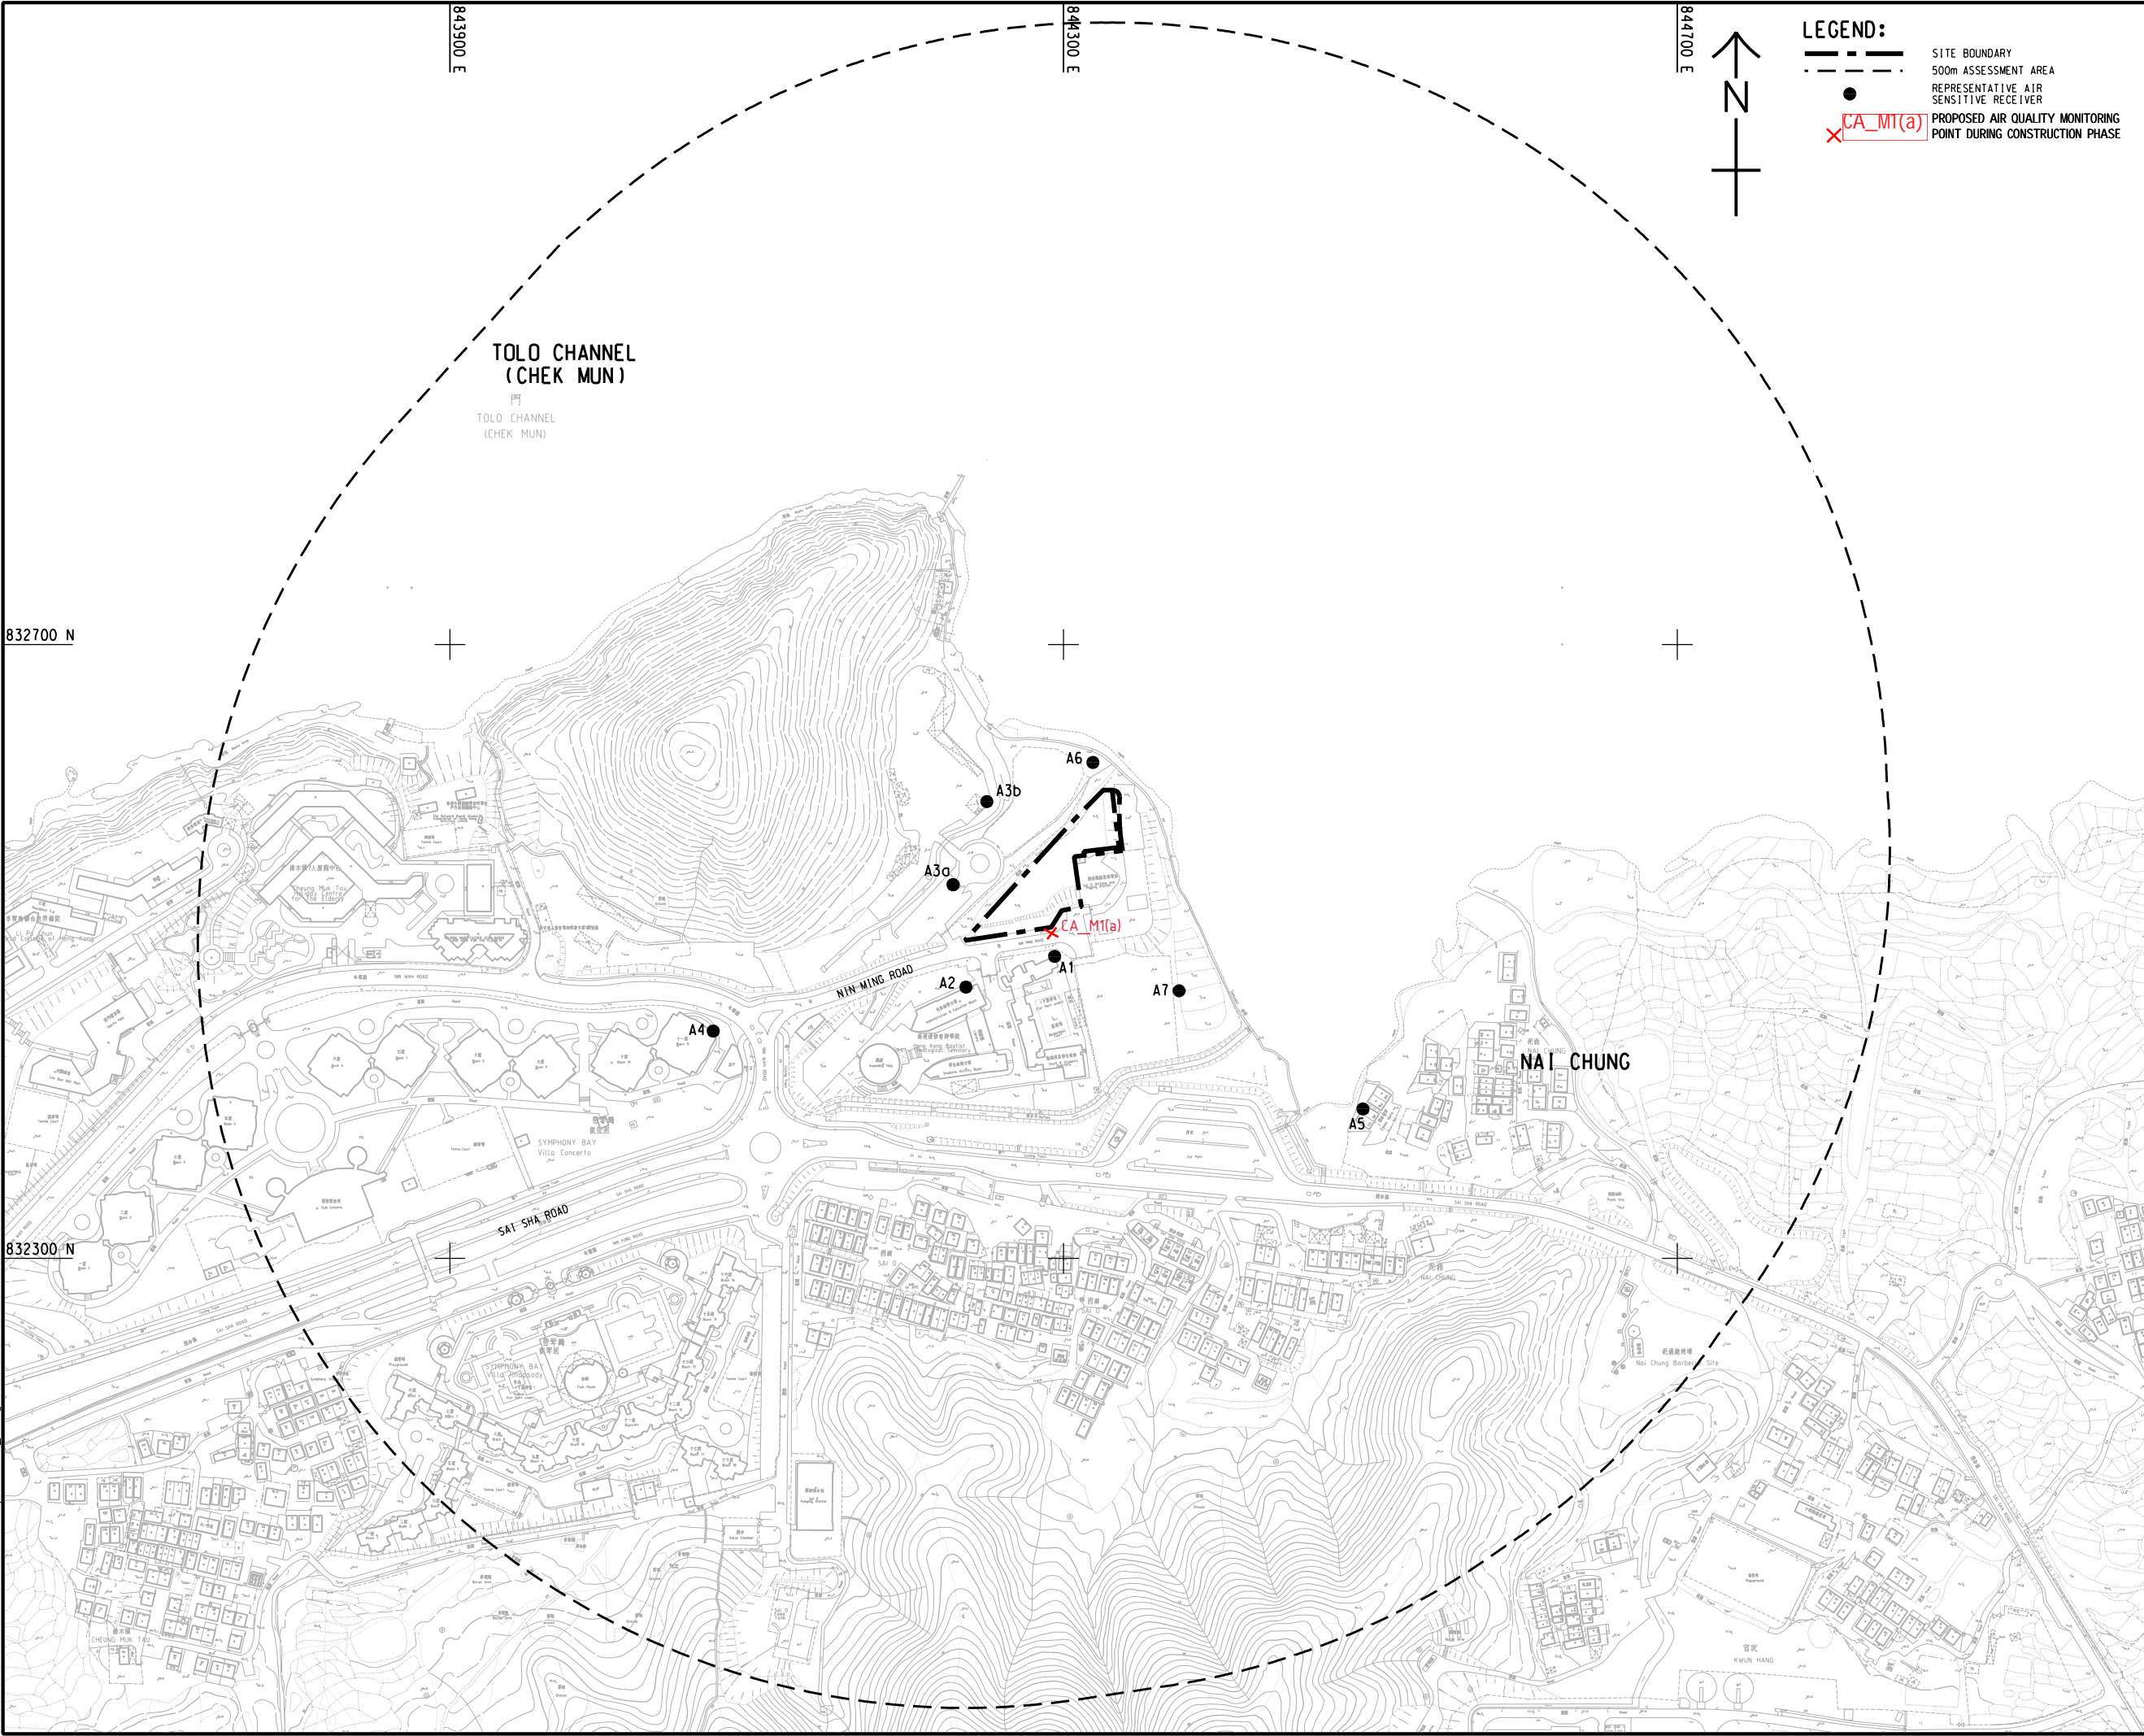
Air Quality Monitoring Location

- 2.6.1 In accordance with the EM&A Manual, air quality monitoring should be carried out at a designated monitoring location.
- 2.6.2 As limitation of stable electricity supply & safety concern could not be obtained from the designated dust monitoring location, an alternative monitoring location (CA_M1(a)) was proposed to measure 1-hour TSP levels in accordance with EP Condition 3.1 & Section 2.2.1.20 of the EM&A manual. The alternative monitoring location (CA_M1(a)) was approved by EPD on 15 December 2021.
- 2.6.3 The air quality monitoring location summarised in **Table 2.3** and shown in **Figure 2.1**.

- SITE BOUNDARY
- - - 500m ASSESSMENT AREA
- REPRESENTATIVE AIR SENSITIVE RECEIVER
- X CA_M1(a) PROPOSED AIR QUALITY MONITORING POINT DURING CONSTRUCTION PHASE

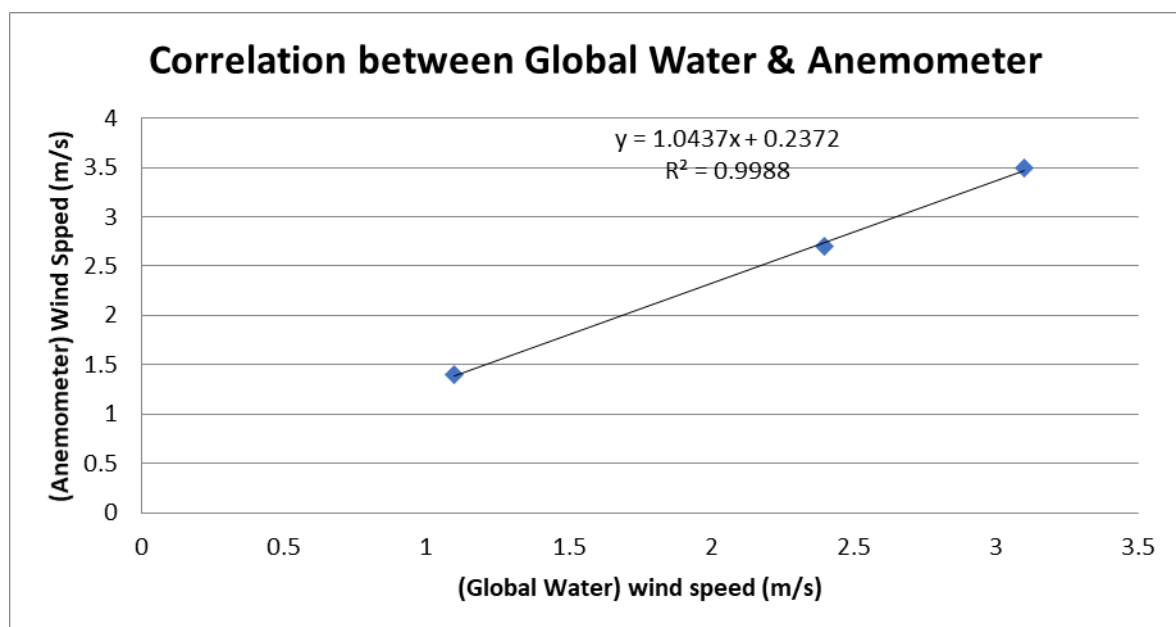
Wind Speed Test:

Global Water (m/s)	Anemometer (m/s)
1.1	1.4
2.4	2.7
3.1	3.5

- Actual Wind Speed Value (m/s) = $1.1071 \times (\text{Reading of Global Water Instrument}) + 0.0643$
- Correlation coefficient (R^2) = 0.9988
- Acceptable Range: $R^2 \geq 0.99$
