Monthly EM&A Report (September 2022)

Sai O Trunk Sewer Sewage Pumping Station

**Re: Sai O Trunk Sewer Sewage Pumping Station
Environmental Permit No. EP-597/2021
Monthly EM&A Report (September 2022)**

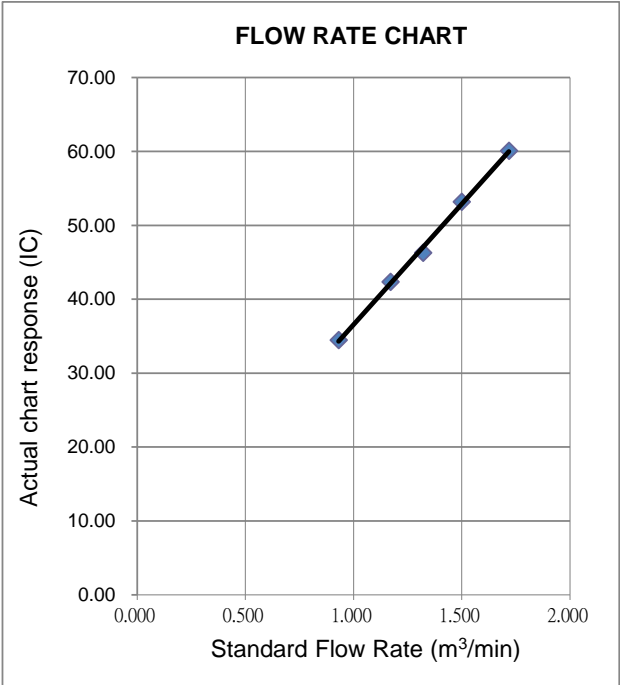
FLOW RATE CHART

- 2.4.2 Prior to the commencement of the dust sampling, the flow rate of the HVS shall be properly set. The flow rate shall be indicated on the flow rate chart. The power supply should be checked to ensure the proper functioning of the sampler. The sampler is recommended to be operated for 5 minutes to establish thermal equilibrium before placing any filter media at the designated air monitoring station.
- 2.4.1 The filter holding frame should be removed by loosening the four nuts and placing carefully a weighted and conditioned filter at the centre with the stamped number upwards on a supporting screen.
- 2.4.2 The filter should be aligned on the screen so that the gasket formed an airtight seal on the outer edges of the filter. The filter holding frame should be tightened to the filter holder with swing bolts. The applied pressure should be sufficient to avoid air leakage at the edges.

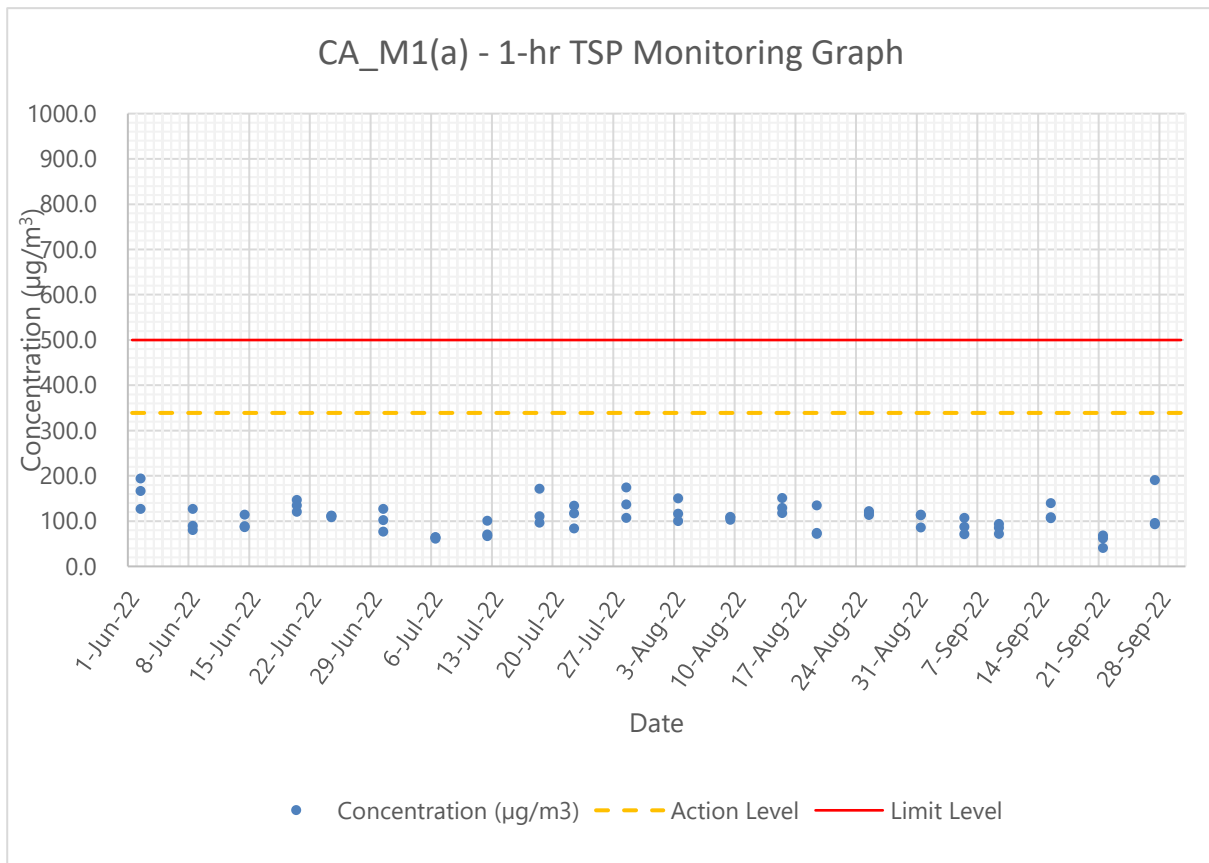
1-hr TSP Monitoring Graph

- 2.7.3 No Action / Limit Level exceedance was recorded for 1-hr TSP at CA_M1(a).
- 2.7.4 No effect that arose from the other special phenomena and work progress of the concerned site was noted during the current monitoring month.
- 2.7.5 The Action and Limit Levels for impact air quality monitoring have been set and are presented in **Appendix G**.
- 2.7.6 The Event and Action Plan for Air Quality is given in **Appendix H**.
- 2.7.7 The weather conditions during the monitoring are provided in **Appendix I**.
- 2.7.8 The wind data obtained from the on-site wind station during the reporting period is provided in **Appendix J**.
