Monthly EM&A Report (November 2022)

Sai O Trunk Sewer Sewage Pumping Station

**Re: Sai O Trunk Sewer Sewage Pumping Station
Environmental Permit No. EP-597/2021
Monthly EM&A Report (November 2022)**

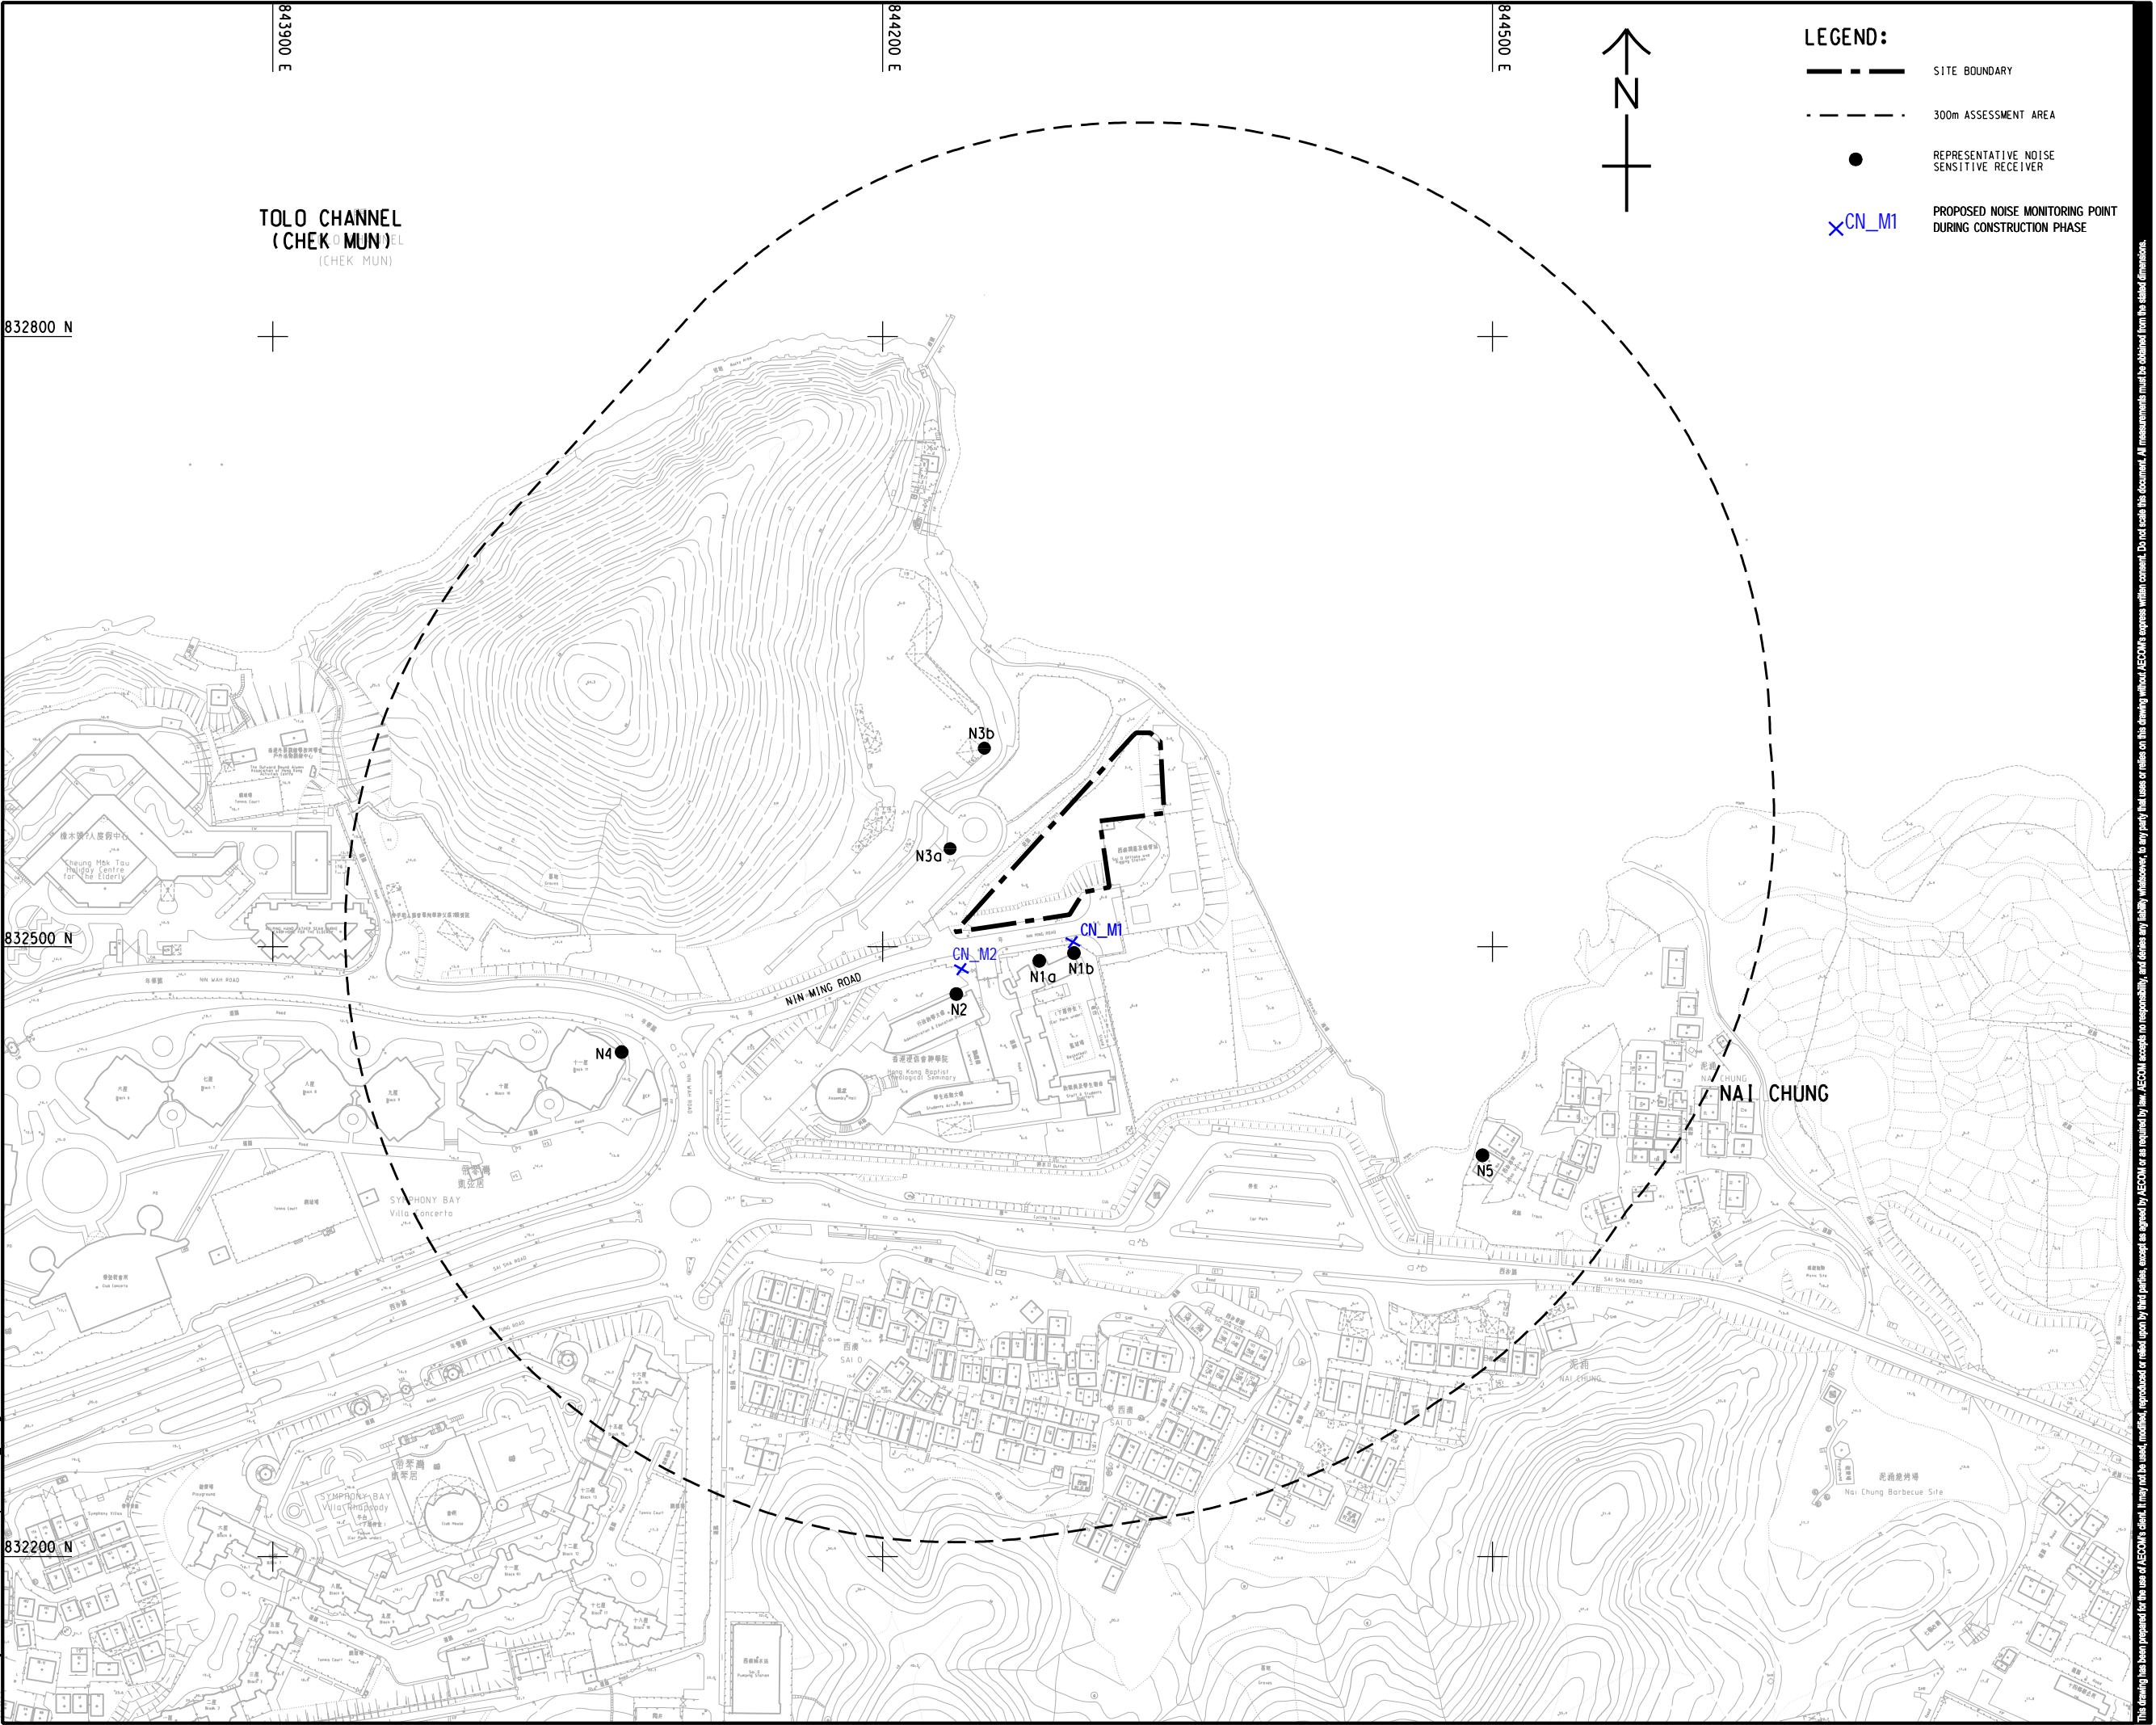
Noise Monitoring Locations

- SITE BOUNDARY
- - - 300m ASSESSMENT AREA
- REPRESENTATIVE NOISE SENSITIVE RECEIVER
- ✕CN_M1 PROPOSED NOISE MONITORING POINT DURING CONSTRUCTION PHASE

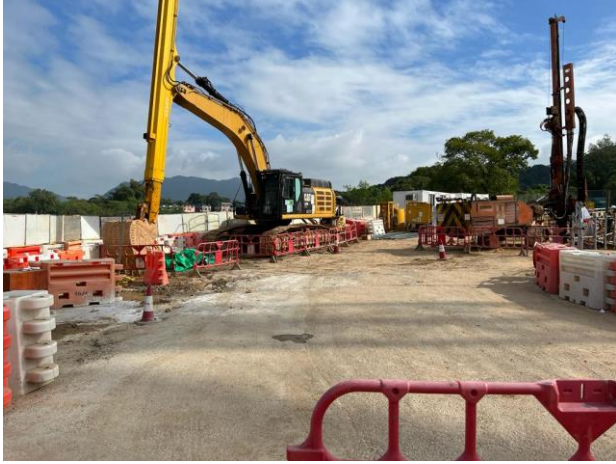
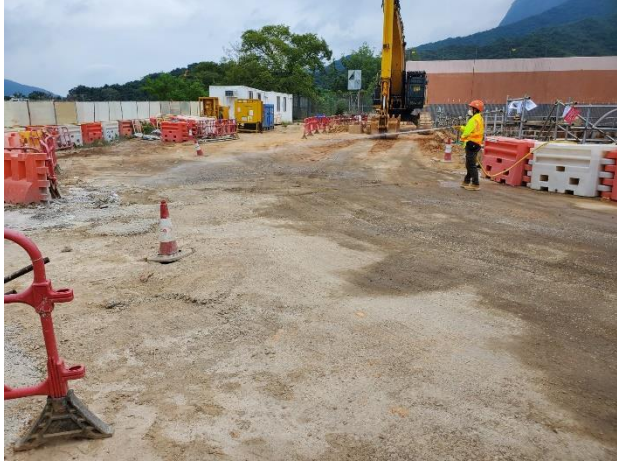
Date of Inspection: 14 November 2022

Reminder 1: Frequency of water spraying should be increased as dust control measures.	Water spraying had been provided more frequently.

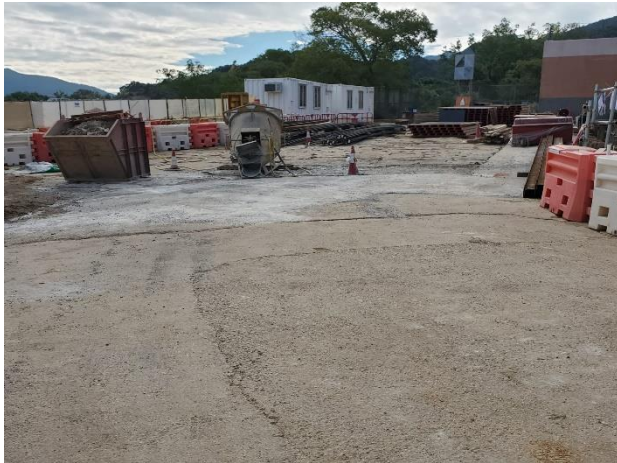
Date of Inspection: 28 November 2022

Reminder 1: Mud near the main haul should be removed.	Mud near the main haul had been removed
