Monthly EM&A Report (December 2022)

Sai O Trunk Sewer Sewage Pumping Station

**Re: Sai O Trunk Sewer Sewage Pumping Station
Environmental Permit No. EP-597/2021
Monthly EM&A Report (December 2022)**

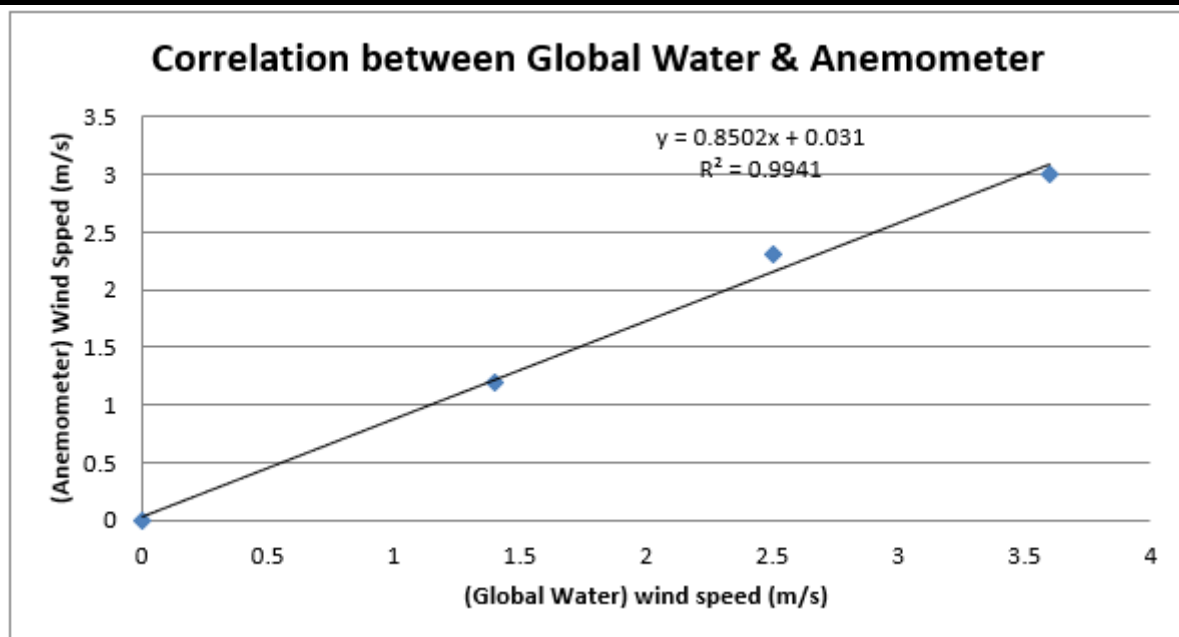
Wind Speed Test:

Global Water (m/s)	Anemometer (m/s)
1.2	1.4
2.3	2.5
3.0	3.6

- Actual Wind Speed Value (m/s) = $0.8502 \times (\text{Reading of Global Water Instrument}) + 0.031$
- Correlation coefficient (R^2) = 0.9941
- Acceptable Range: $R^2 \geq 0.99$

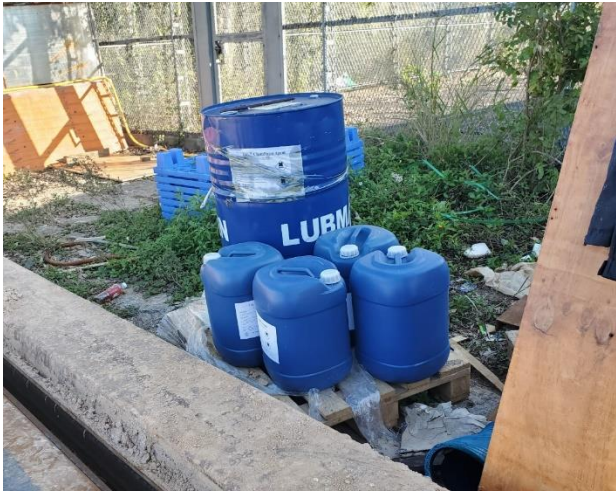
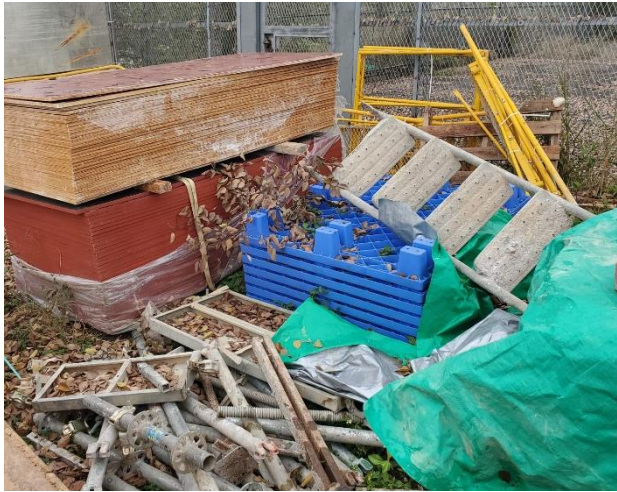
Date of Inspection: 19 December 2022

- Drip tray should be provided to prevent any chemical leakage.

Reminder 1: Drip tray should be provided to prevent any chemical leakage	Chemicals on-site had been stored separately.
