Reprovisioning and Upgrading of Salt  
Water Service Reservoirs in Western  
District for Water Supplies Department:  
*Tenth Monthly Environmental  
Monitoring and Audit Report*

June 2008

MONTHLY ENVIRONMENTAL  
MONITORING & AUDIT REPORT

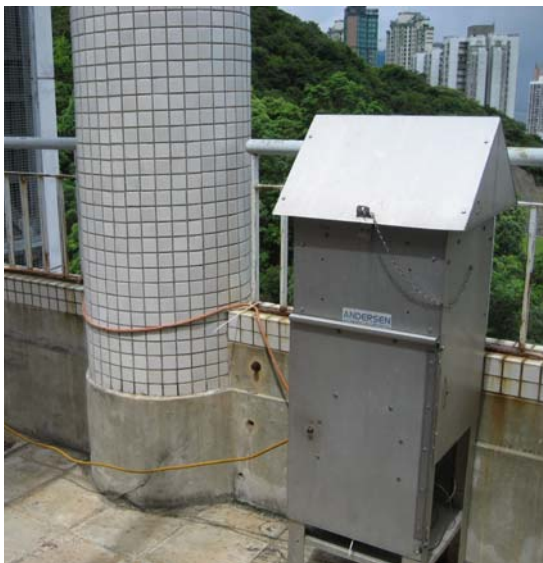
The HVS at AM1 were placed at the rooftop of Chow Yei Ching Building at about 33 m above local ground level. The HVS was free-standing with no obstruction.

Air Quality Monitoring Station (AM1)

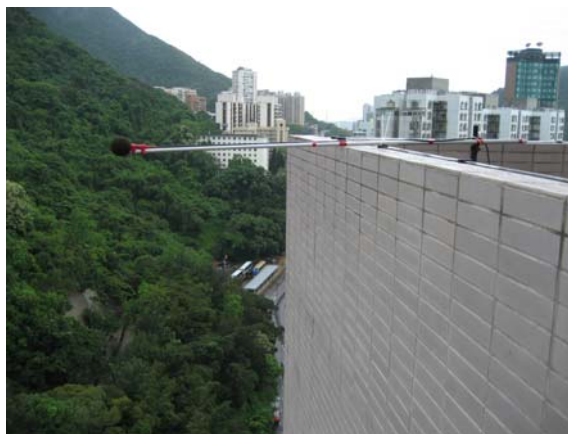
Baseline Noise Monitoring Station (NM2)
