Reprovisioning and Upgrading of Salt
Water Service Reservoirs in Western
District for Water Supplies Department:
*Sixteenth Monthly Environmental
Monitoring and Audit Report*

December 2008

MONTHLY ENVIRONMENTAL
MONITORING & AUDIT REPORT

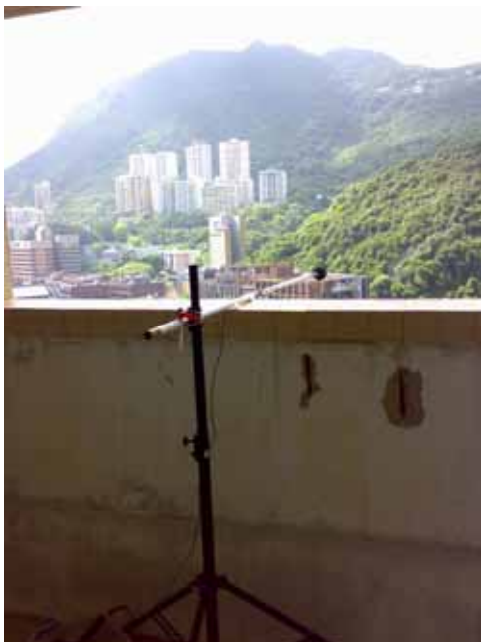
Noise Monitoring Station (NM1)

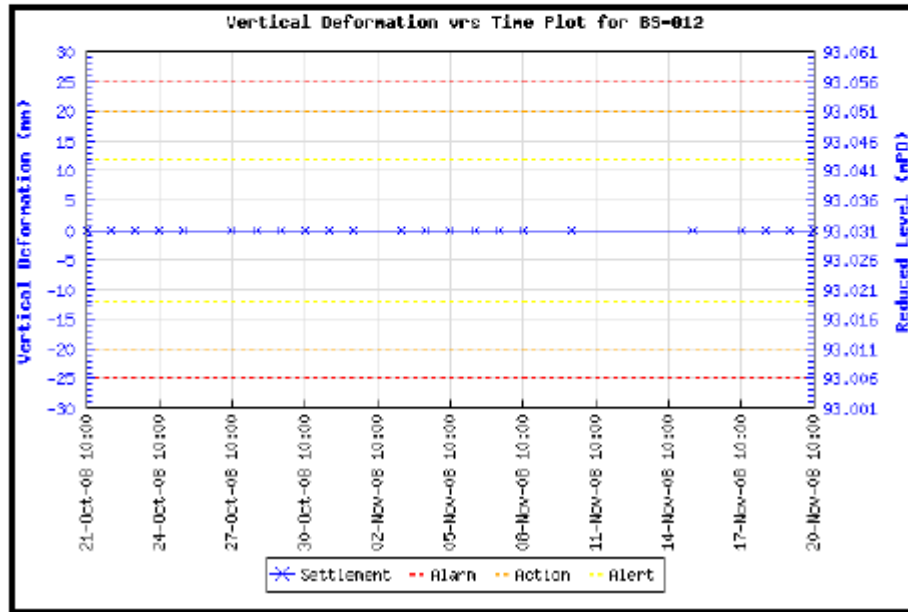
SETTLEMENT MONITORING RECORD SHEET

Instrument ID : BS-012
 Easting : 831796.239
 Location : Valve House
 Remark :

Type : Building Settlement Marker Type DMP5
 Northing : 816000.503 Initial Level : 93.031 mPD
