Reprovisioning and Upgrading of Salt
Water Service Reservoirs in Western
District for Water Supplies Department:
*Twenty-sixth Monthly Environmental
Monitoring and Audit Report*

October 2009

MONTHLY ENVIRONMENTAL
MONITORING & AUDIT REPORT

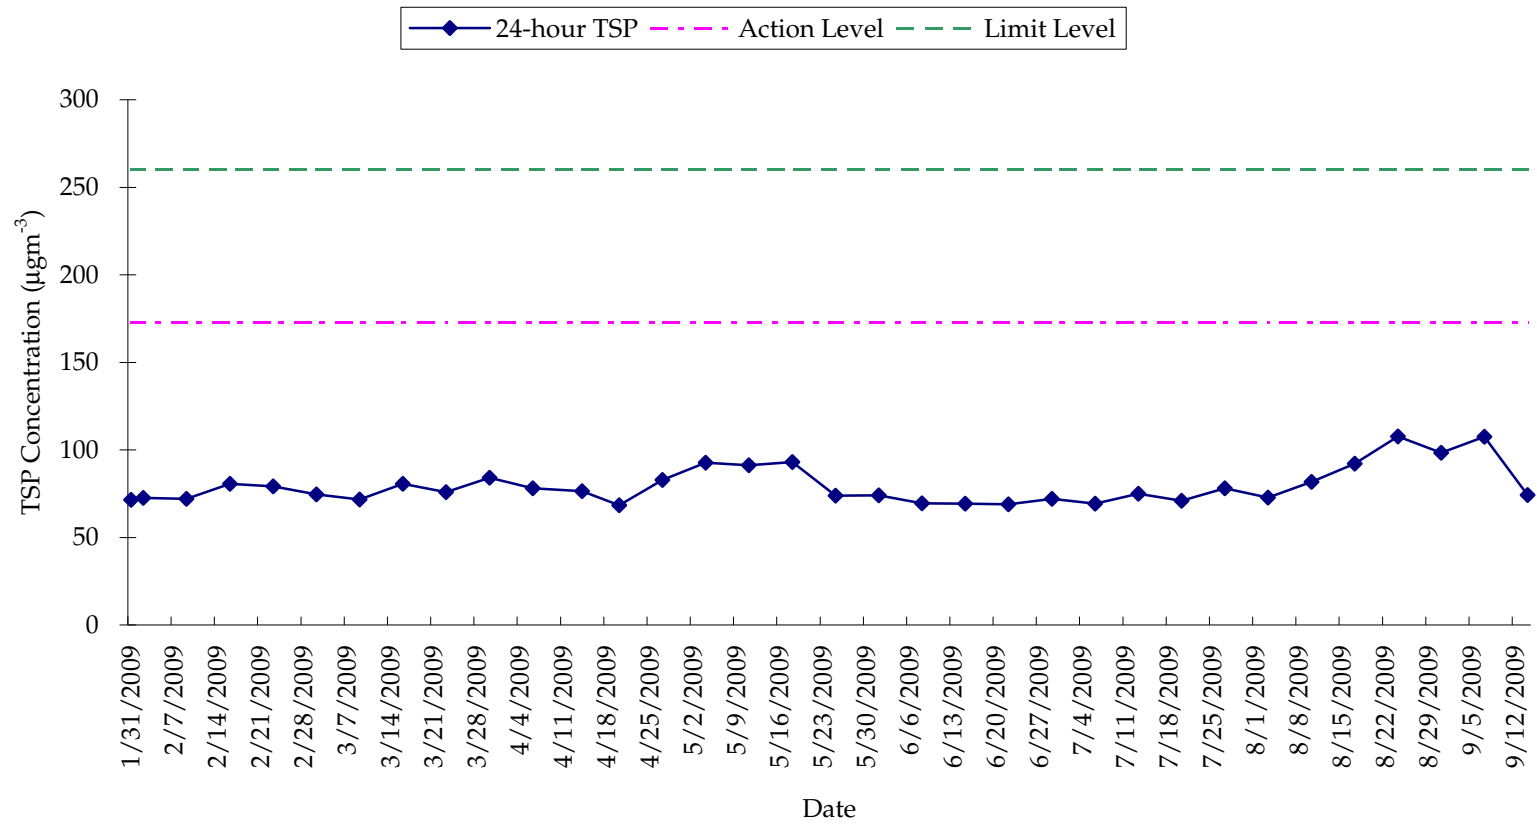
Four sets of 24-hour TSP measurements were carried out at the monitoring station AM1 during the reporting period. The monitoring data for 24-hour TSP together with wind data and graphical presentations are presented in *Annex F*. The weather condition during the monitoring period varied from sunny to cloudy. The local impacts near the monitoring station were mainly associated with vehicular emissions from the road traffic along Pok Fu Lam Road. No exceedance of the Action and Limit Levels for 24-hour TSP was recorded during the reporting period.

Figure F1 - Measured 24-hour TSP Concentration (μgm^{-3}) at AM1

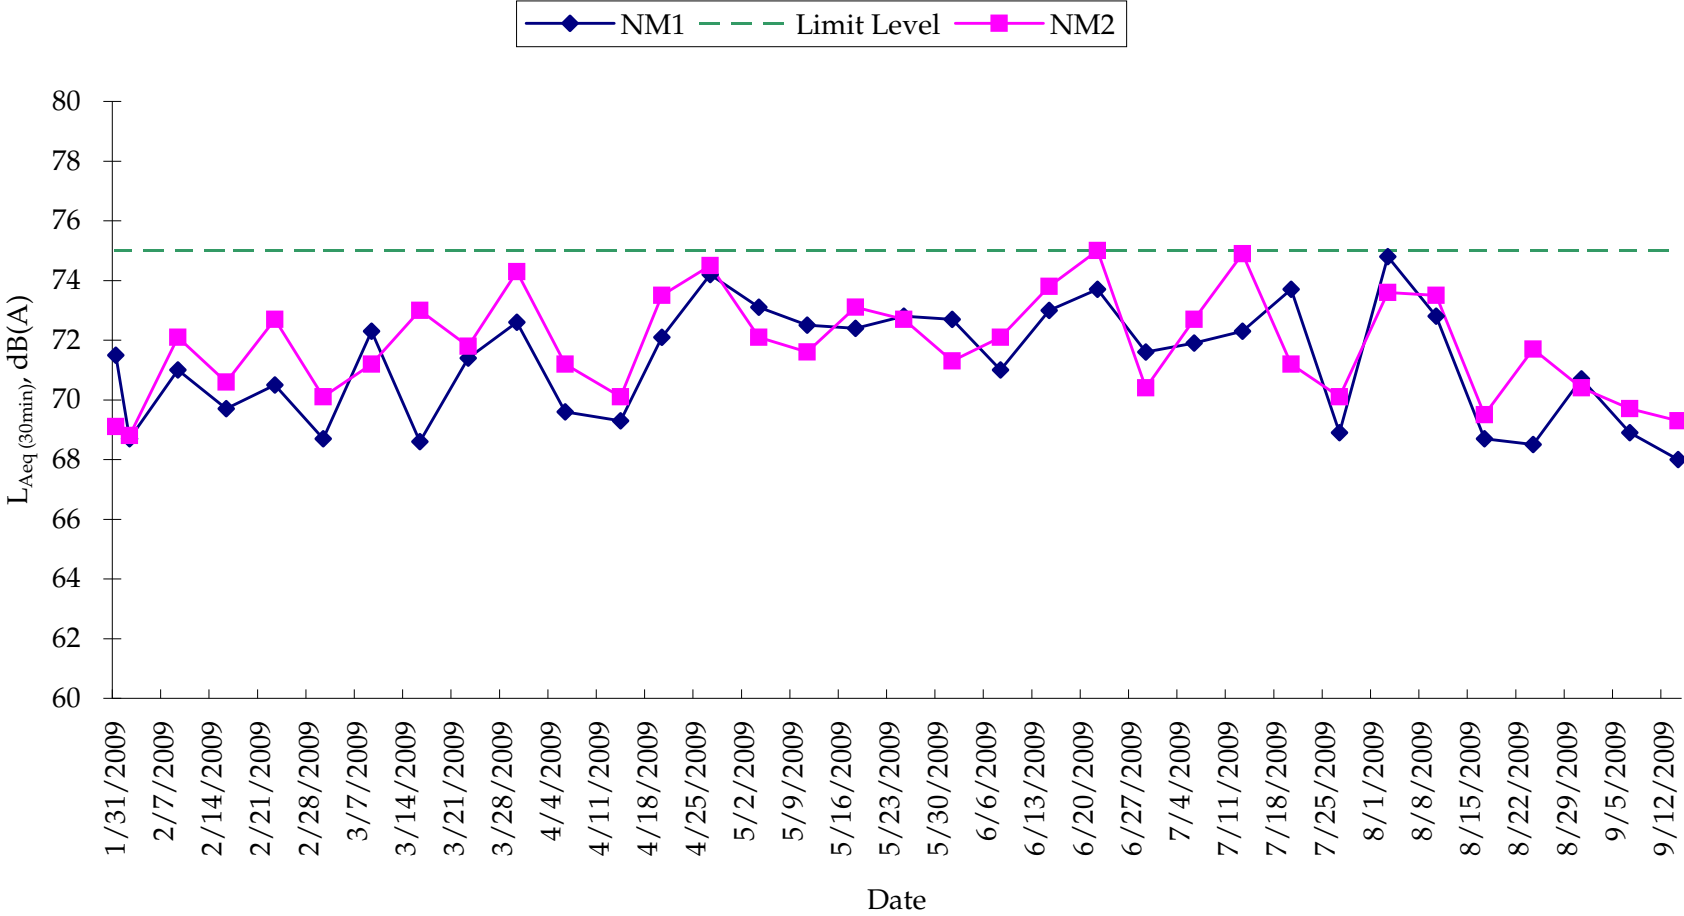
Four sets of 30-minute construction noise measurements were carried out at monitoring stations NM1 & NM2 during the reporting period. The monitoring results together with graphical presentations are presented in *Annex G*. The local impacts observed near the monitoring stations were mainly traffic noise from Pok Fu Lam Road and the concurrent projects undertaken in the vicinity. No exceedance of the Action and Limit Levels for construction noise was recorded during the reporting period.

Figure G1 - Noise Monitoring Results ($L_{eq, 30min}$)
