Construction of a Secondary Boundary
Fence and New Sections of Primary
Boundary Fence and Boundary Patrol Road

Section 4 – Lin Ma Hang Village to Sha Tau Kok
Monthly EM&A Report for August 2011 (Rev A)

September 2011
Architectural Services Department

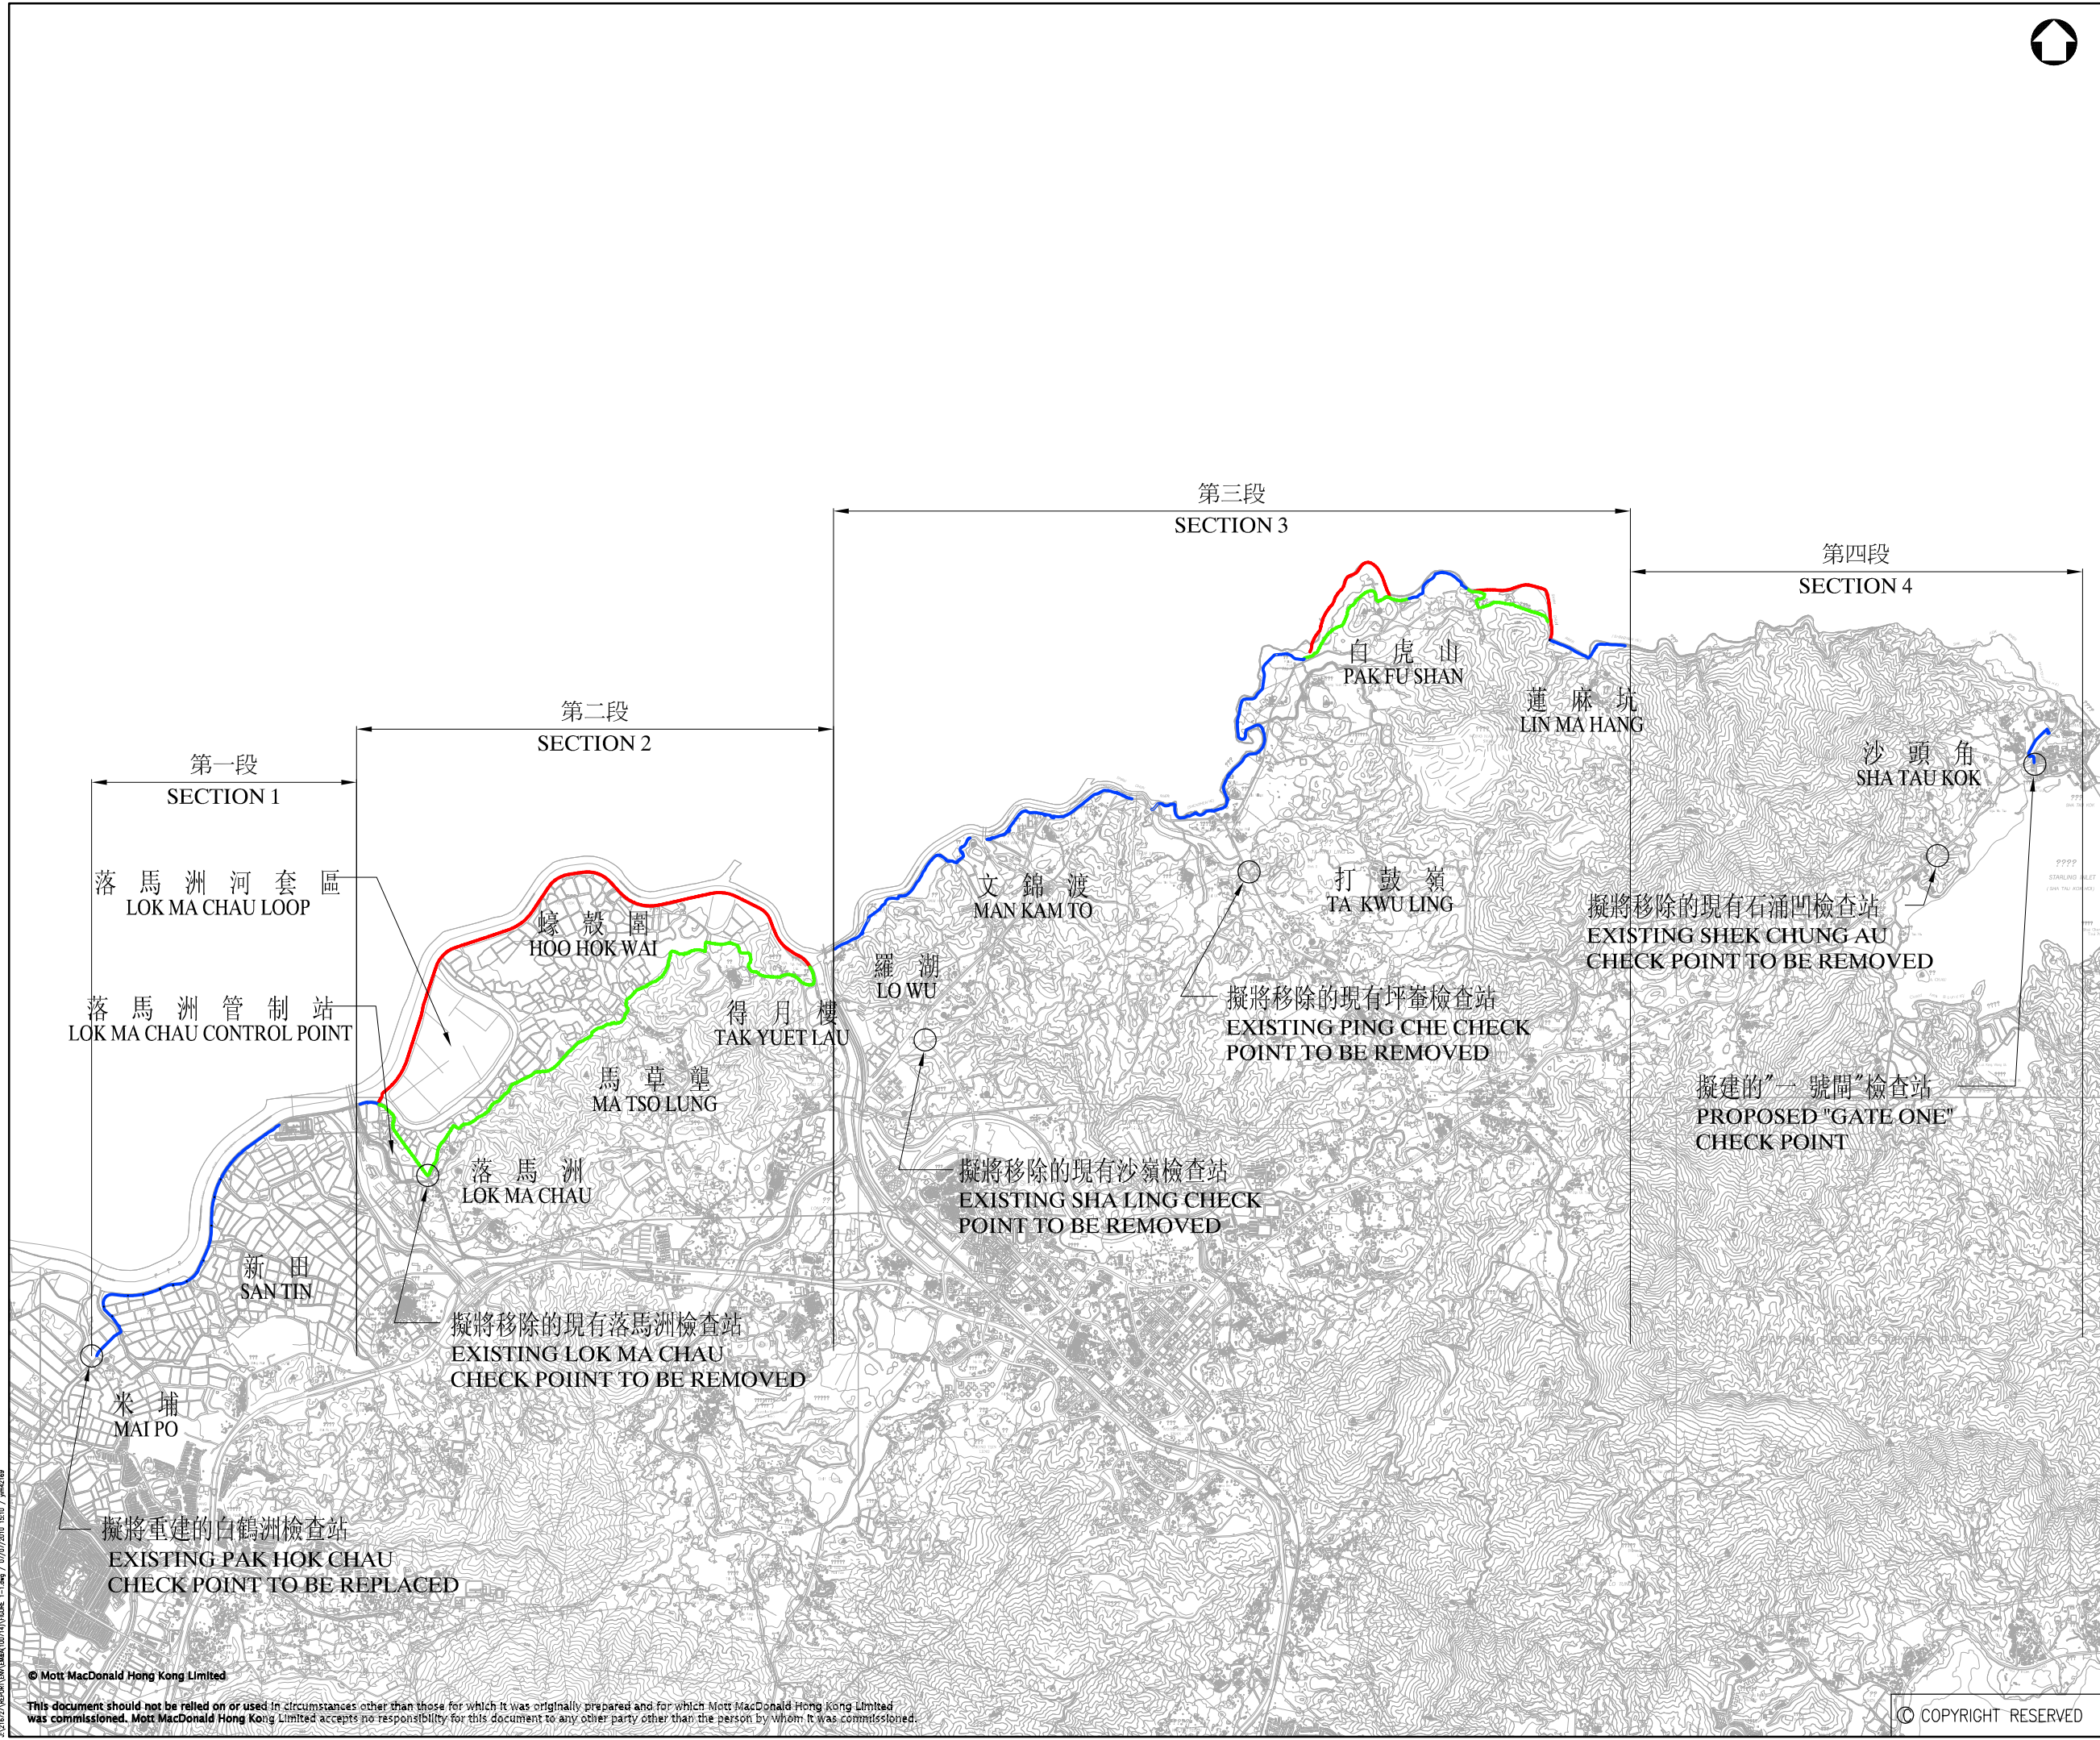
Designed	WHC	Eng.Chk.	WHC
Drawn	MCL	Coordination	WHC
Dwg.Chk.	WHC	Approved	TI
Scale	Project 216727		Status
N.T.S.	CAD File	INF	
Drawing No.		FIGURE 1.1 (圖 1.1)	Rev
© COPYRIGHT RESERVED			P1

- 建議於現有邊界巡邏通路興建的輔助邊界圍網
PROPOSED SECONDARY BOUNDARY FENCE
ALONG EXISTING BOUNDARY PATROL ROAD
- 建議的主要及輔助邊界圍網及新邊界巡邏通路
PROPOSED NEW BOUNDARY PATROL ROAD WITH
PRIMARY AND SECONDARY BOUNDARY FENCES
- 擬將移除的現有邊界圍網
EXISTING BOUNDARY FENCE TO BE REMOVED

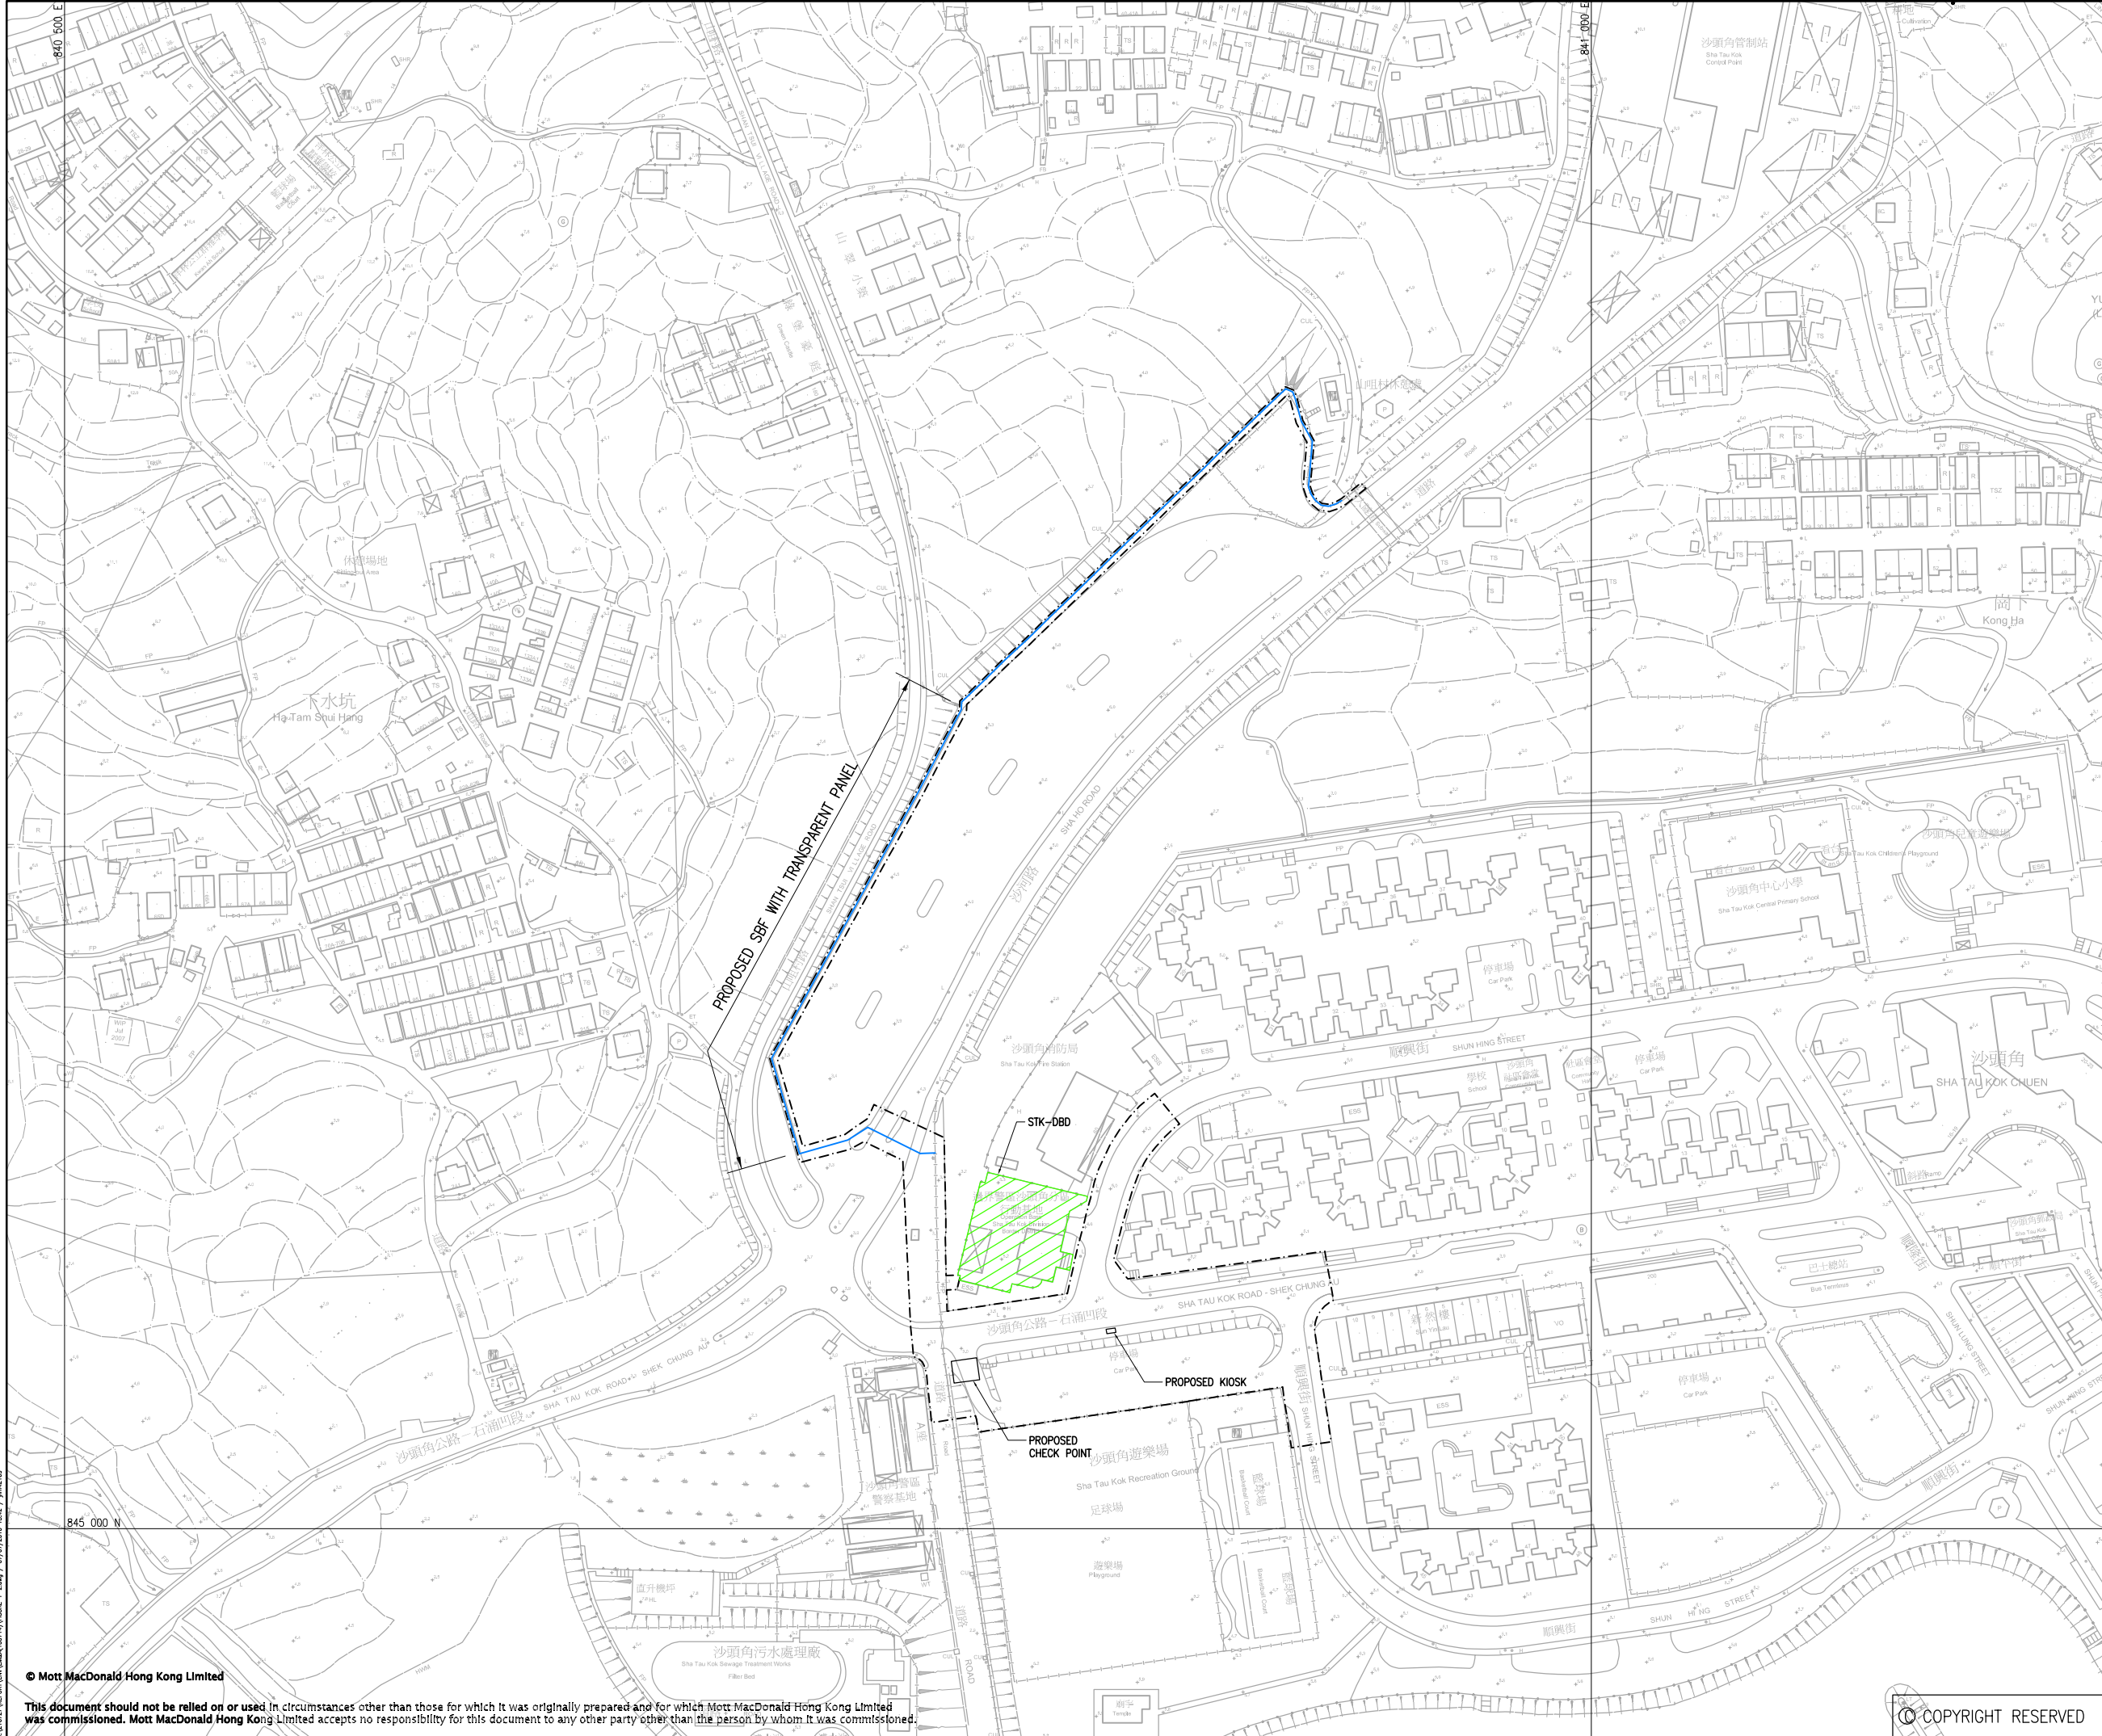
LEGEND:
 PROPOSED SBF ALIGNMENT

An Environmental Impact Assessment (EIA) for the proposed works was carried out under the Environmental Impact Assessment Ordinance (EIAO, Cap 499). An EIA Report and an Environmental Monitoring and Audit (EM&A) Manual were completed in January 2009 and approved by the Environmental Protection Department (EPD) in April 2009 (Register No. AEIAR-136/2009). The entire length of the proposed works is about 21.7 km from west of Pak Hok Chau to east of Sha Tau Kok and is divided into four sections. A general layout plan of the Project site is presented in Figure 1.1, while the location of the SBF at Section 4 in Sha Tau Kok is presented in Figure 1.2.
