Contract No. SSW327

***Reprovisioning of Cape Collinson
Crematorium***

**Monthly Environmental and Audit Report
February 2013
(Version 1.0)**

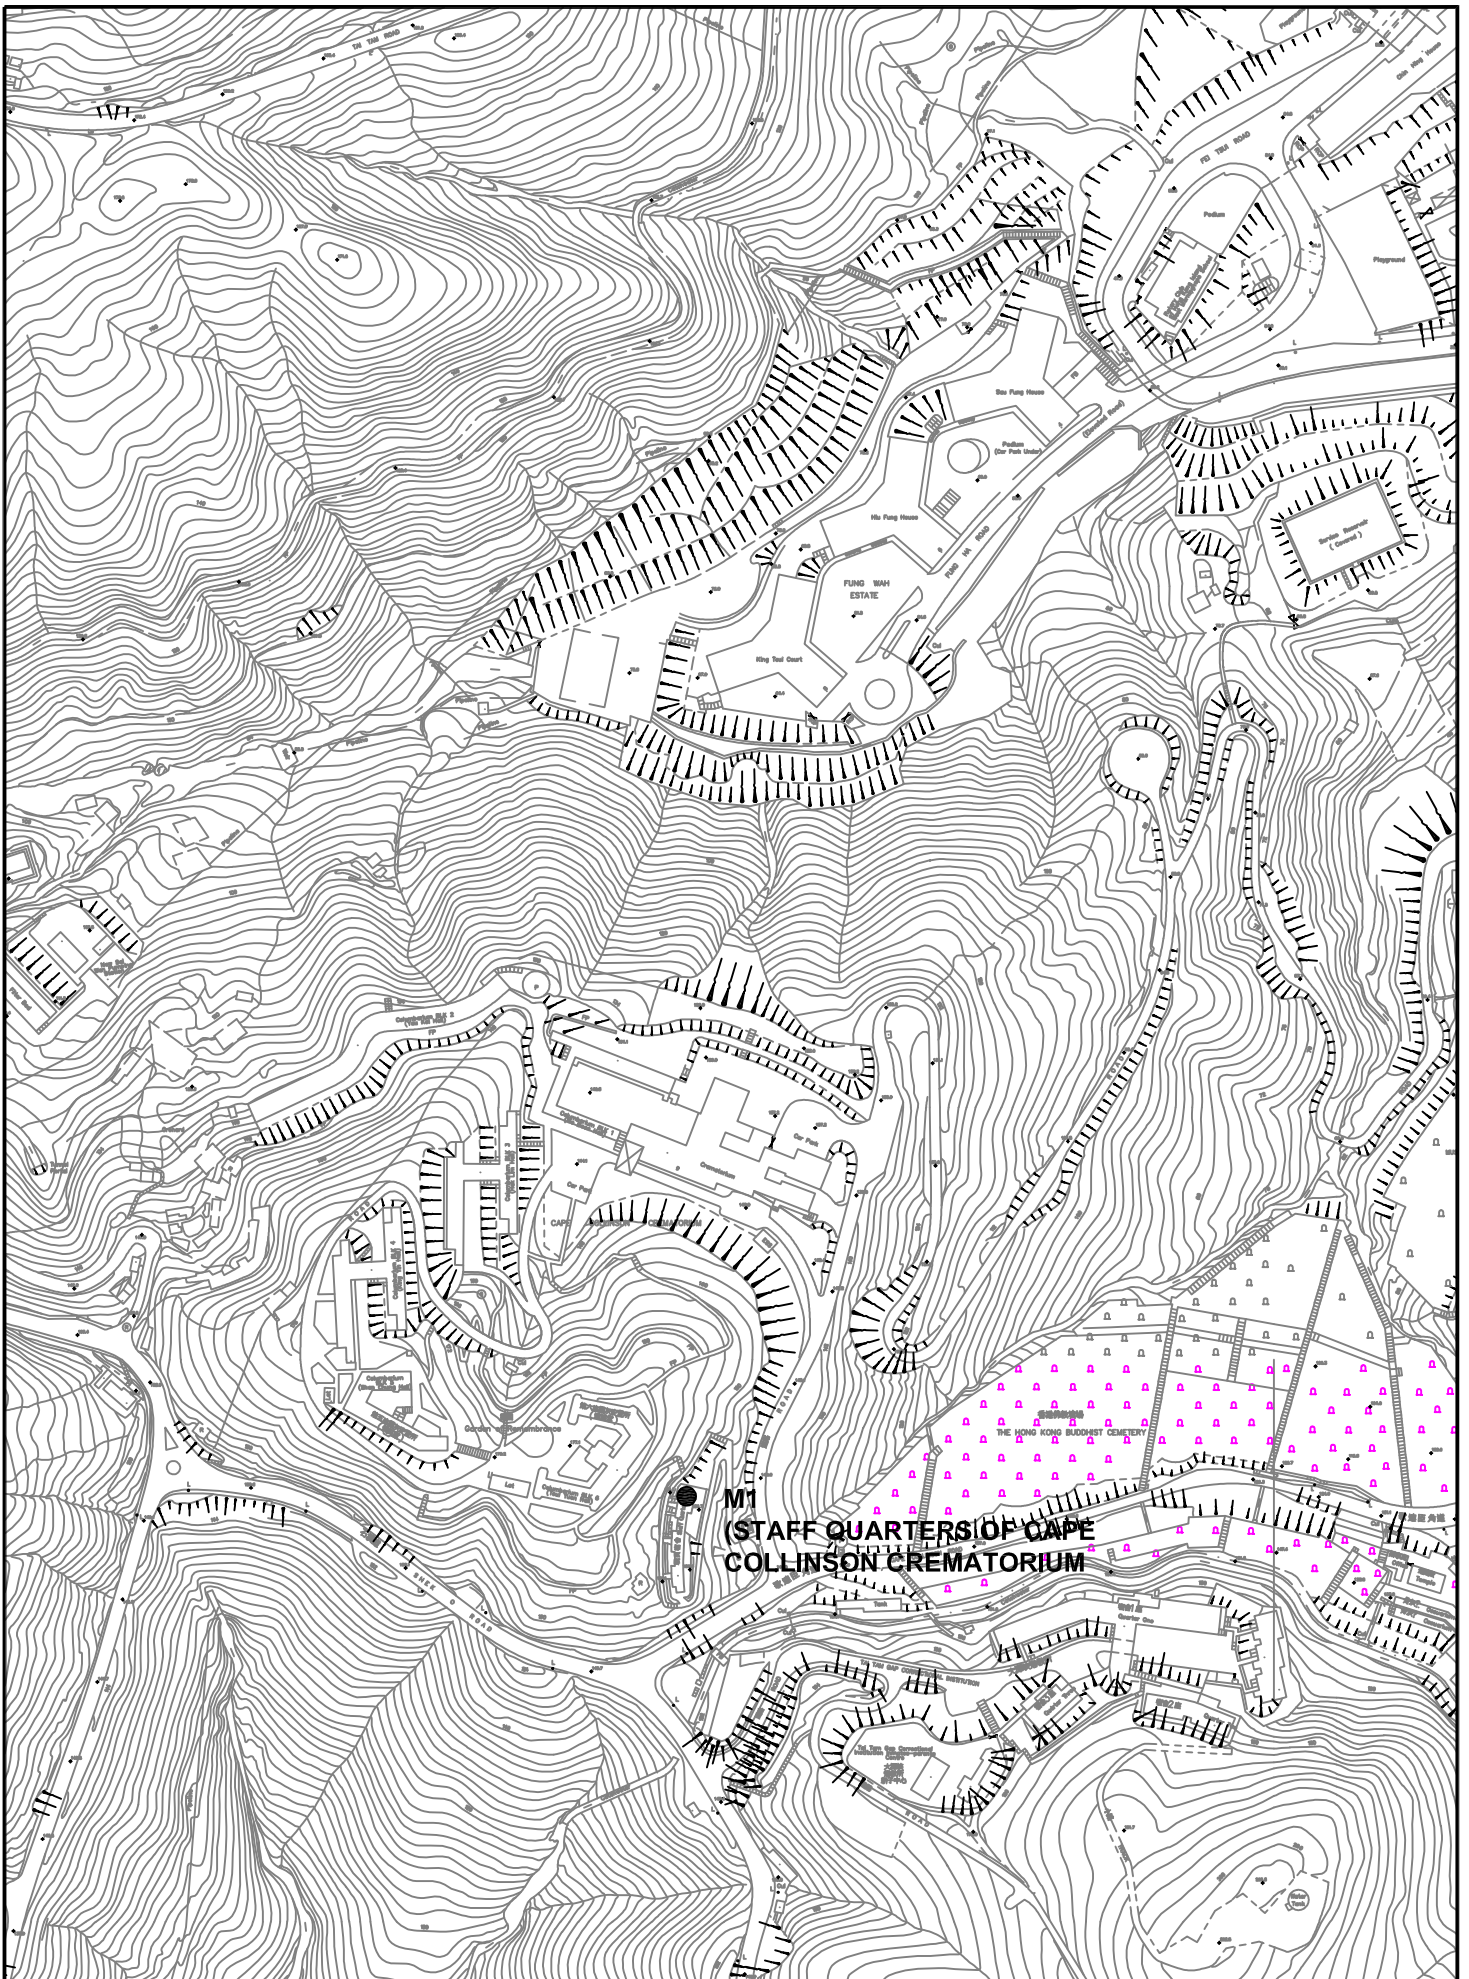
SCALE	1:3000 (A4)	DATE	JUL 2010	
CHECK	PC	DRAWN	SL	
JOB No.	MA0031	FIGURE NO.	3	REV -

**LOCATIONS OF NOISE
 MONITORING STATIONS**

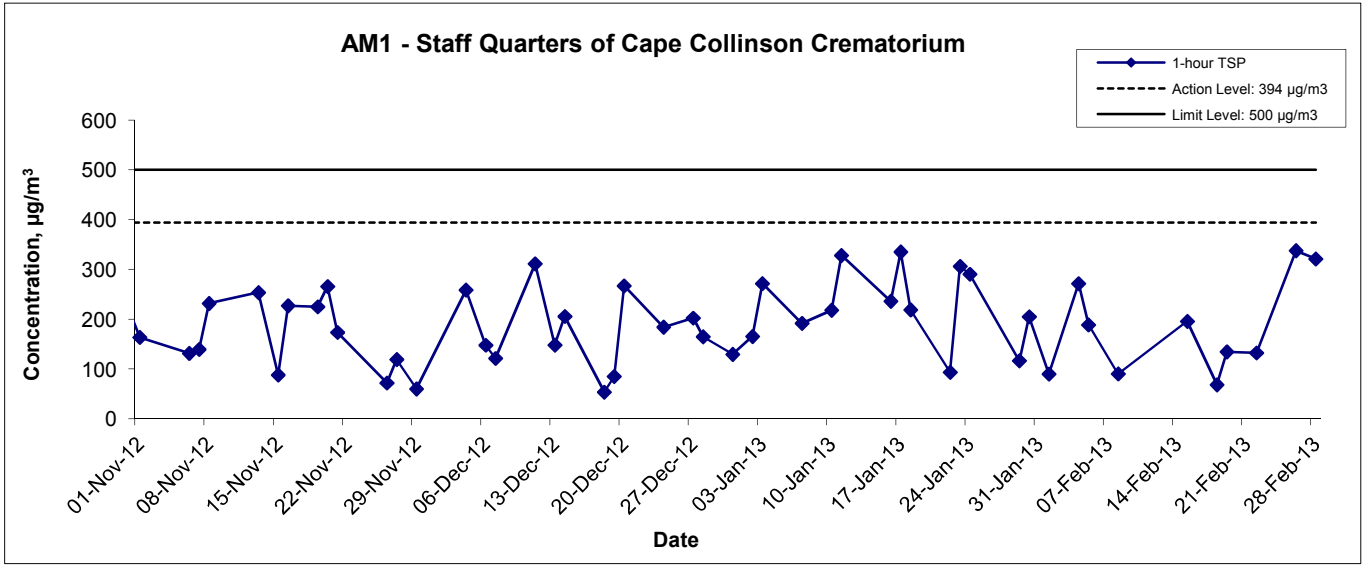
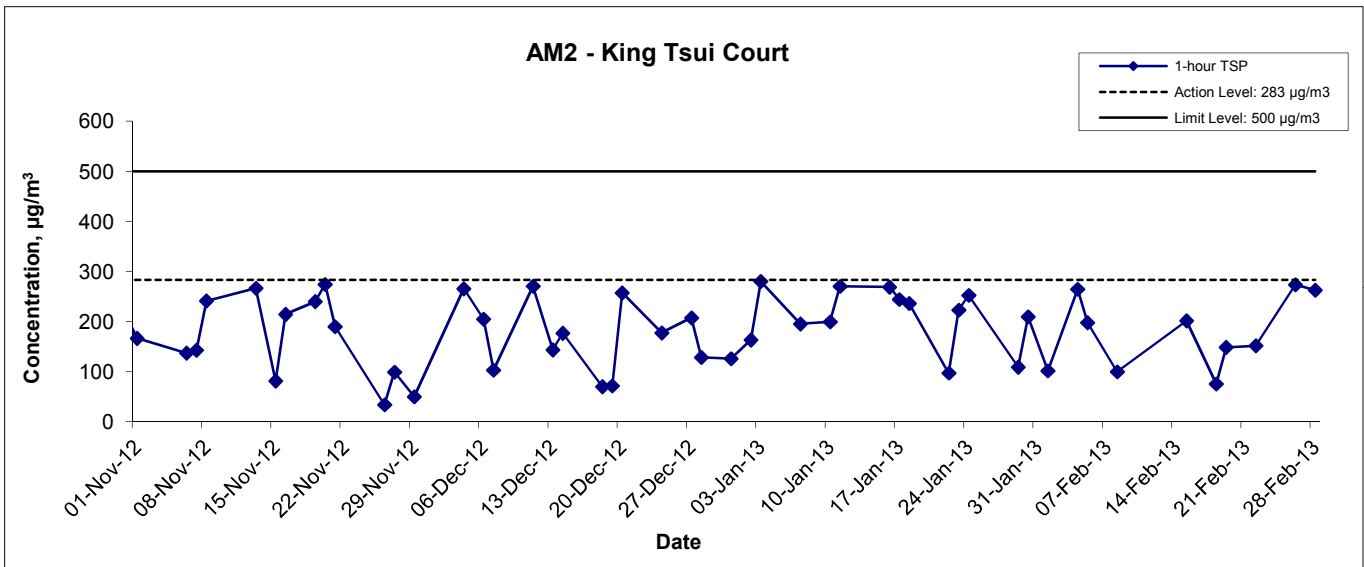
1-hr TSP Concentration Levels

Title Contract No. SSW 327 Reprovisioning of Cape Collinson Crematorium Graphical Presentation of 1-hour TSP Monitoring Results	Scale N.T.S	Project No. MA0031	
	Date Feb 13	Appendix D
