Contract No. SSW327

***Reprovisioning of Cape Collinson
Crematorium***

**Monthly Environmental and Audit Report
September 2014
(Version 1.0)**

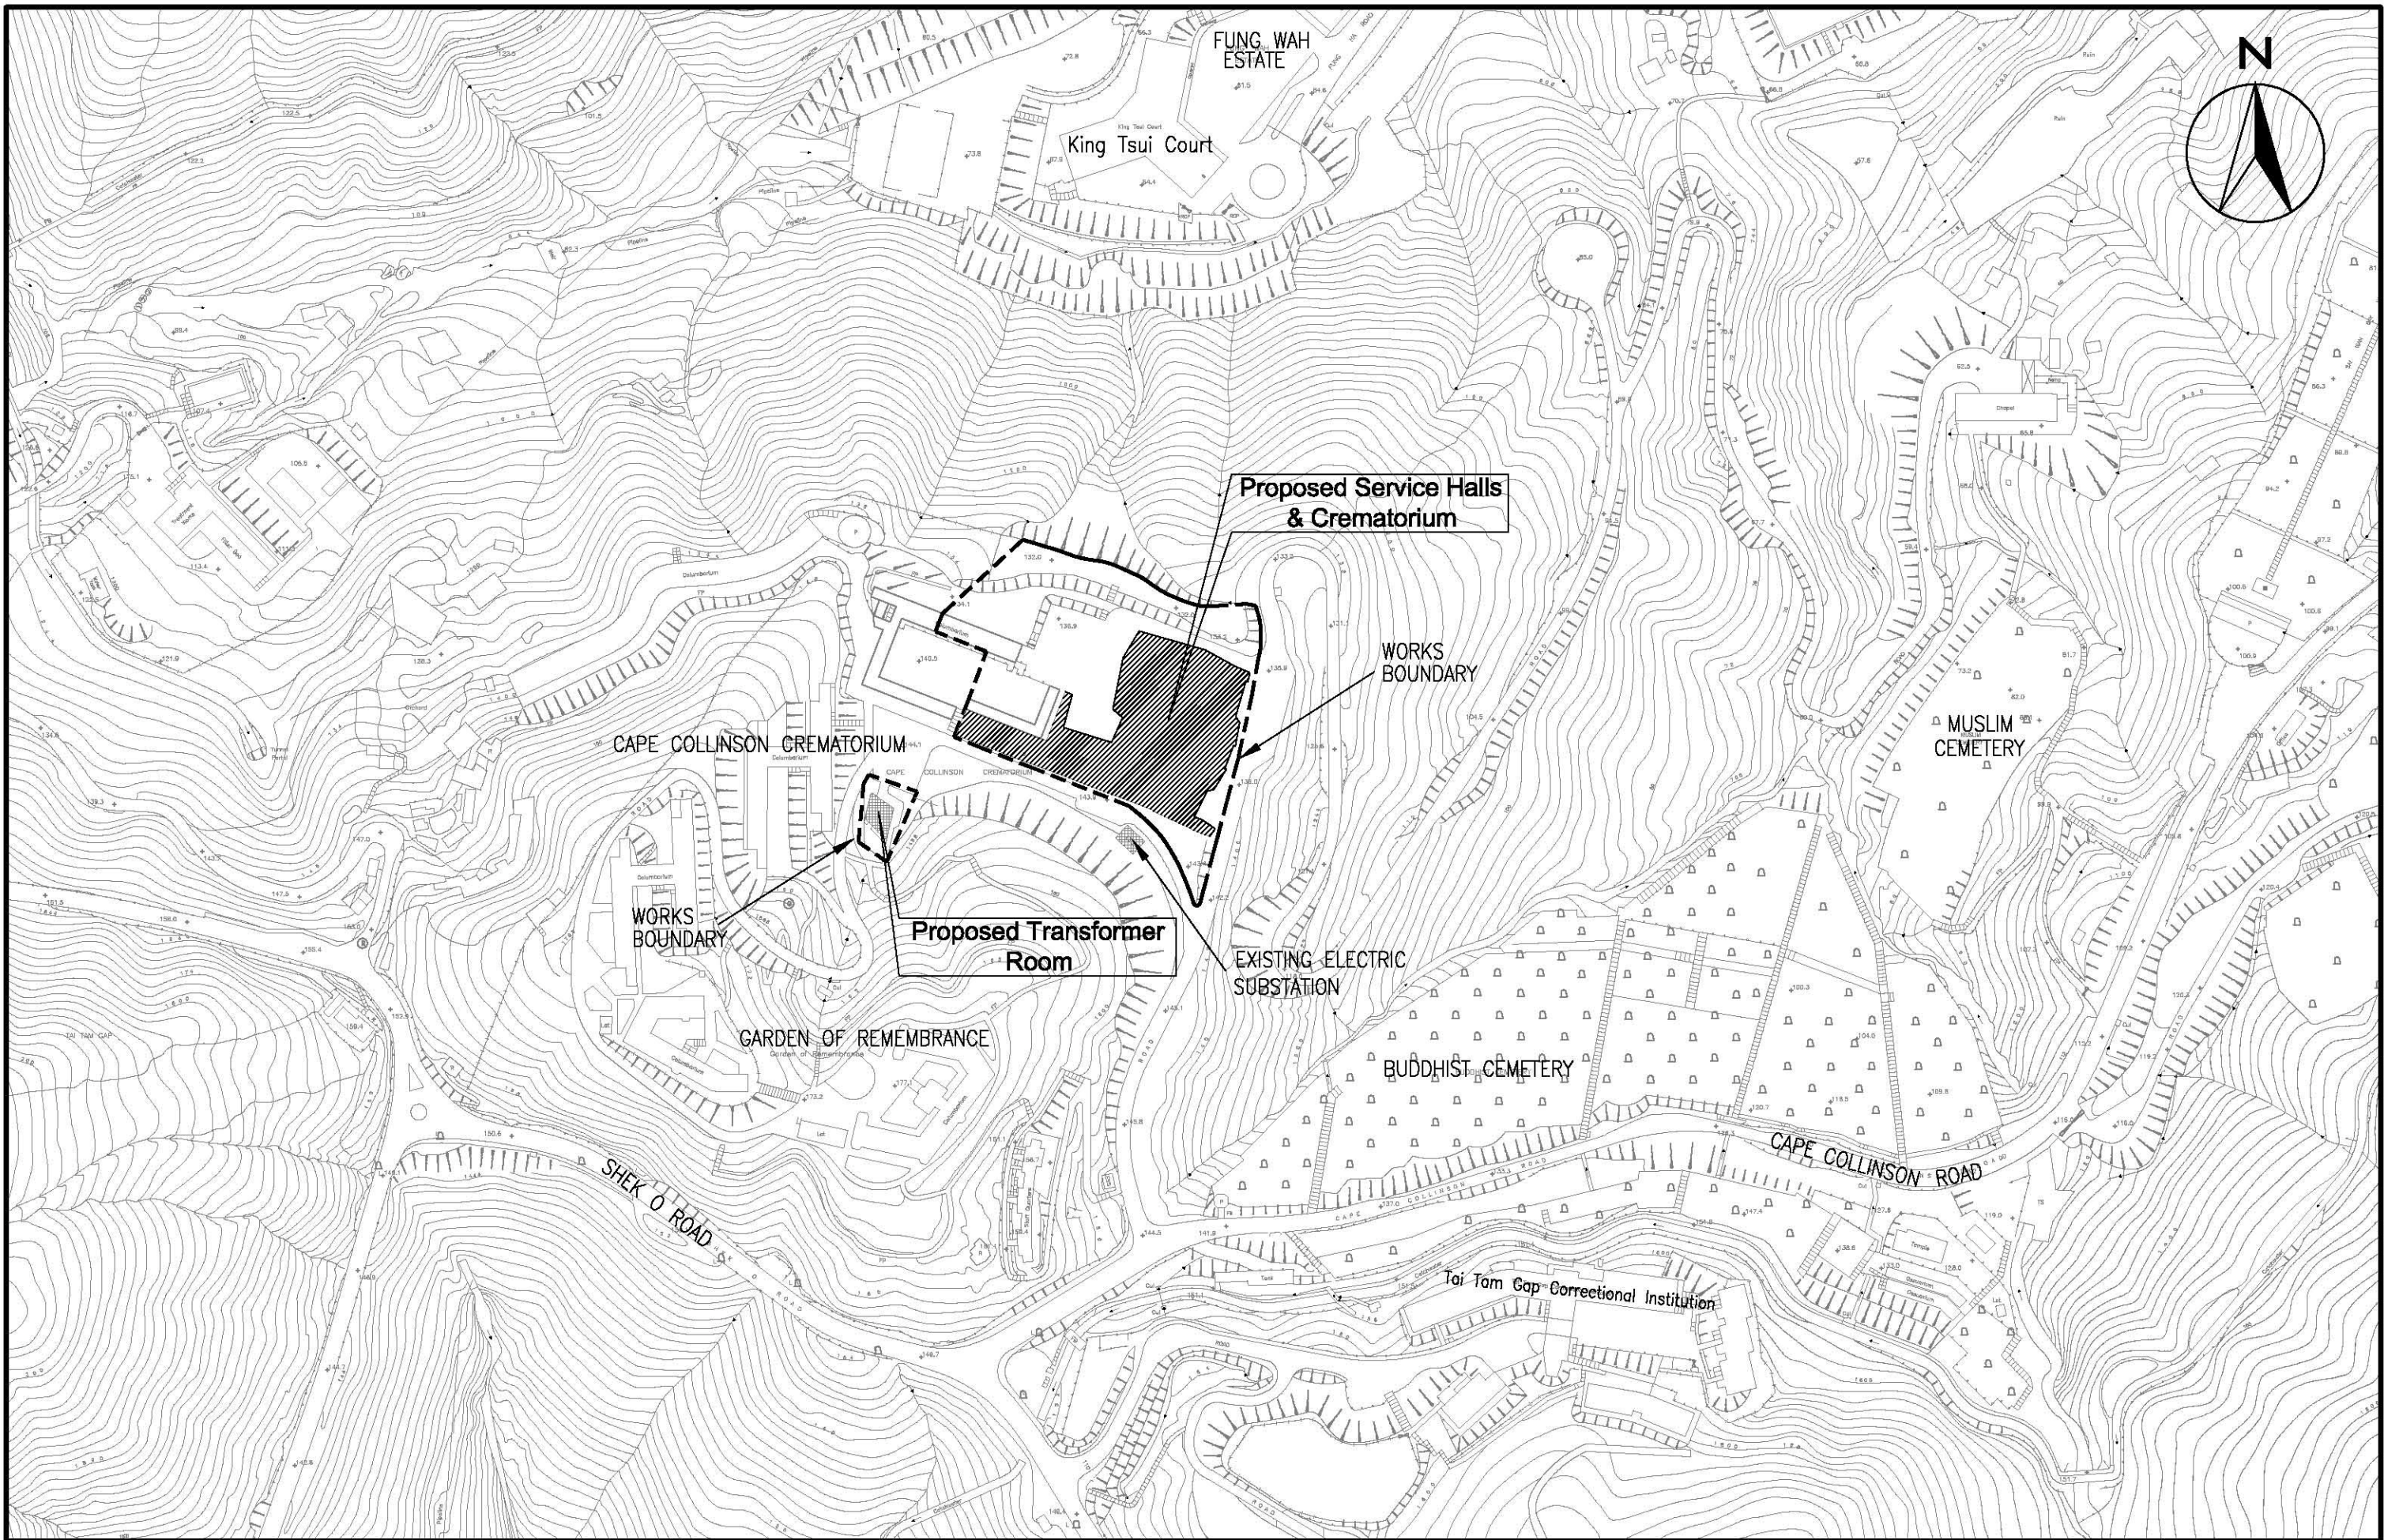
Scale	A3 1:2000	Date	June - 2010
Check	GL	Drawn	GL
Project No.	MA 0031	Figure No.	Figure 1
		REV	—

Contract No. SSW 327
 Repeovisioning of Cape Collinson Crematorium
 Layout Plan of the Project

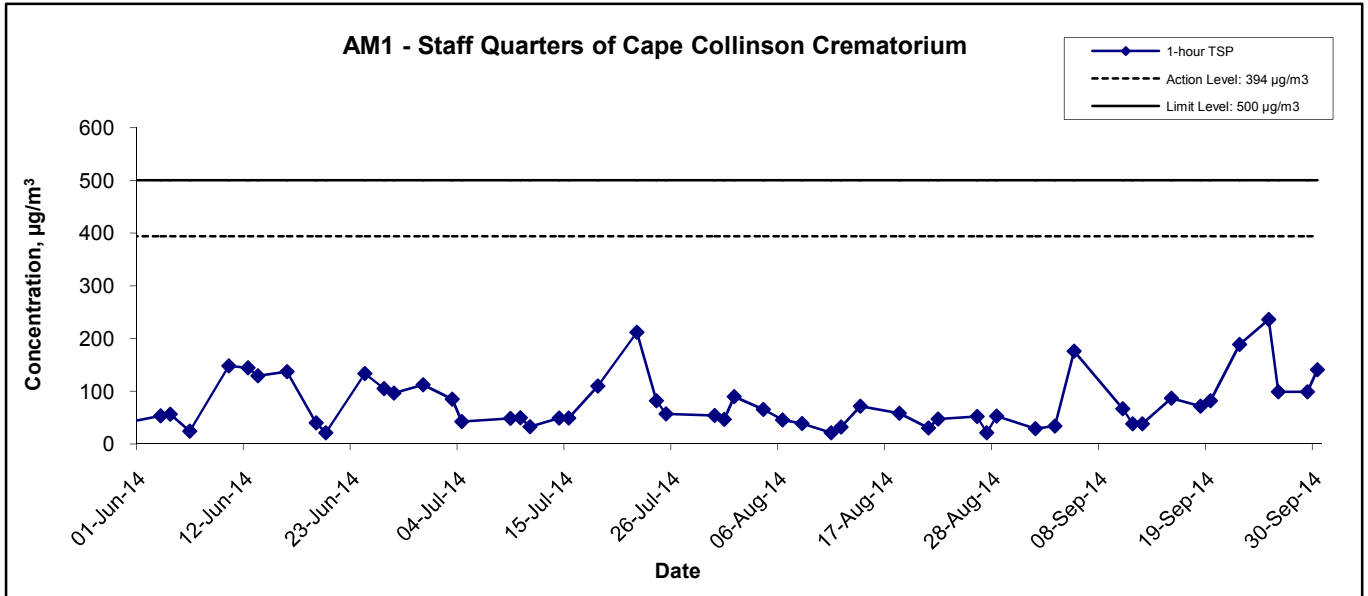
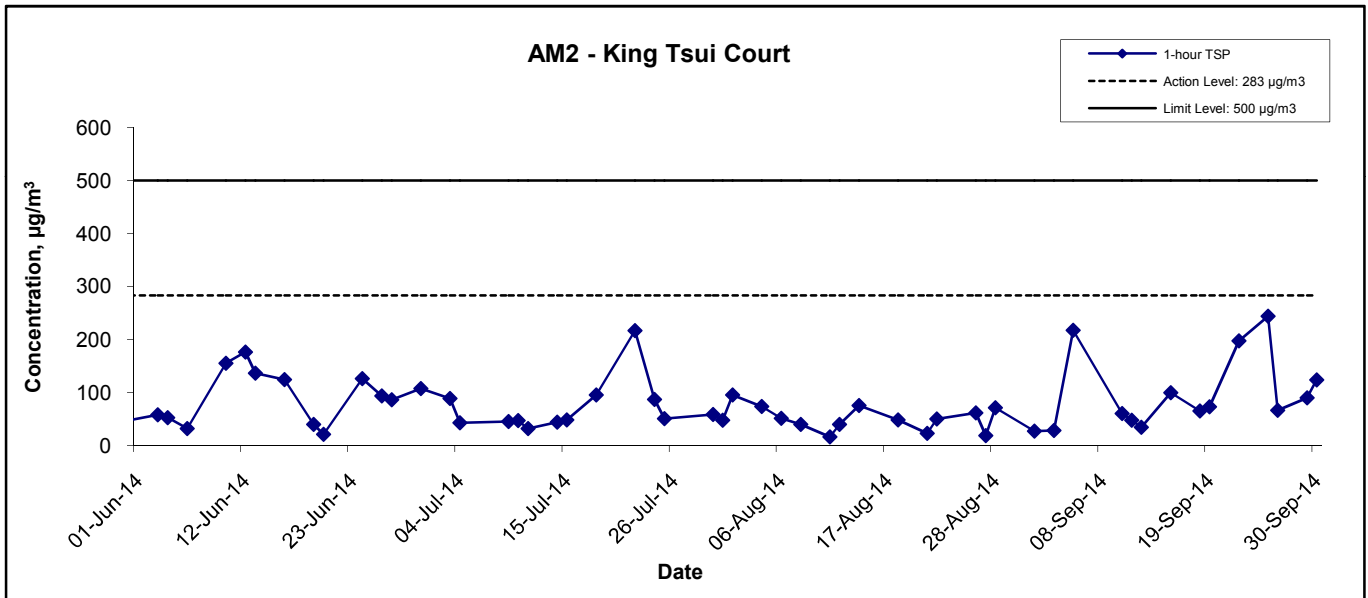
1-hr TSP Concentration Levels

Title Contract No. SSW 327 Reprovisioning of Cape Collinson Crematorium Graphical Presentation of 1-hour TSP Monitoring Results	Scale N.T.S	Project No. MA0031	CINOTECH
	Date Sep 14	Appendix D

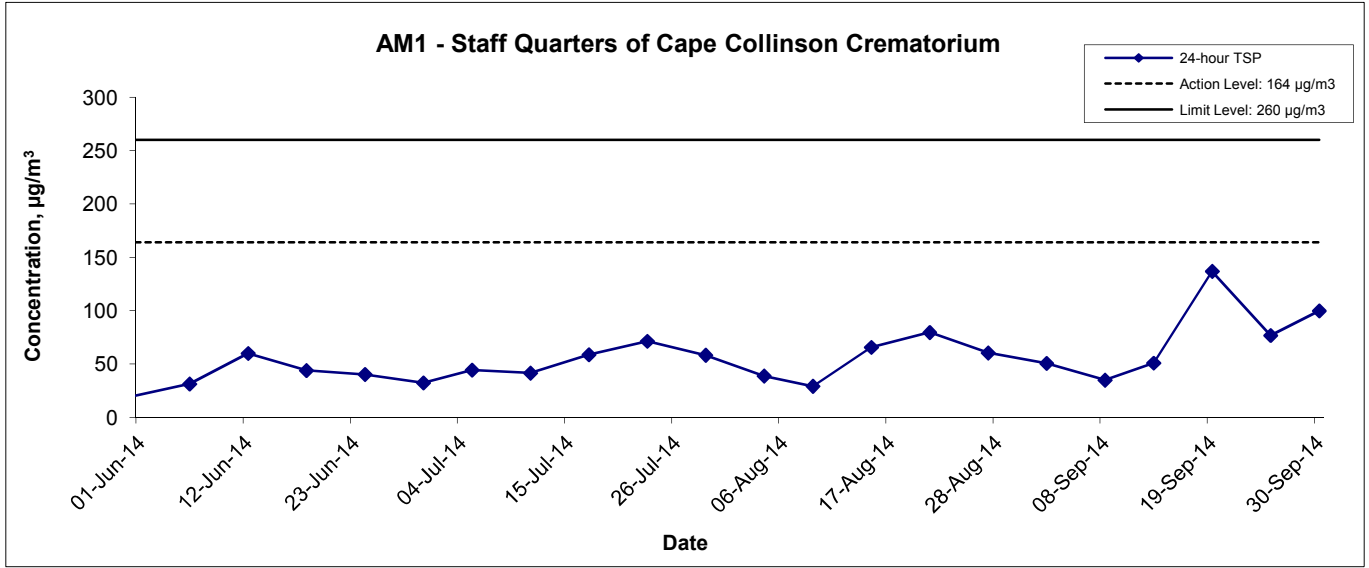
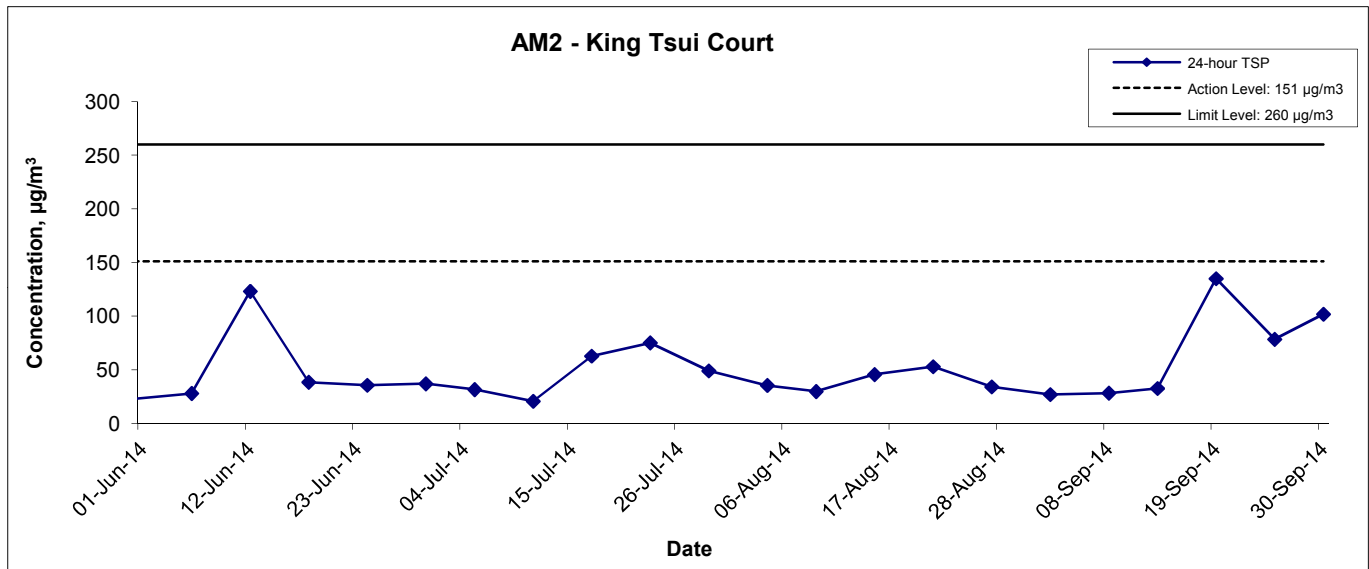
24-hr TSP Concentration Levels

Title Contract No. SSW 327 Reprovisioning of Cape Collinson Crematorium Graphical Presentation of 24-hour TSP Monitoring Results	Scale N.T.S	Project No. MA0031	
	Date Sep 14	Appendix E

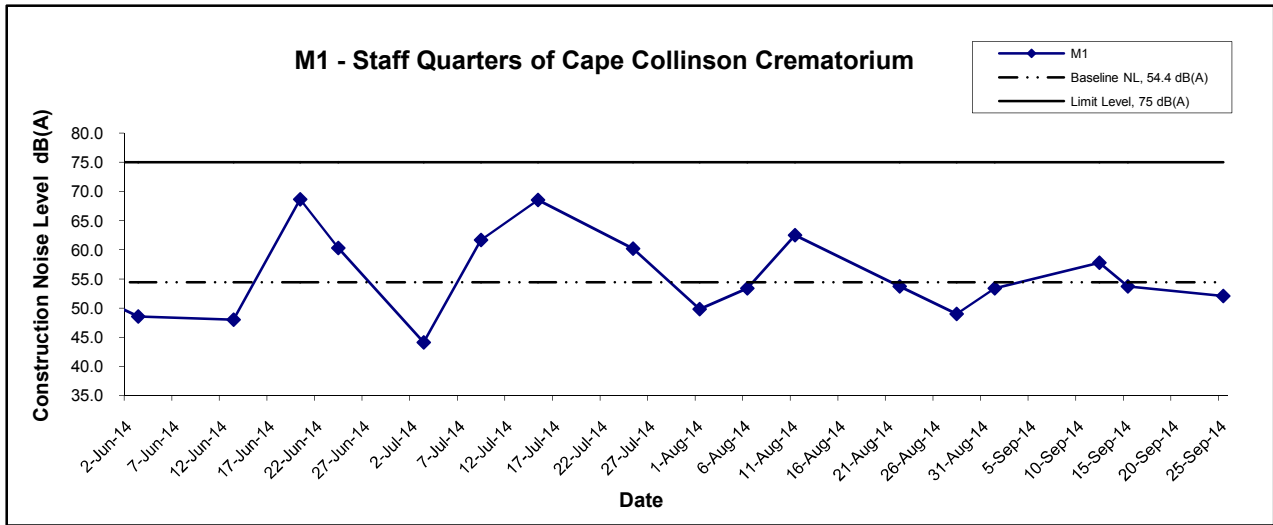
Noise Levels

Title Contract No. SSW 327 Reprovisioning of Cape Collinson Crematorium Graphical Presentation of Construction Noise Monitoring Results	Scale N.T.S	Project No. MA0031	CINOTECH
	Date Sep 14	Appendix F
