**Contract No. EP/SP/58/08**

**Sludge Treatment Facilities**

**Quarterly Environmental Monitoring and Audit Report  
for  
December 2010 to February 2011**

Report No. : 100440EN110260

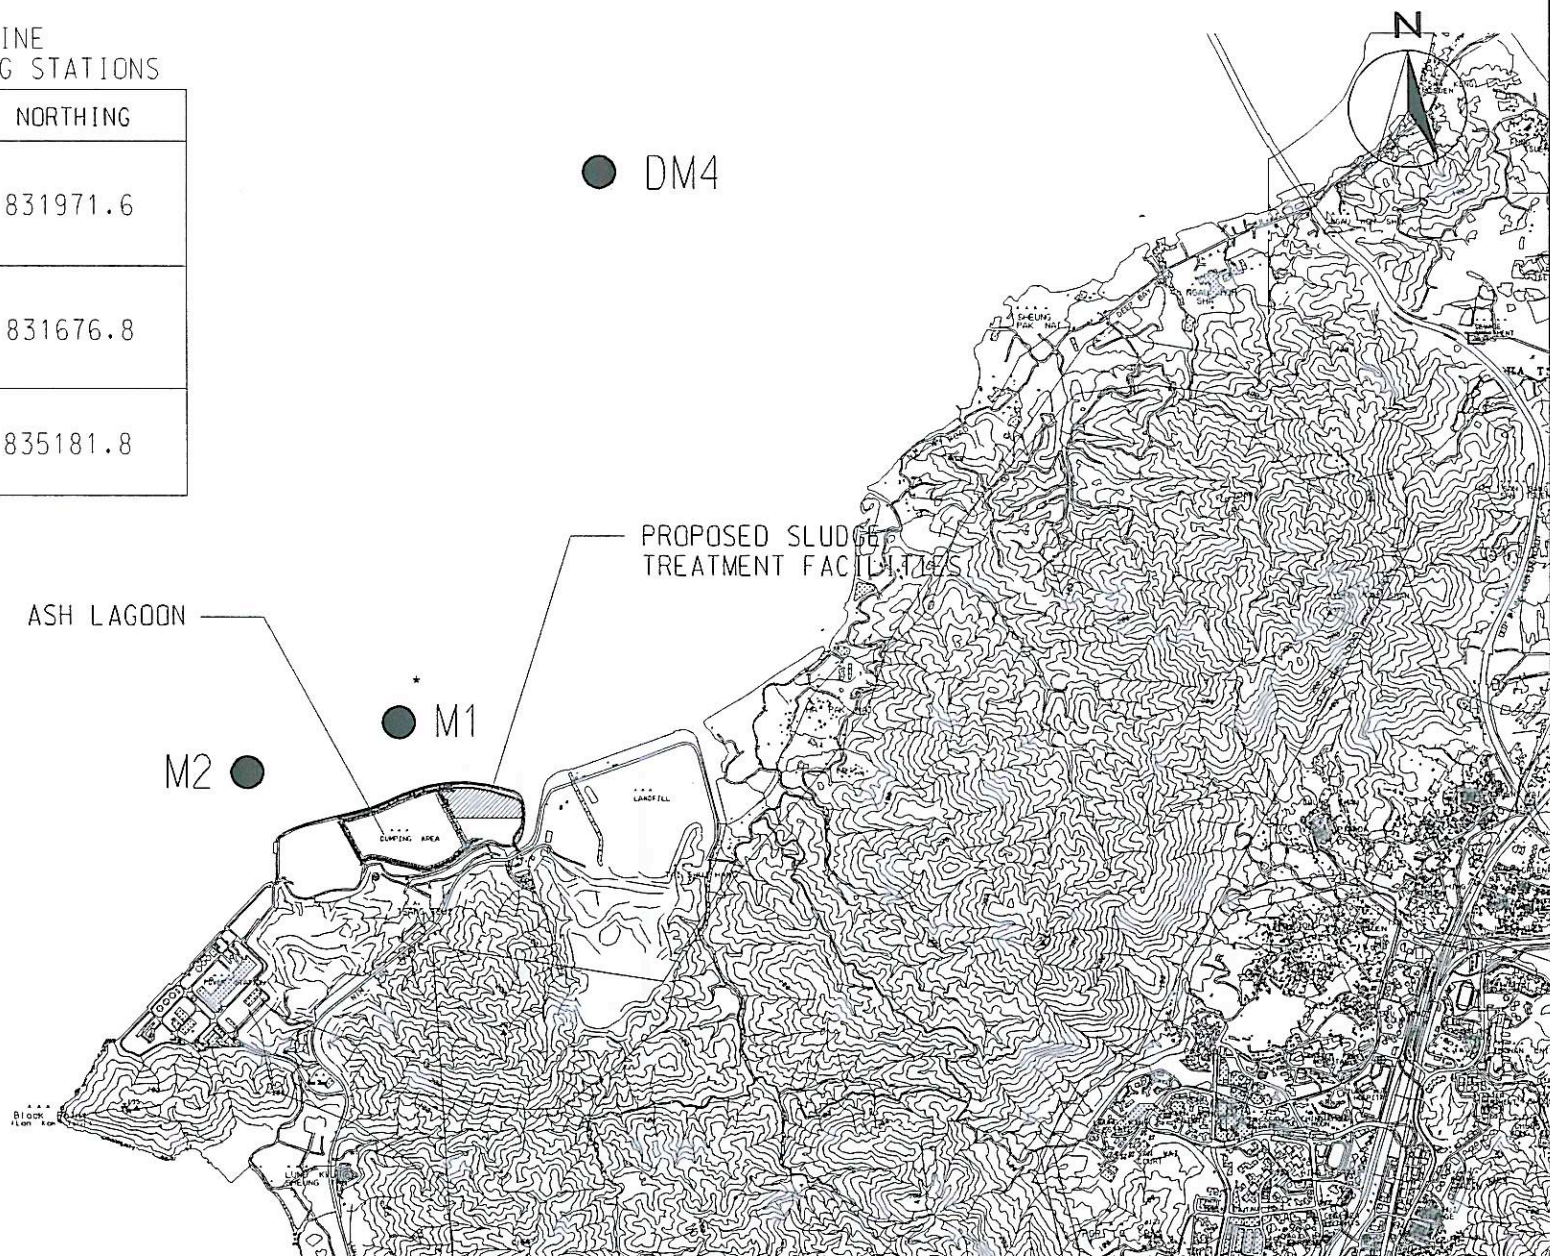
LOCATIONS OF MARINE  
WATER QUALITY MONITORING STATIONS

STATION	EASTING	NORTHING
M1 (IMPACT MONITORING STATION)	809915.3	831971.6
M2 (IMPACT MONITORING STATION)	809026.4	831676.8
DM4 (CONTROL STATION)	811092.2	835181.8

Monitoring of marine water was started on 17th February 2011. As far as concern, full compliance of heavy metal content is achieved that indicates the piling work did not cause leaching of PFA leachate into the nearby Deep Bay Zone.
