**Contract No. EP/SP/58/08**

**Sludge Treatment Facilities**

**Quarterly Environmental Monitoring and Audit Report  
for  
March 2011 to May 2011**

Report No. : 100440EN110848

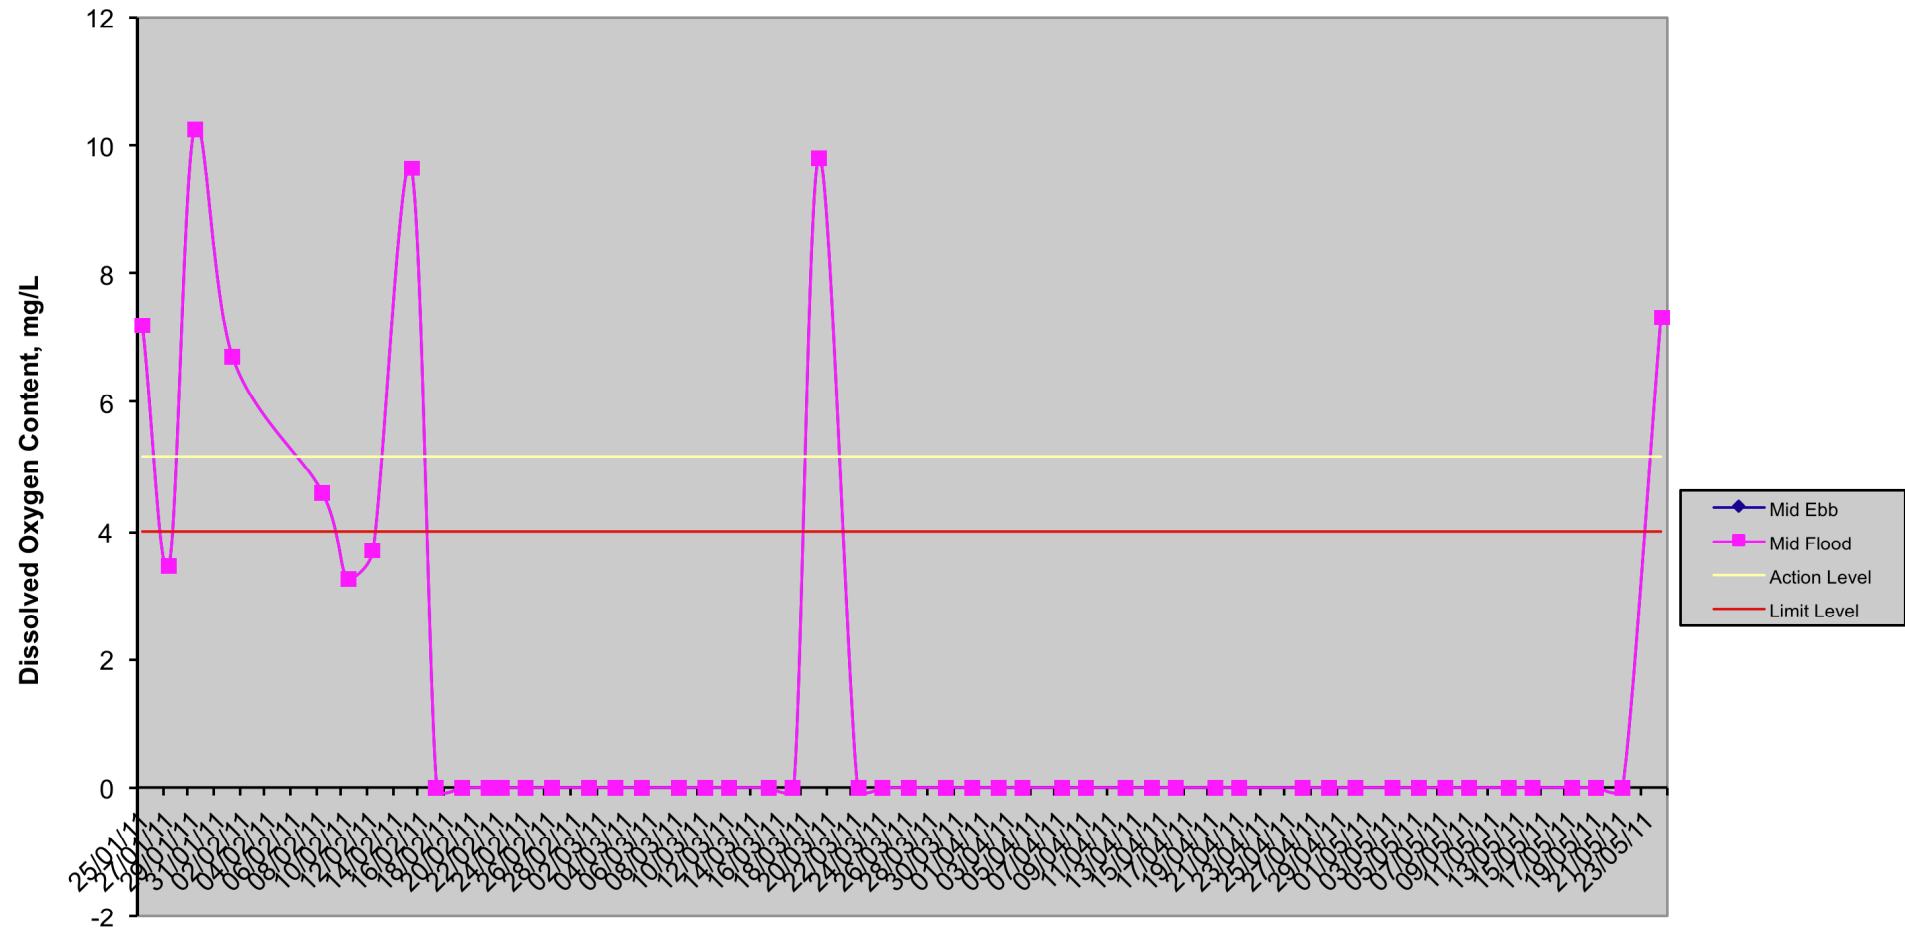
## C1 - Dissolved Oxygen Content

Remark: No water at C1 occasionally after 17/02/2011. Zero values are shown in the graph

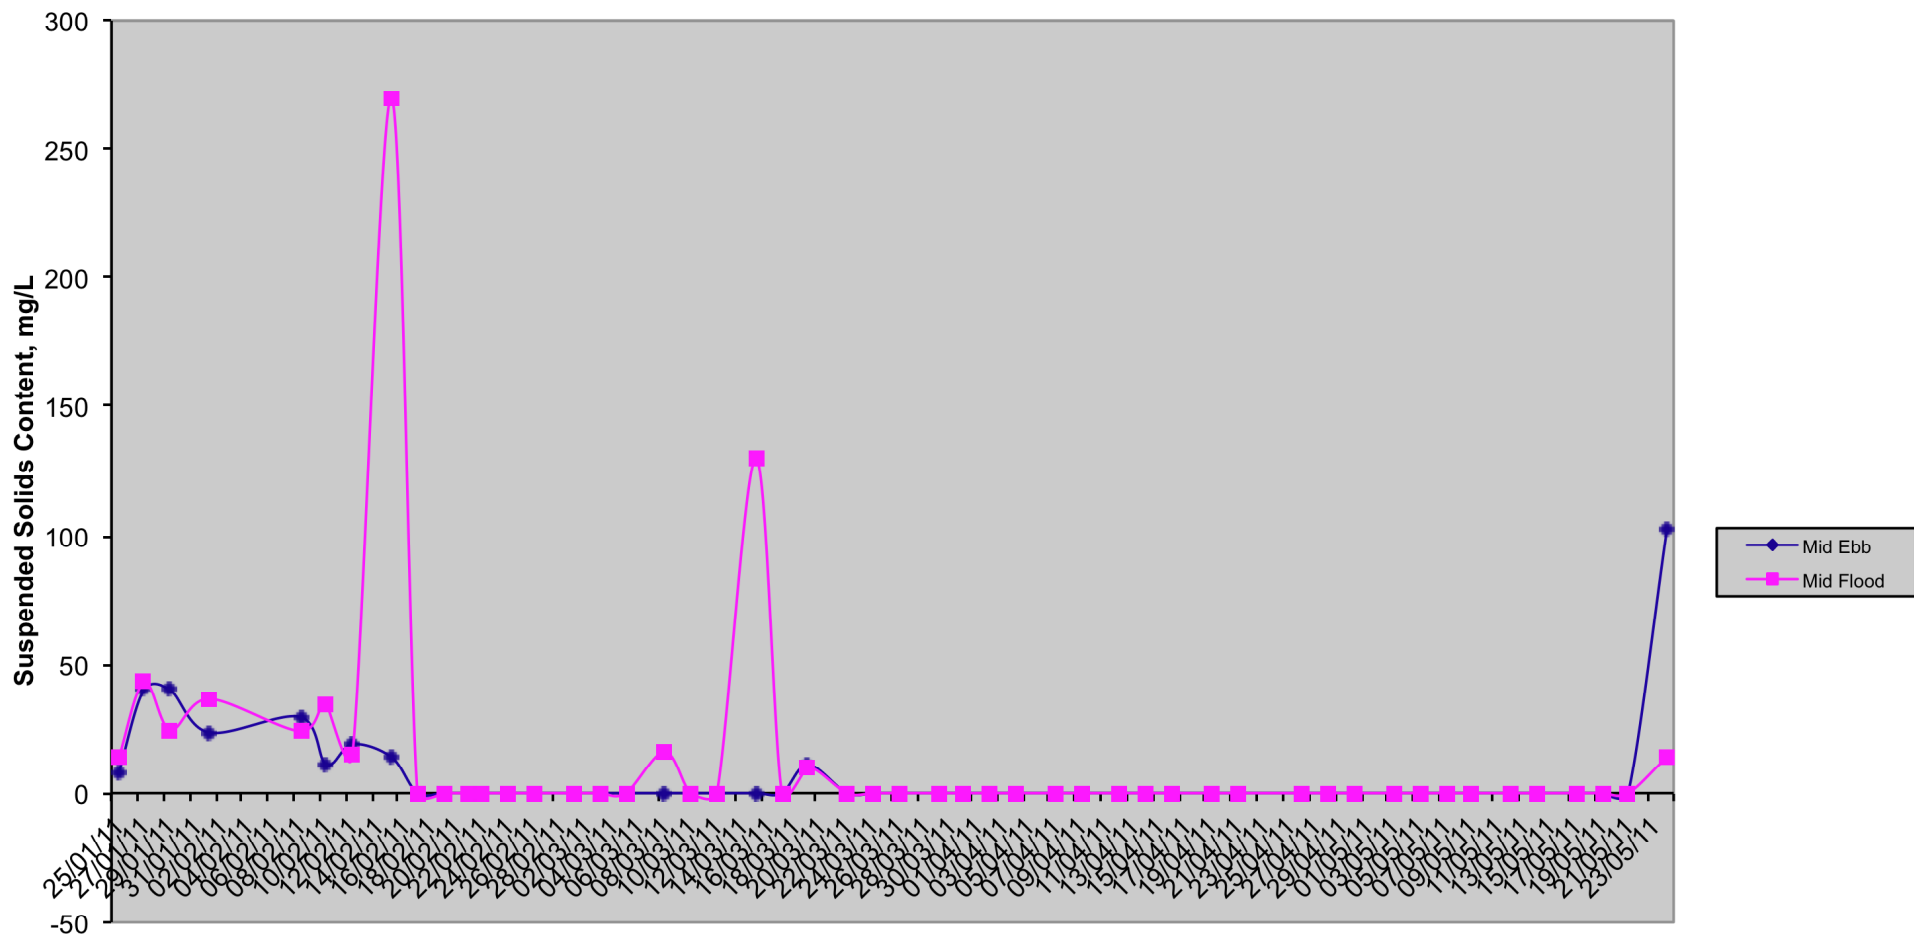
## C1 - Suspended Solids Content

Remark: No water at C1 occasionally after 17/02/2011. Zero values are shown in the graph
