Contract No. EP/SP/58/08
Sludge Treatment Facilities
Environmental Monitoring and Audit Report
for
April 2011

MateriaLab Ref No.: 100440EN110547

Date : 3 May 2011

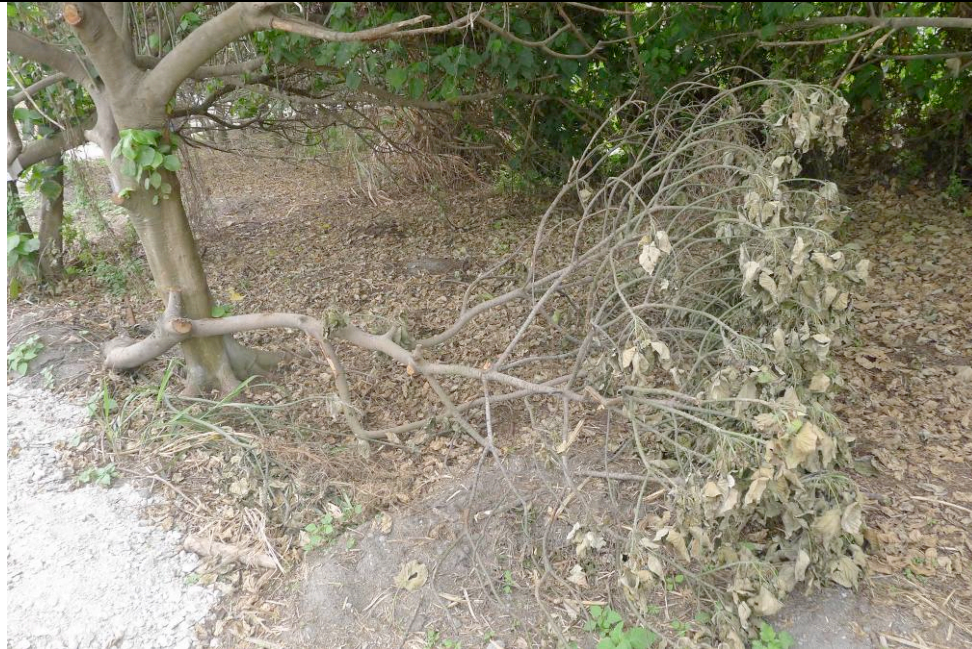
Hanging and broken branch should be removed to prevent further damaged.
