**Environmental Permit (EP) No. FEP-24/004/1998/I  
West Rail, Phase I - MTRC Works Contract 1117  
Pat Heung Depot Modification Works**

**- Monthly Noise Monitoring Report (August 2016) for Pat Heung Depot Modification Works**

**Monthly Noise Monitoring Report  
for  
August 2016**

Pat Heung Modification Works  
Monthly Noise Monitoring Report No. 42  
[Period from 1 to 31 August 2016]

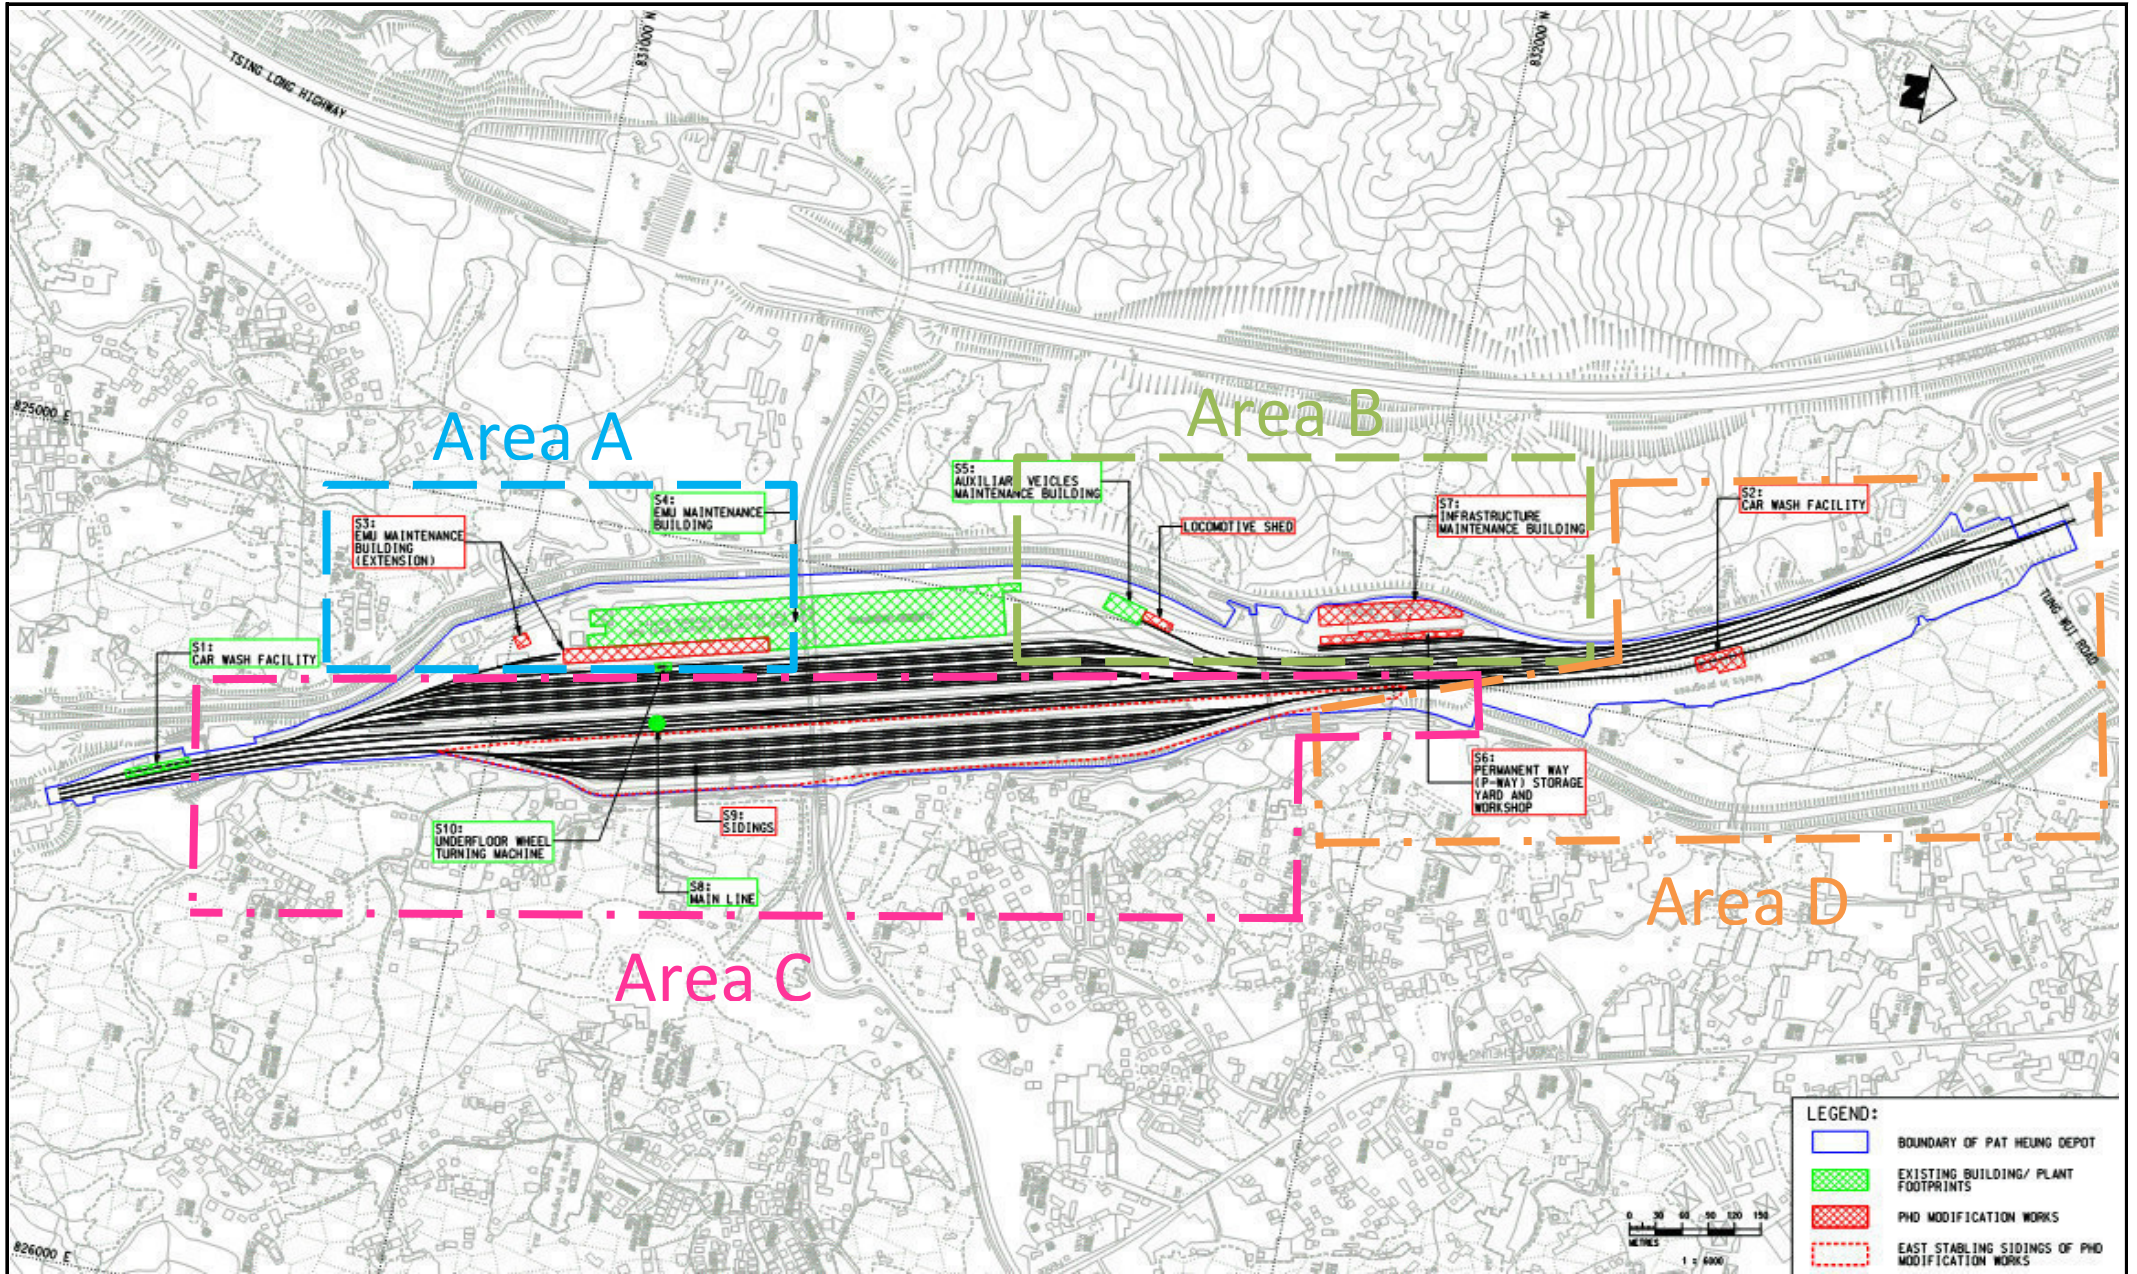
Scale	N.T.S	Proposal No.	MA13003
Date	Apr-13	Figure	1

- 2.5 The site layout and proposed modification works are illustrated in **Figure 1**.

Title SCL Contract 1117  
 Shatin to Central Link -  
 Pat Heung Depot Modification Works  
 Site Layout Plan

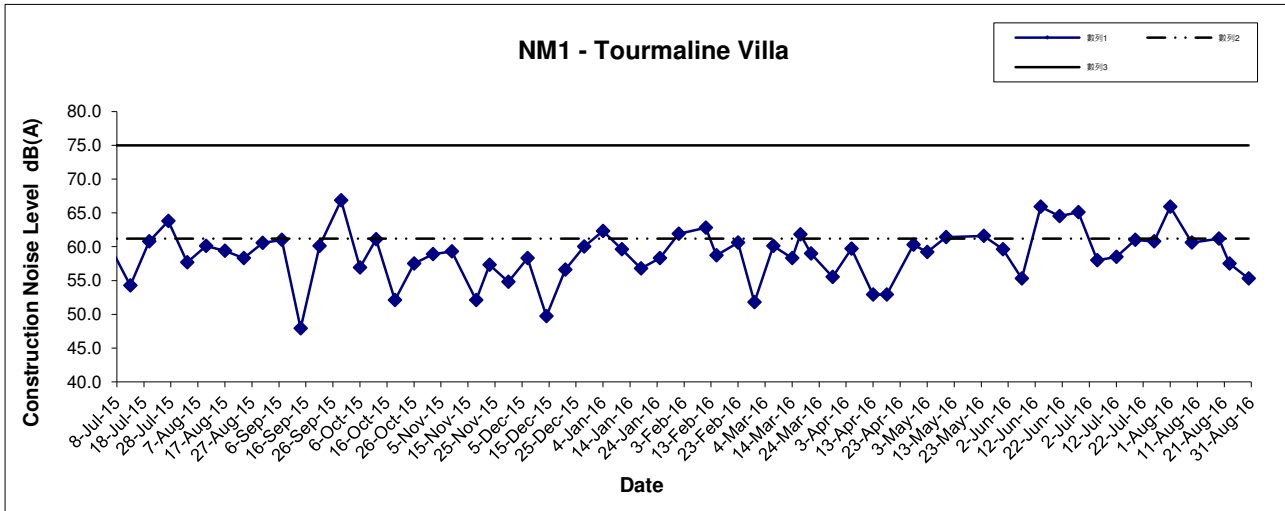
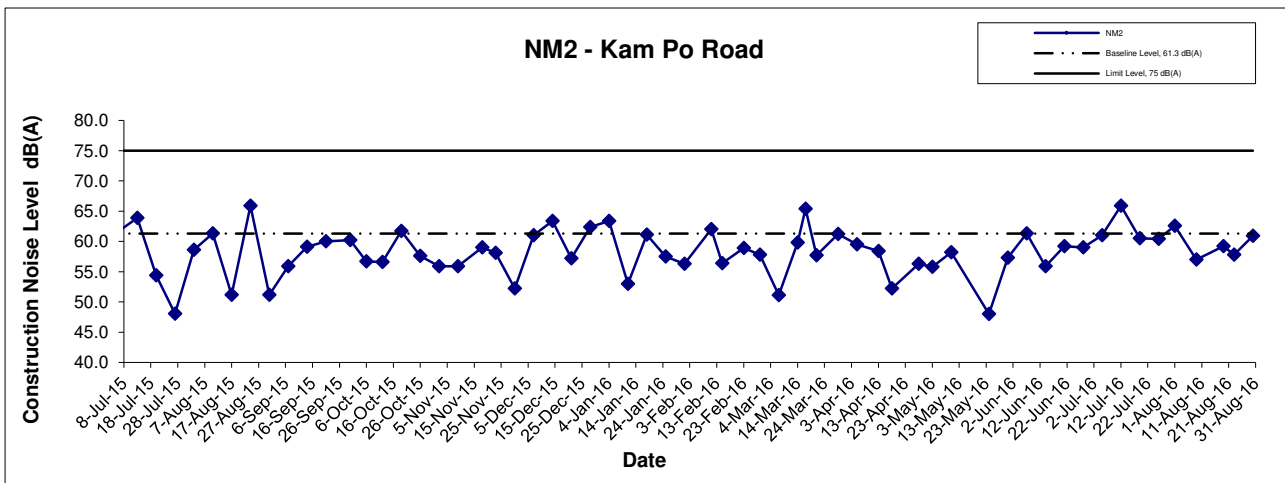
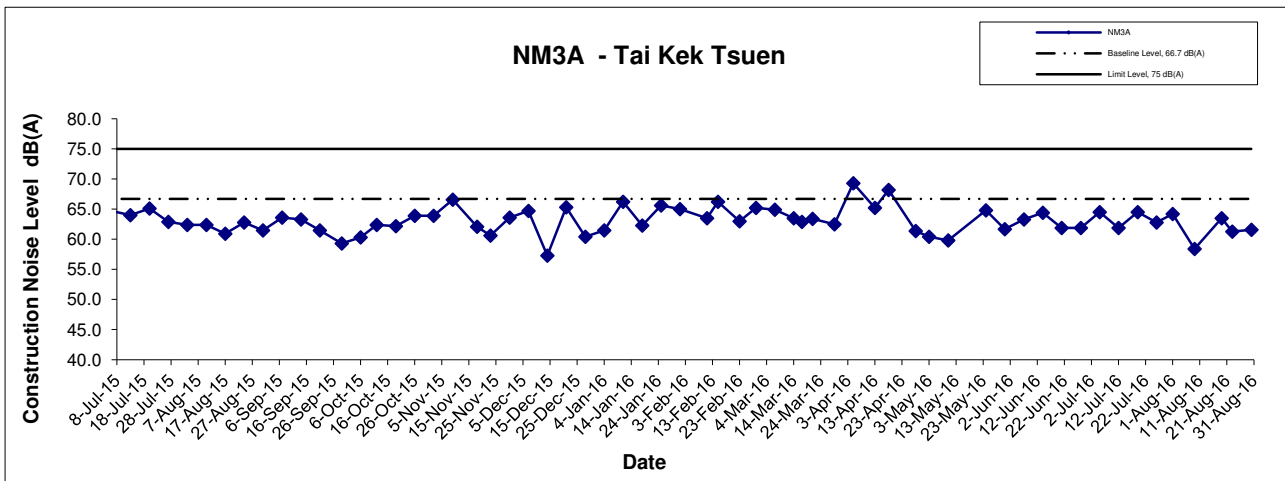
Title MTR Works Contract 1117 Pat Heung Depot Modification Works Graphical Presentation of the Construction Noise Monitoring Results	Scale N.T.S	Project No. MA13003	
	Date Aug-16	Appendix F

Location NM3A - Tai Kek Tsuen							
Date	Time	Weather	Unit: dB (A) (30-min)				
			Measured Noise Level			Baseline Level	Construction Noise Level
			L <sub>eq</sub>	L <sub>10</sub>	L <sub>90</sub>	L <sub>eq</sub>	L <sub>eq</sub>
1-Aug-16	9:00	Cloudy	64.2	62.2	56.2	66.7	64.2 Measured ≤ Baseline
9-Aug-16	10:35	Sunny	67.3	69.8	51.5		58.4
19-Aug-16	9:00	Sunny	68.4	66.3	54.3		63.5
23-Aug-16	10:22	Sunny	67.4	70.4	50.3		61.3
30-Aug-16	11:10	Sunny	61.6	59.4	55.1		61.6 Measured ≤ Baseline

## Noise Levels
