Contract No. EP/SP/66/12
Integrated Waste Management Facilities, Phase 1
Monthly EM&A Report No.15

Monthly EM&A Report No.15 (Period from 1 September to 30 September 2019)

(Clause 3.3, Further Environmental Permit FEP-01/429/2012/A)

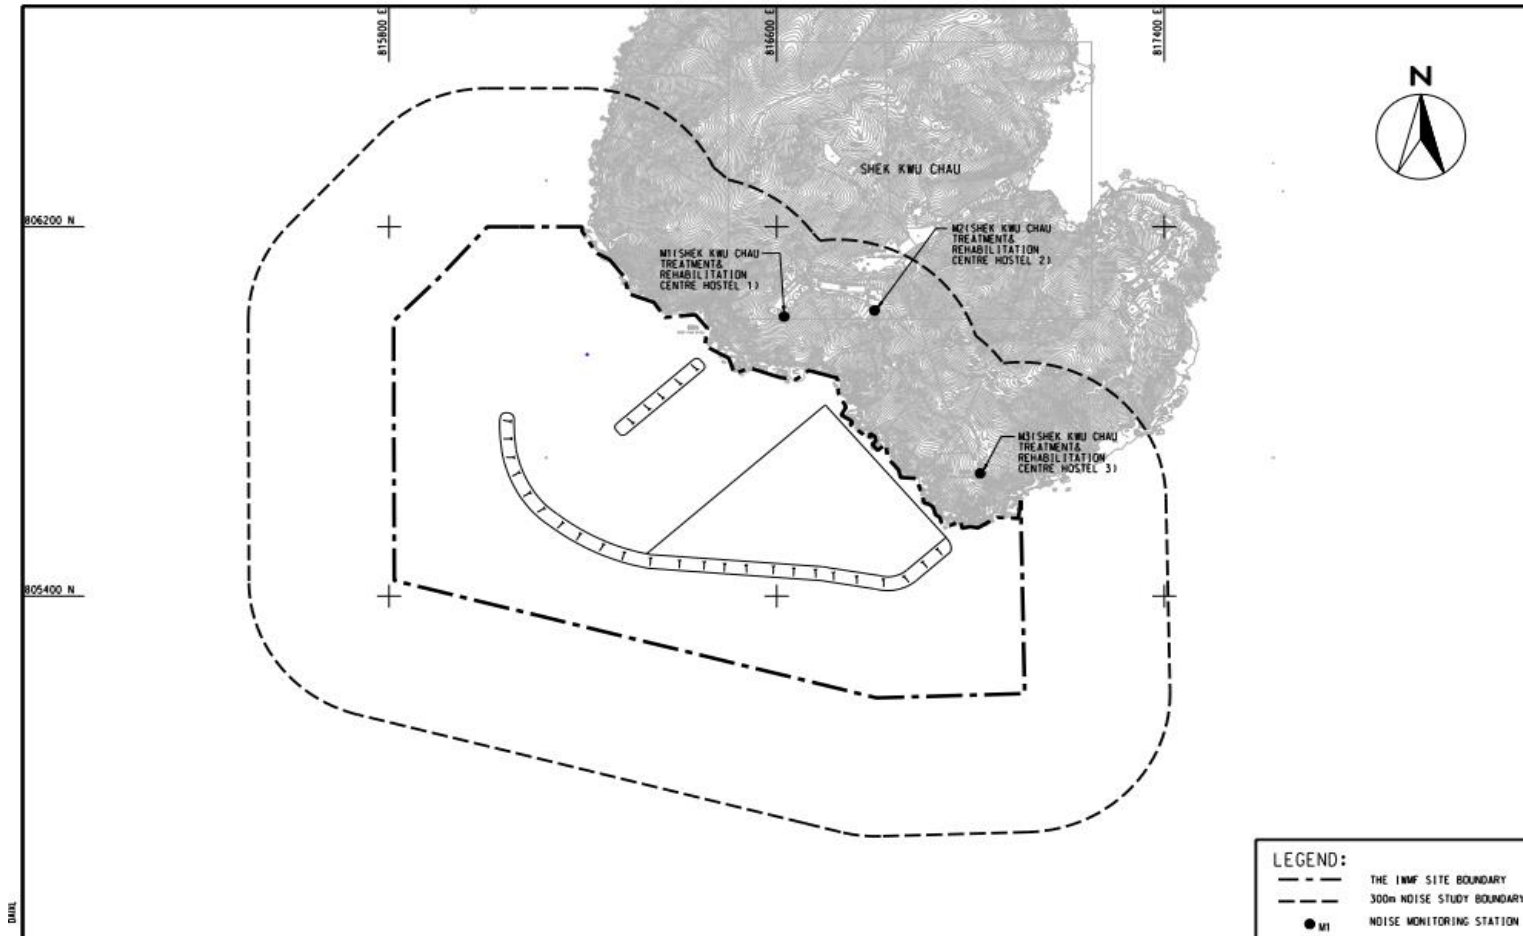
Figure 3.1 Noise monitoring locations at SKC

3.3.1 Three noise monitoring locations for impact monitoring and additional impact monitoring at the nearby sensitive receivers are shown in **Figure 3.1**.

3.3.2 M1, M2 and M3 are Shek Kwu Chau Treatment and Rehabilitation Centre Hostel 1, 2 and 3 respectively of The Society for the Aid and Rehabilitation of Drug Abusers (SARDA) located at southern part of Shek Kwu Chau.

3.3.3 Measurements at M1 & M3 were conducted at a point 1m from the exterior of the sensitive receivers building façade and at a position 1.2m above the ground. Measurement setup at M3 has been varying with minor adjustment to minimize the disturbance to the users of Treatment Centre. Measurement at M2 was conducted at a point 1m from building façade of the ceiling of 1st floor level for avoidance of mutual disturbance with users of Treatment Centre. The minor adjustment of monitoring locations, which were in favour to mutual convenience with the users of Treatment Centre, were found with no effect on monitoring result based on on-site observation and experience from the Baseline monitoring of the Project. The noise monitoring stations are summarized in **Table 3.2** below.

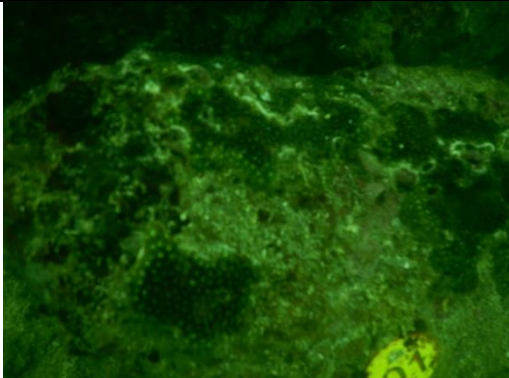
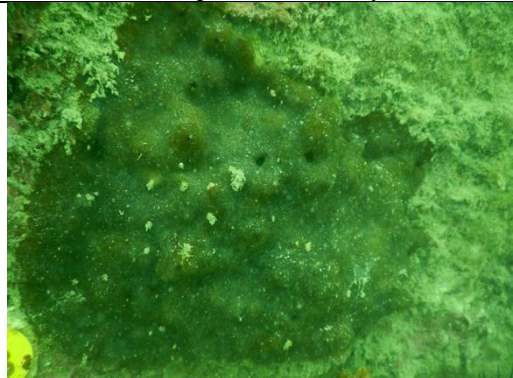
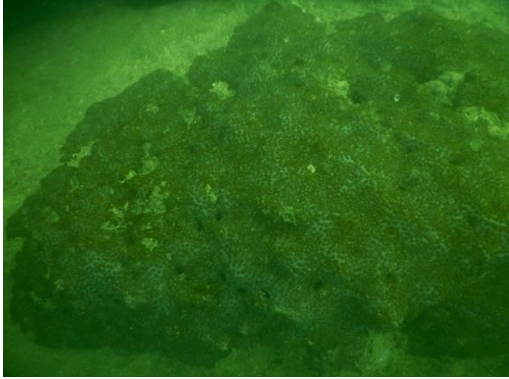
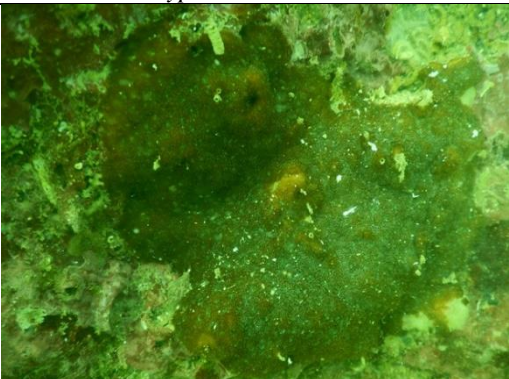
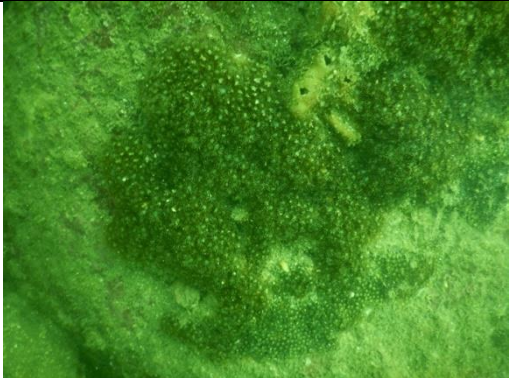
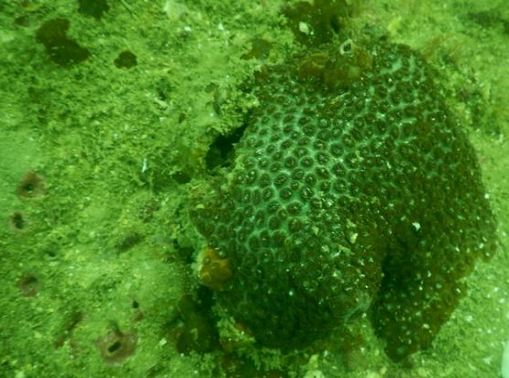
Tag #	18 September 2019
#1

5.6.2 Ten (10) hard coral colonies were monitored at each Control site and Indirect Impact Site as suggested in the Construction Phase Monitoring Plan. The general health conditions (size, mortality, bleaching and sediment) were recorded and summarized in **Table 5.8** and **Table 5.9**. Photos of each coral colonies were taken during the monitoring activities shown in **Photo Plate 5.1** and **5.2**.

- 5.6.5 All tagged and re-tagged coral colonies showed good health condition during the 3rd Quarterly Construction Phase Monitoring. There was no increased level of mortality, bleaching and sediment when compared with the baseline results.

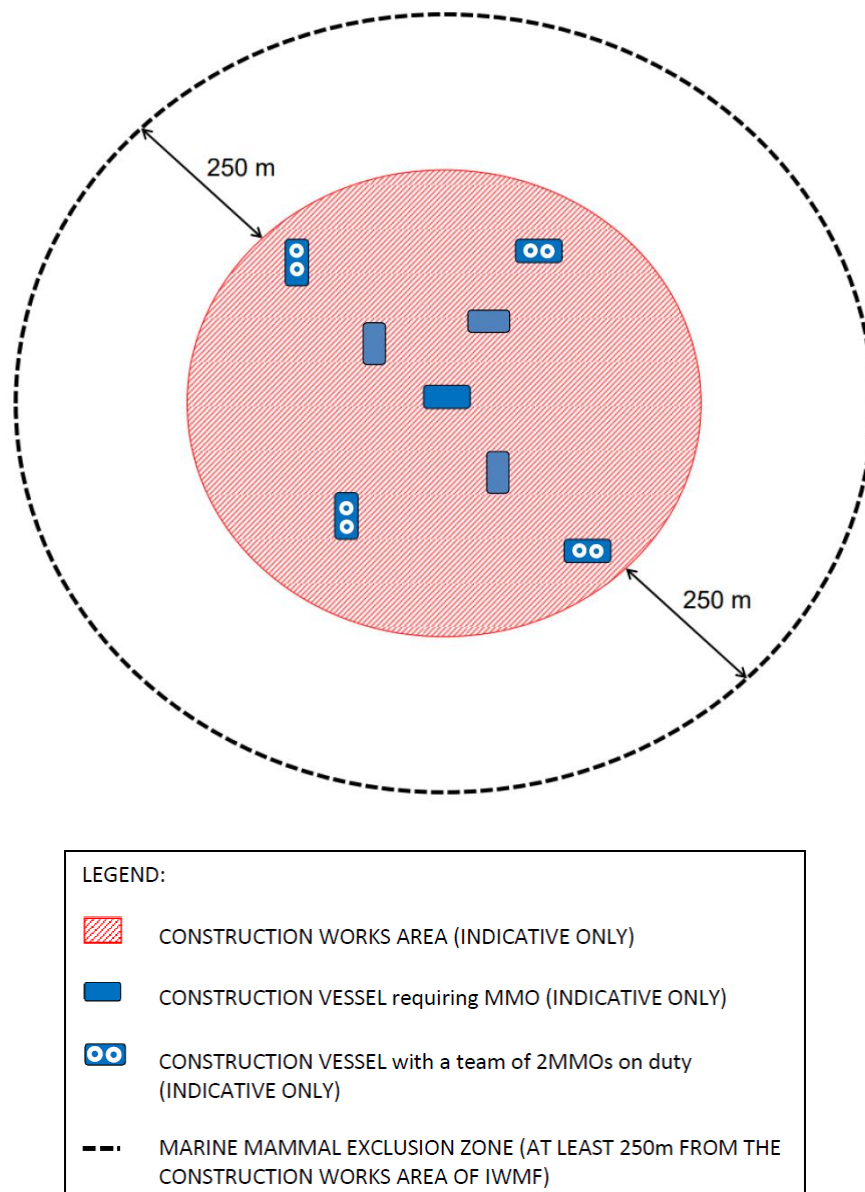
Figure 6.4 Illustration of Typical MMEZ

6.3.1.3 A MMEZ with 250 m distance from the boundary of a work area shall be established during the above situation. A typical MMEZ is indicated in **Figure 6.4** for reference. The MMEZ serves as a monitoring approach to provide appropriate and immediate actions once finless porpoise or Chinese White Dolphin is sighted within the MMEZ. All MMEZ will be monitored by competent Marine Mammal Observers (MMOs) to be provided by the Environmental Team (ET) for the IWMF and trained by the Marine Mammal Monitoring Specialist of the ET who is independent from JV.
