Contract No. EP/SP/66/12
Integrated Waste Management Facilities, Phase 1
Monthly EM&A Report No.30

Monthly EM&A Report No.30 (Period from 1 December to 31 December 2020)

(Clause 3.3, Further Environmental Permit FEP-01/429/2012/A)

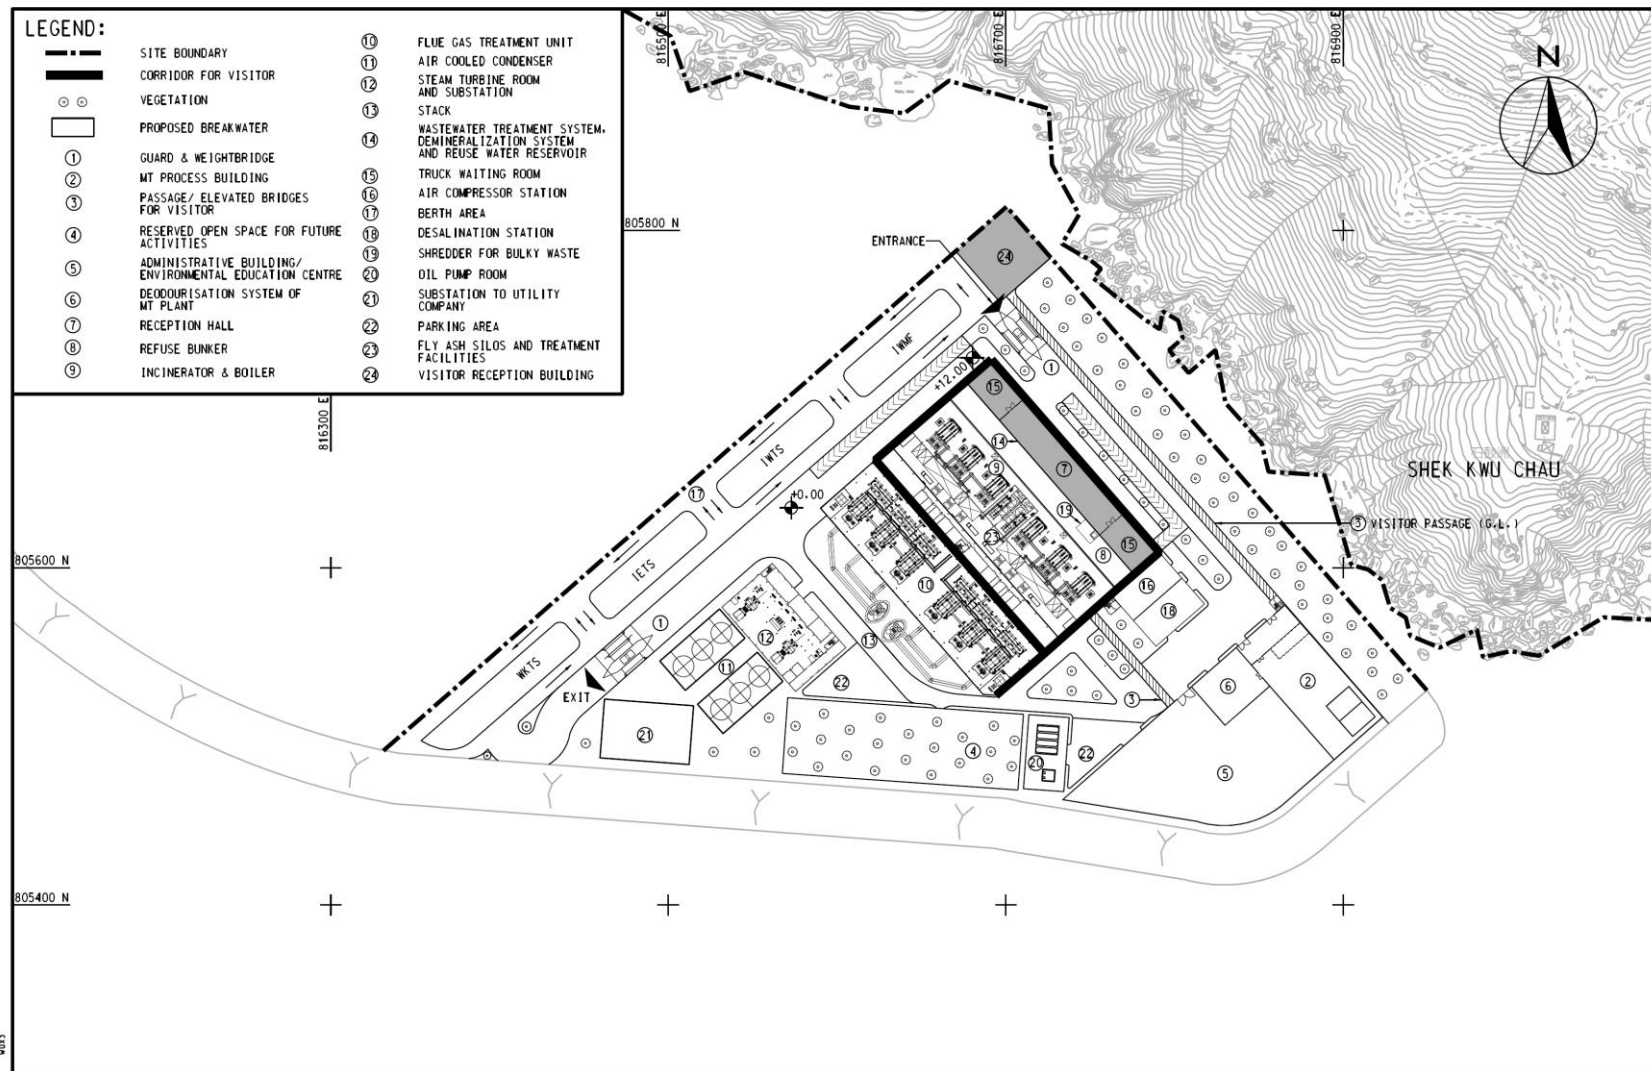
Figure 1.2 General Layout of the IWMF at the Artificial Island near SKC

- 1.1.5 The location of the IWMF near Shek Kwu Chau (SKC) and general layout of IWMF are shown in **Figure 1.1** and **Figure 1.2** respectively.

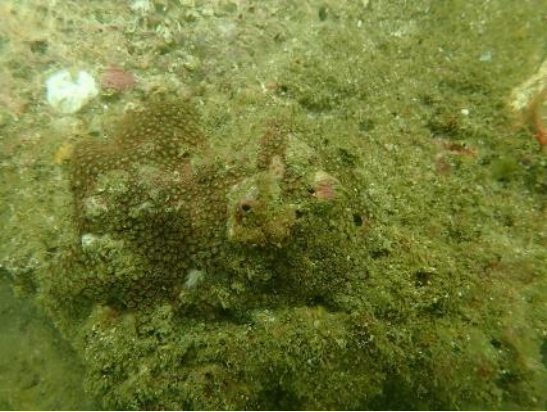
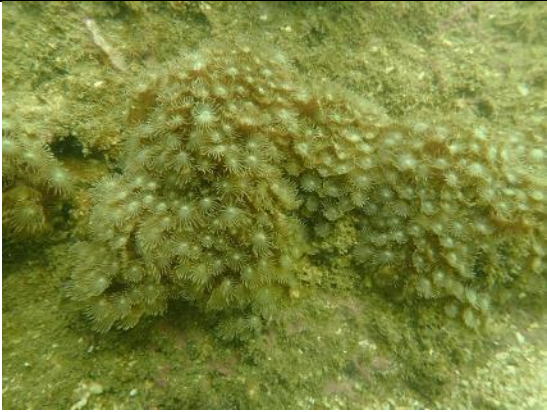
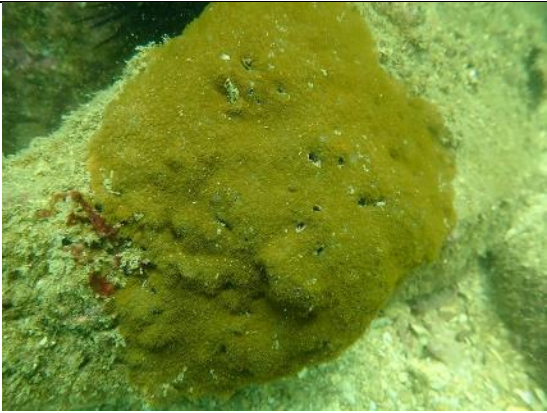
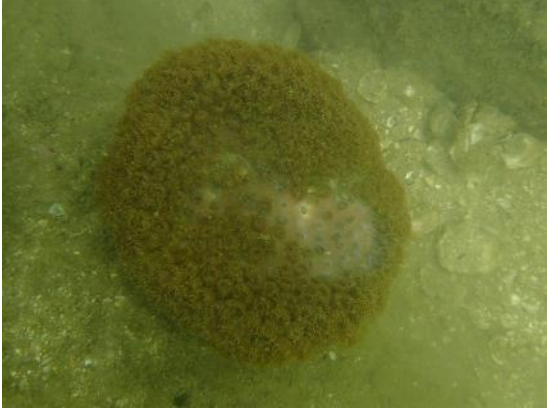
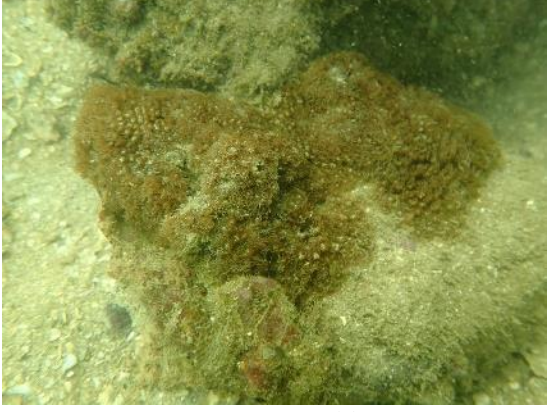
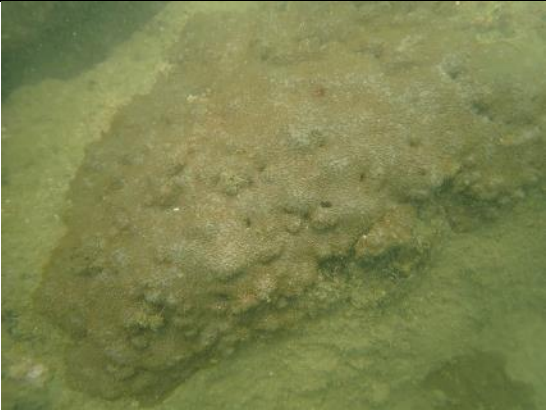
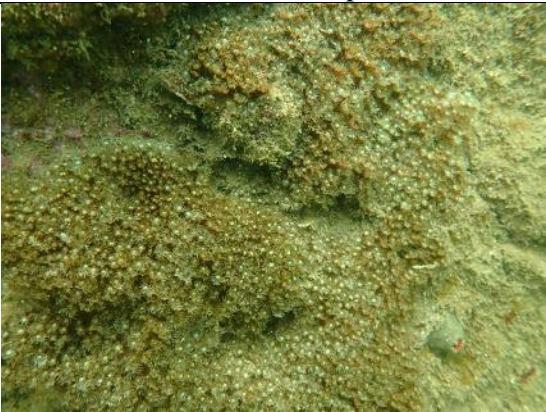
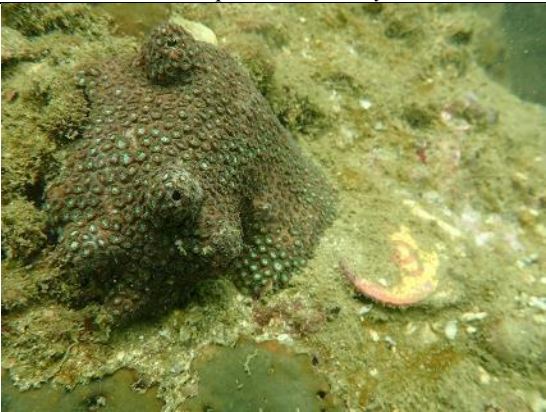
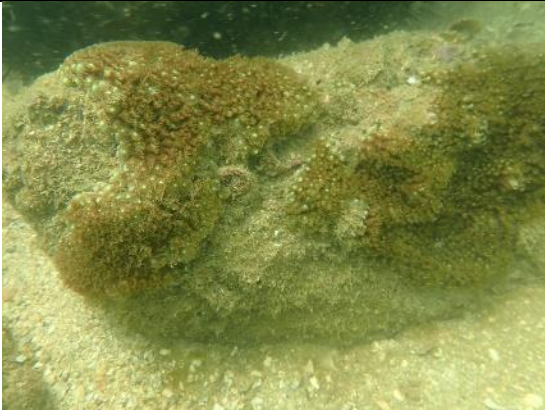
5.6.2 Ten (10) hard coral colonies were monitored at each Control site and Indirect Impact Site as suggested in the Construction Phase Monitoring Plan. The general health conditions (size, mortality, bleaching and sediment) were recorded and summarized in **Table 5.8** and **Table 5.9**. Photos of each coral colonies were taken during the monitoring activities shown in **Photo Plate 5.1** and **5.2**.

Tag #	Species	Size (cm) – Max. Diameter	Condition	Mortality (%)		Bleaching (%)		Sediment (%)	
				Baseline	23/12	Baseline	23/12	Baseline	23/12
1	<i>Goniopora stutchburyi</i>	25	Fair	0	0	0	0	0	0
2R	<i>Goniopora stutchburyi</i>	10	Good	0	0	0	0	0	0
3	<i>Psammocora superficialis</i>	18	Fair	0	0	0	0	0	0
4	<i>Turbinaria peltata</i>	13	Good	0	0	0	0	0	0
5R	<i>Goniopora stutchburyi</i>	18	Good	0	0	0	0	0	0
6	<i>Cyphastrea serailia</i>	43	Fair	0	0	0	0	0	0
7R	<i>Coscinaraea</i> sp.	15	Good	0	0	0	0	0	0
8	<i>Goniopora stutchburyi</i>	21	Good	0	0	0	0	0	0
9	<i>Goniopora stutchburyi</i>	11	Fair	0	0	0	0	0	0
10R	<i>Goniopora stutchburyi</i>	20	Good	0	0	0	0	0	0

- 5.6.4 All tagged and re-tagged coral colonies showed good health condition during the 8th Quarterly Construction Phase Monitoring. There was no increased level of mortality, bleaching and sediment when compared with the baseline results.

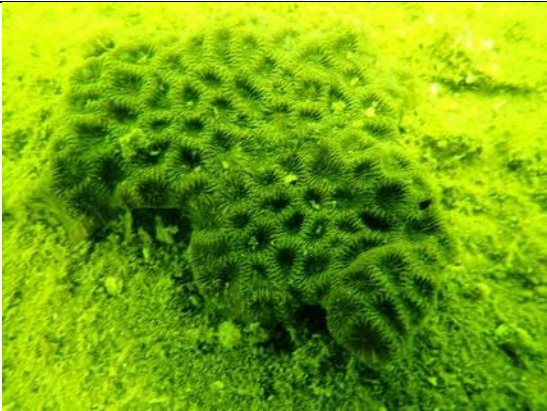
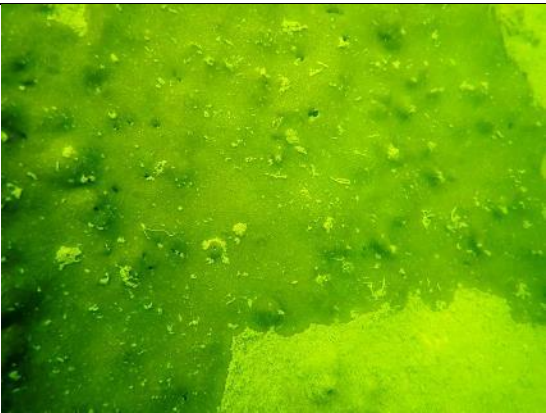
Tag #	Species	Size (cm) – Max. Diameter	Condition	Mortality (%)		Bleaching (%)		Sediment (%)	
				Baseline	23/12	Baseline	23/12	Baseline	23/12
11R	<i>Cyphastrea serailia</i>	48	Good	0	0	0	0	0	0
12R	<i>Favites chinensis</i>	27	Good	0	0	0	0	0	0
13R	<i>Turbinaria peltata</i>	21	Good	0	0	0	0	0	0
14R	<i>Favites chinensis</i>	8	Good	0	0	0	0	0	0
15R	<i>Goniopora stutchburyi</i>	11	Good	0	0	0	0	0	0
16R	<i>Psammocora superficialis</i>	27	Good	0	0	0	0	0	0
17R	<i>Favites chinensis</i>	15	Good	0	0	0	0	0	0
18R	<i>Psammocora superficialis</i>	39	Good	0	0	0	0	0	0
19R	<i>Psammocora superficialis</i>	42	Good	0	0	0	0	0	0
20R	<i>Psammocora superficialis</i>	29	Good	0	0	0	0	0	0

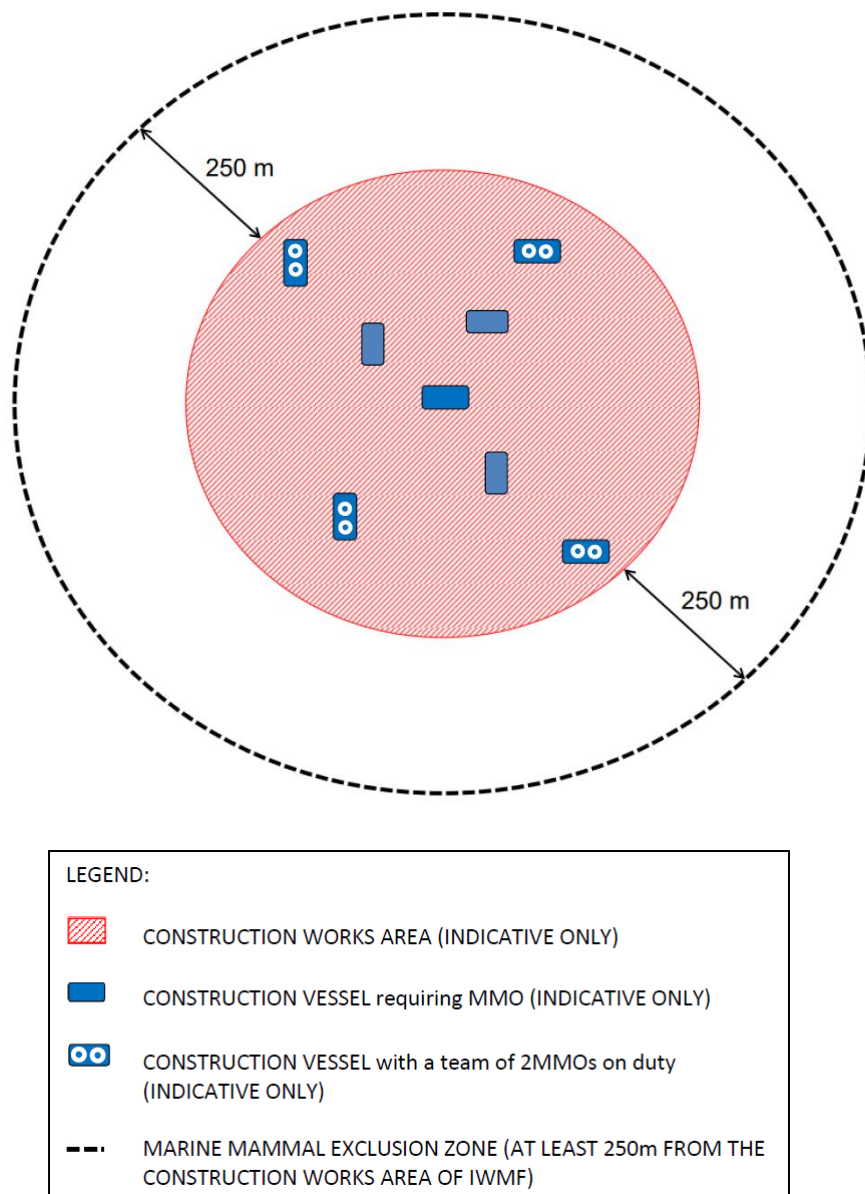
Figure 6.4 Illustration of Typical MMEZ

- 6.3.1.3 A MMEZ with 250 m distance from the boundary of a work area shall be established during the above situation. A typical MMEZ is indicated in **Figure 6.4** for reference. The MMEZ serves as a monitoring approach to provide appropriate and immediate actions once finless porpoise or Chinese White Dolphin is sighted within the MMEZ. All MMEZ will be monitored by competent Marine Mammal Observers (MMOs) to be provided by the Environmental Team (ET) for the IWMF and trained by the Marine Mammal Monitoring Specialist of the ET who is independent from KSZHJV.

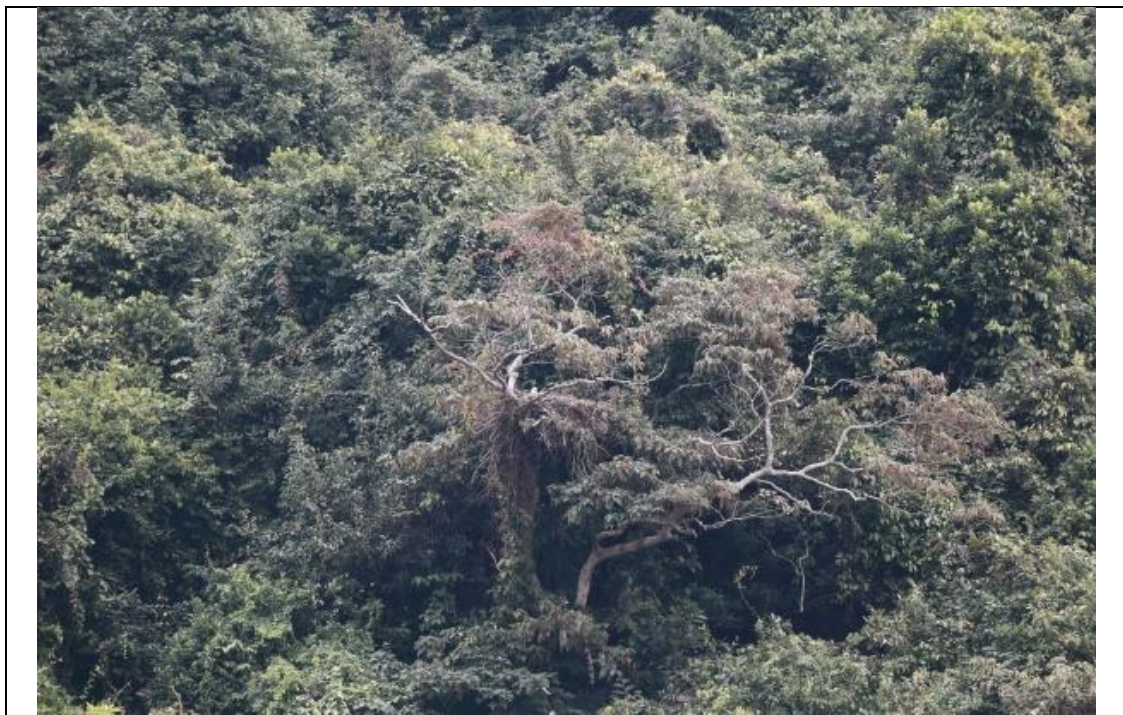
Adult WBSE recorded staying in the old nest

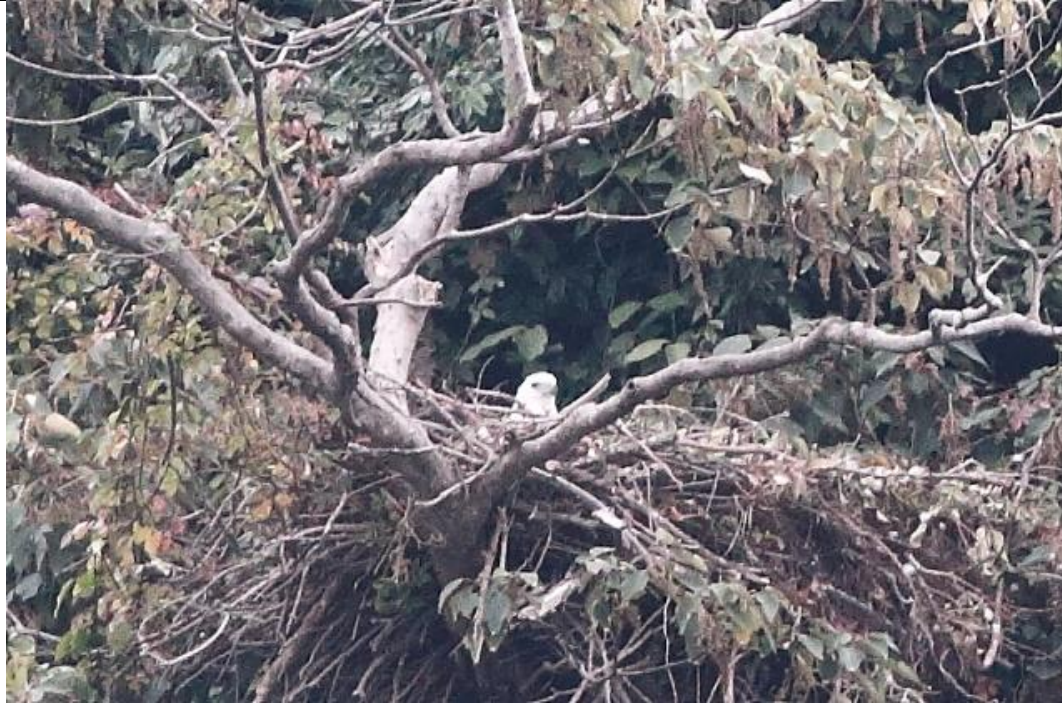
Adult WBSE recorded staying in the old nest

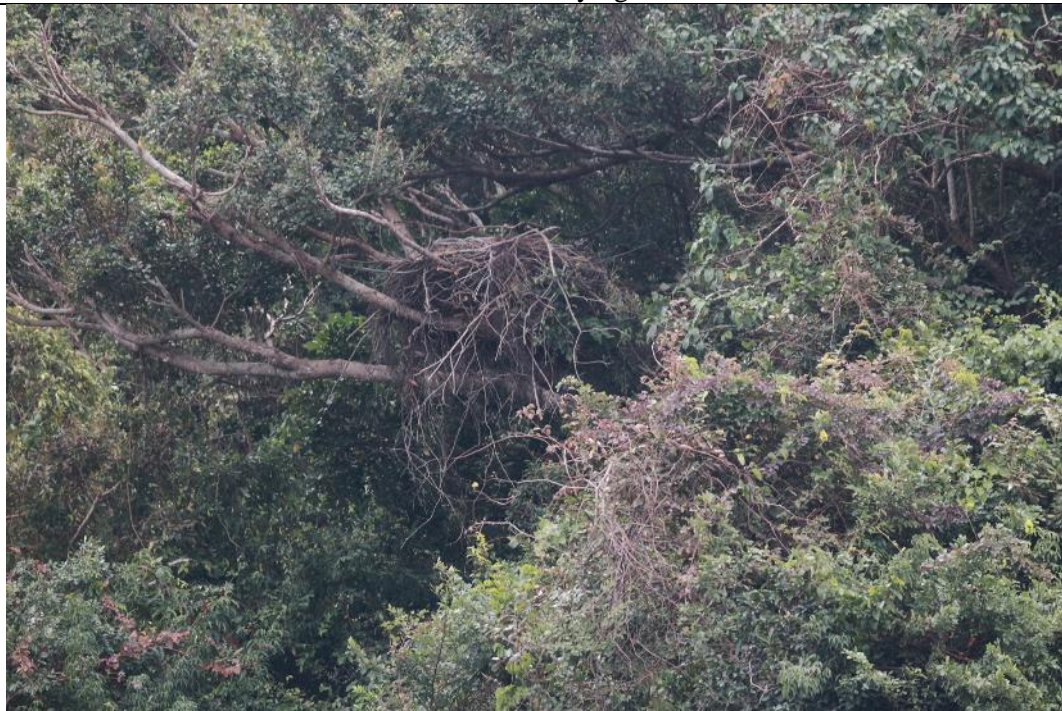
Empty new nest
