Contract No. EP/SP/66/12
Integrated Waste Management Facilities, Phase 1
Monthly EM&A Report No.31

Monthly EM&A Report No.31
(Period from 1 January to 31 January 2021)

(Clause 3.3, Further Environmental Permit FEP-01/429/2012/A)

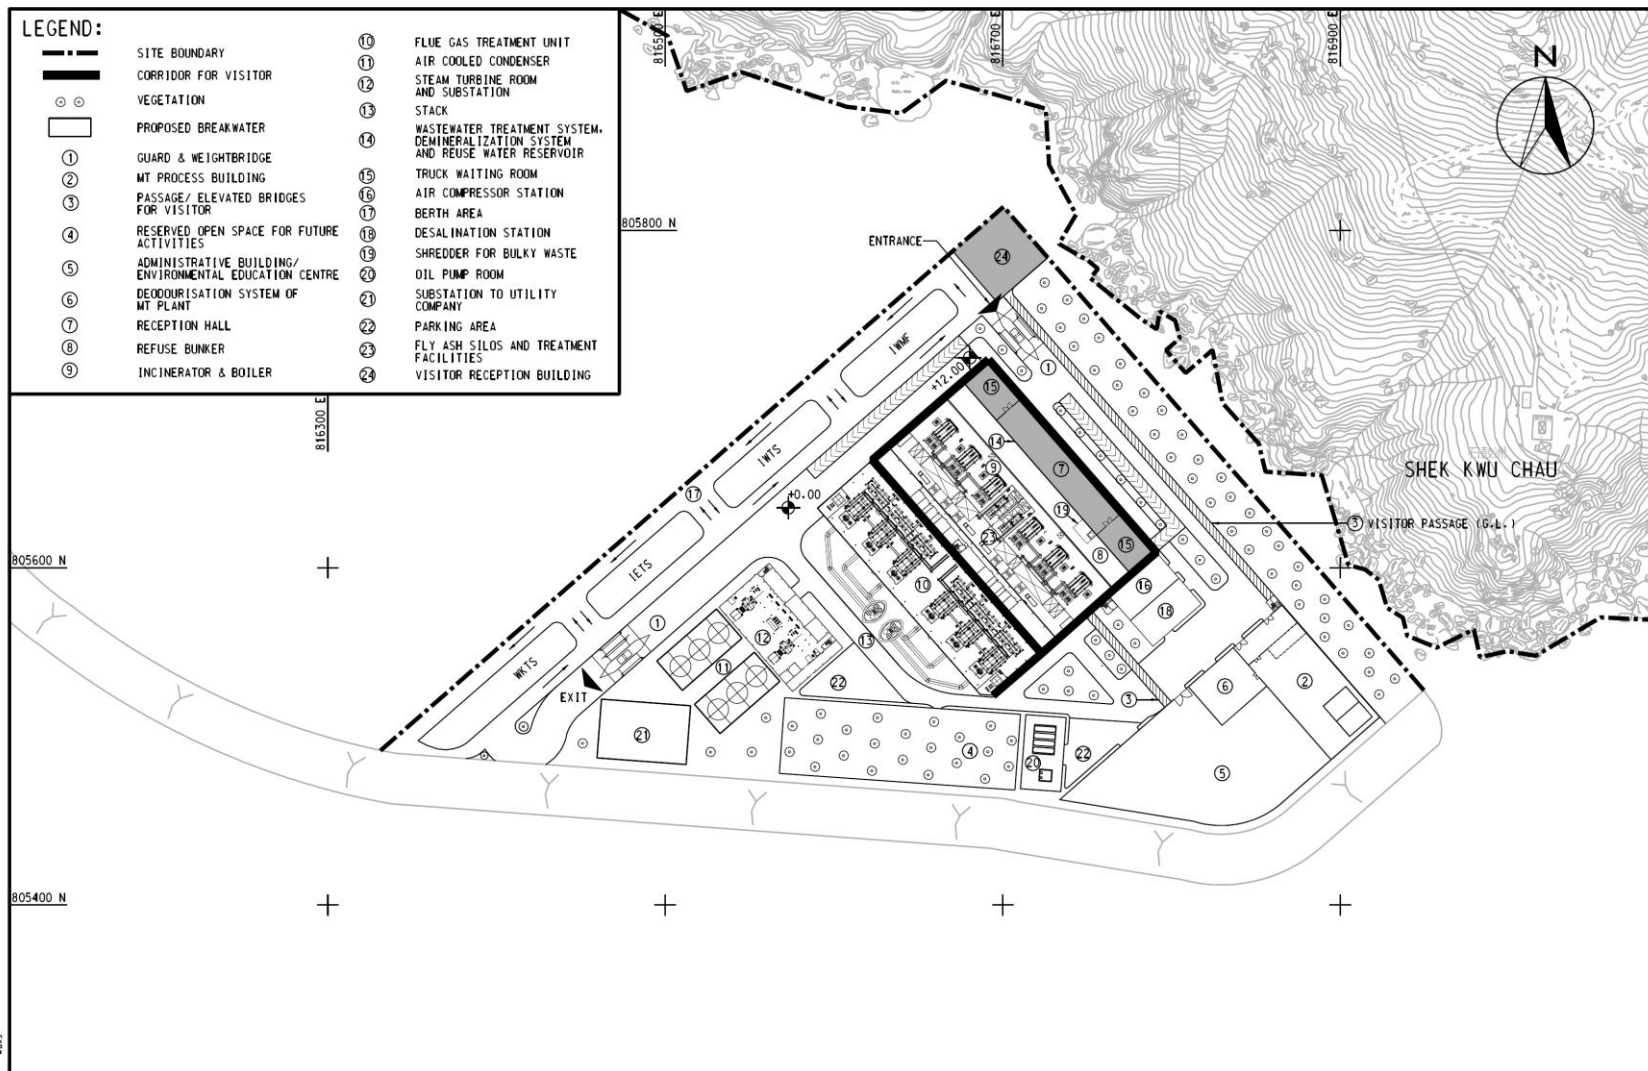
Figure 1.2 General Layout of the IWMF at the Artificial Island near SKC

- 1.1.5 The location of the IWMF near Shek Kwu Chau (SKC) and general layout of IWMF are shown in **Figure 1.1** and **Figure 1.2** respectively.

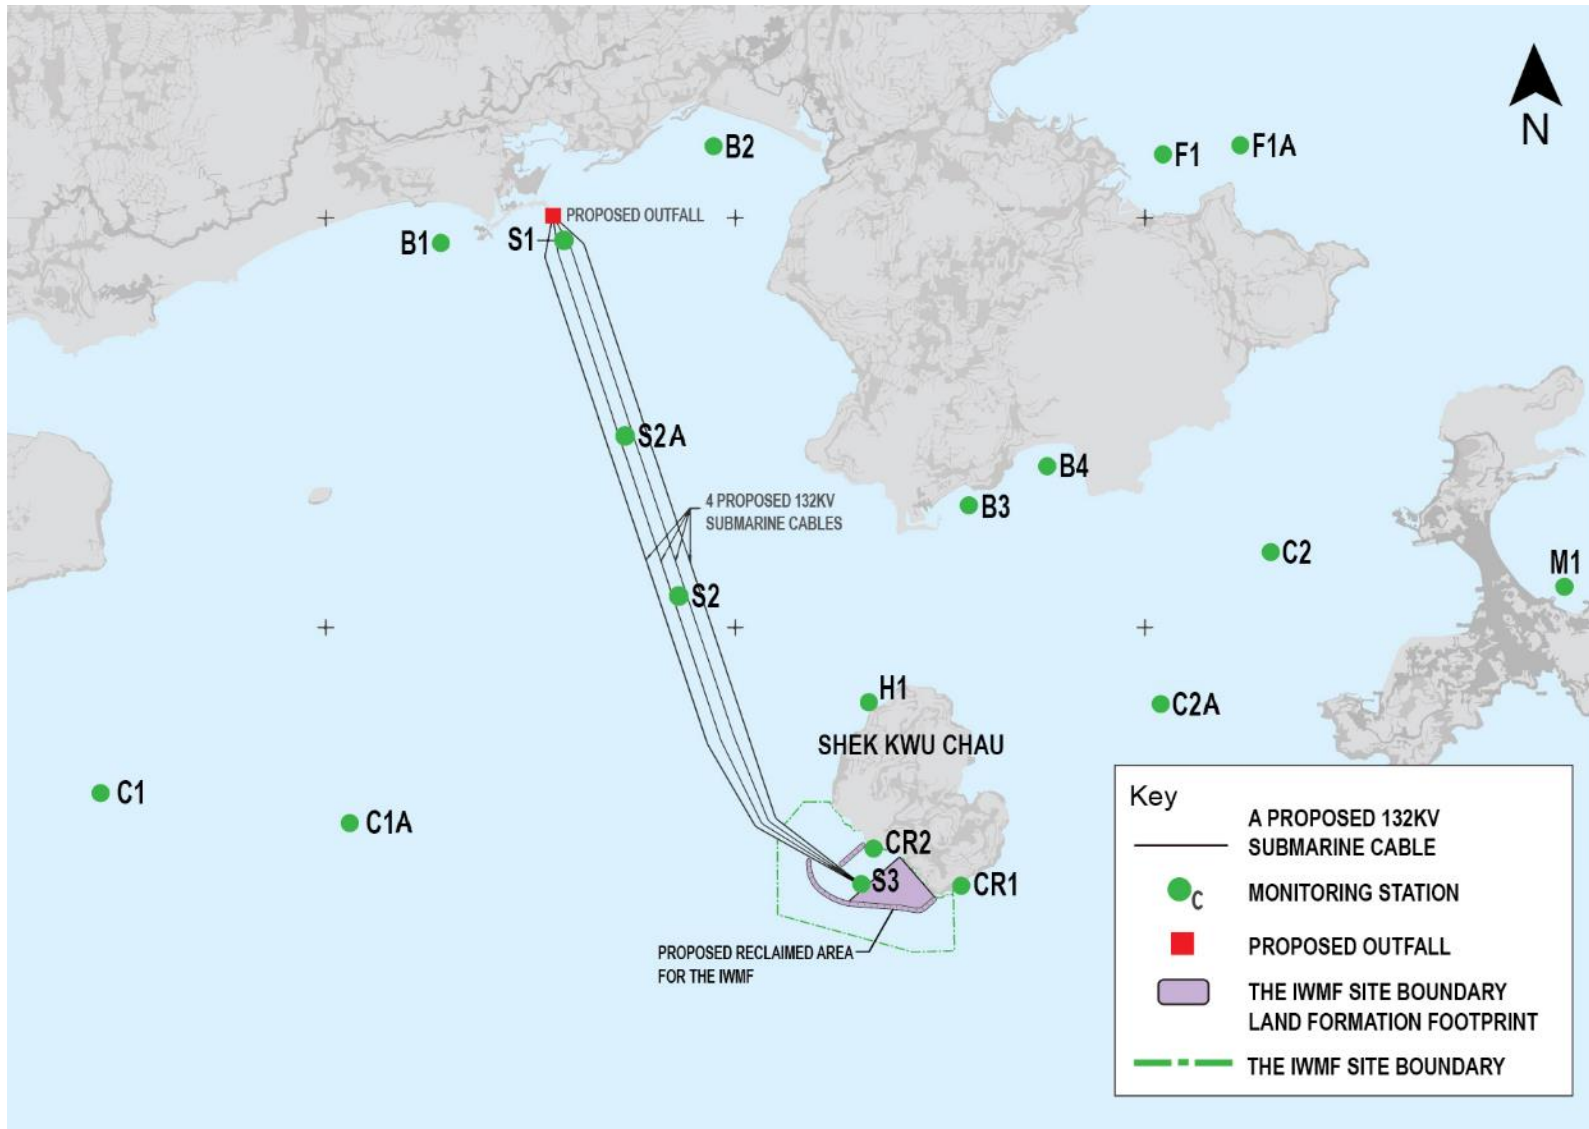
2.3.1 Impact water quality monitoring was conducted at eleven monitoring locations (B1-B4, H1, C1, C2, F1, CR1, CR2 & M1) during general water quality monitoring as shown in **Figure 2.1**. As per the relocation proposal verified by IEC and approved by EPD, the monitoring location C1, C2, S2, F1 are relocated at C1A, C2A, S2A, F1A as equivalent points respectively to clear up the concerns from stakeholders.

2.3.2 B1 to B4 are located at 4 beaches respectively at the southern shore of Lantau Island. Monitoring station H1 is located at the horseshoe crab habitat at northern SKC, while CR1 and CR2 are located at the coral communities at southwestern shore of SKC. Monitoring station F1 is located at the Cheung Sha Wan Fish Culture Zone while monitoring station M1 is located at Tung Wan at Cheung Chau. Monitoring station F1A is relocated for F1 at the Cheung Sha Wan Fish Culture Zone. S1, S2 and S3 are located at the northern landing site, midway and southern landing site of the proposed submarine cable, respectively. S2A is the relocated monitoring station of S2 which represents the midway landing site of the proposed submarine cable. S1, S2/S2A and S3 are required for monitoring due to the laying of submarine cable. Control stations C1 and C2 at far field locations are for comparison. Control stations C1A and C2A are relocated for C1 and C2 respectively as equivalent far field locations for comparison.
