**Contract No. EP/SP/66/12**  
**Integrated Waste Management Facilities, Phase 1**  
**Monthly EM&A Report No.32**

**Monthly EM&A Report No.32**  
**(Period from 1 February to 28 February 2021)**

*(Clause 3.3, Further Environmental Permit FEP-01/429/2012/A)*

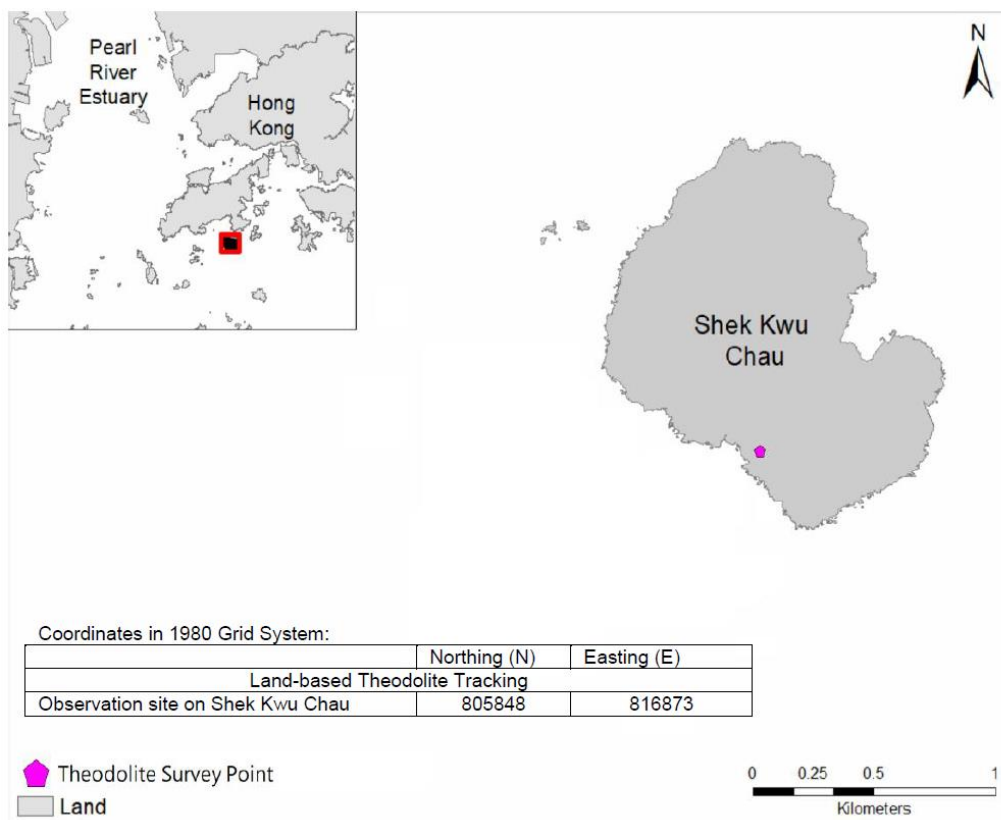
**Figure 6.3 Locations of Land-based Theodolite Tracking**

6.2.4.1 The Land-based Theodolite Tracking study would use the same station as in the AFCD monitoring study (same as the baseline monitoring location), which is situated at the southwest side of Shek Kwu Chau (GPS position: 22°11.47' N and 113°59.33' E) as shown in below **Figure 6.3**. The station was selected based on its height above sea level (at least 20 metres), close proximity to shore, and relatively unobstructed views of the entire Project Area to the southwest of Shek Kwu Chau. The height of the Shek Kwu Chau Station established by the HKCRP team is 74.6 m high at mean low water, and only a few hundred metres to the IWMF reclamation site, which is ideal for the purpose for the present behavioural and movement monitoring of finless porpoises as well during construction phase considering there as an un-obstructed vantage point at a height above the Project Site.
