Contract No. EP/SP/66/12
Integrated Waste Management Facilities, Phase 1
Monthly EM&A Report No.38

Monthly EM&A Report No.38 (Period from 1 August to 31 August 2021)

(Clause 3.3, Further Environmental Permit FEP-01/429/2012/A)

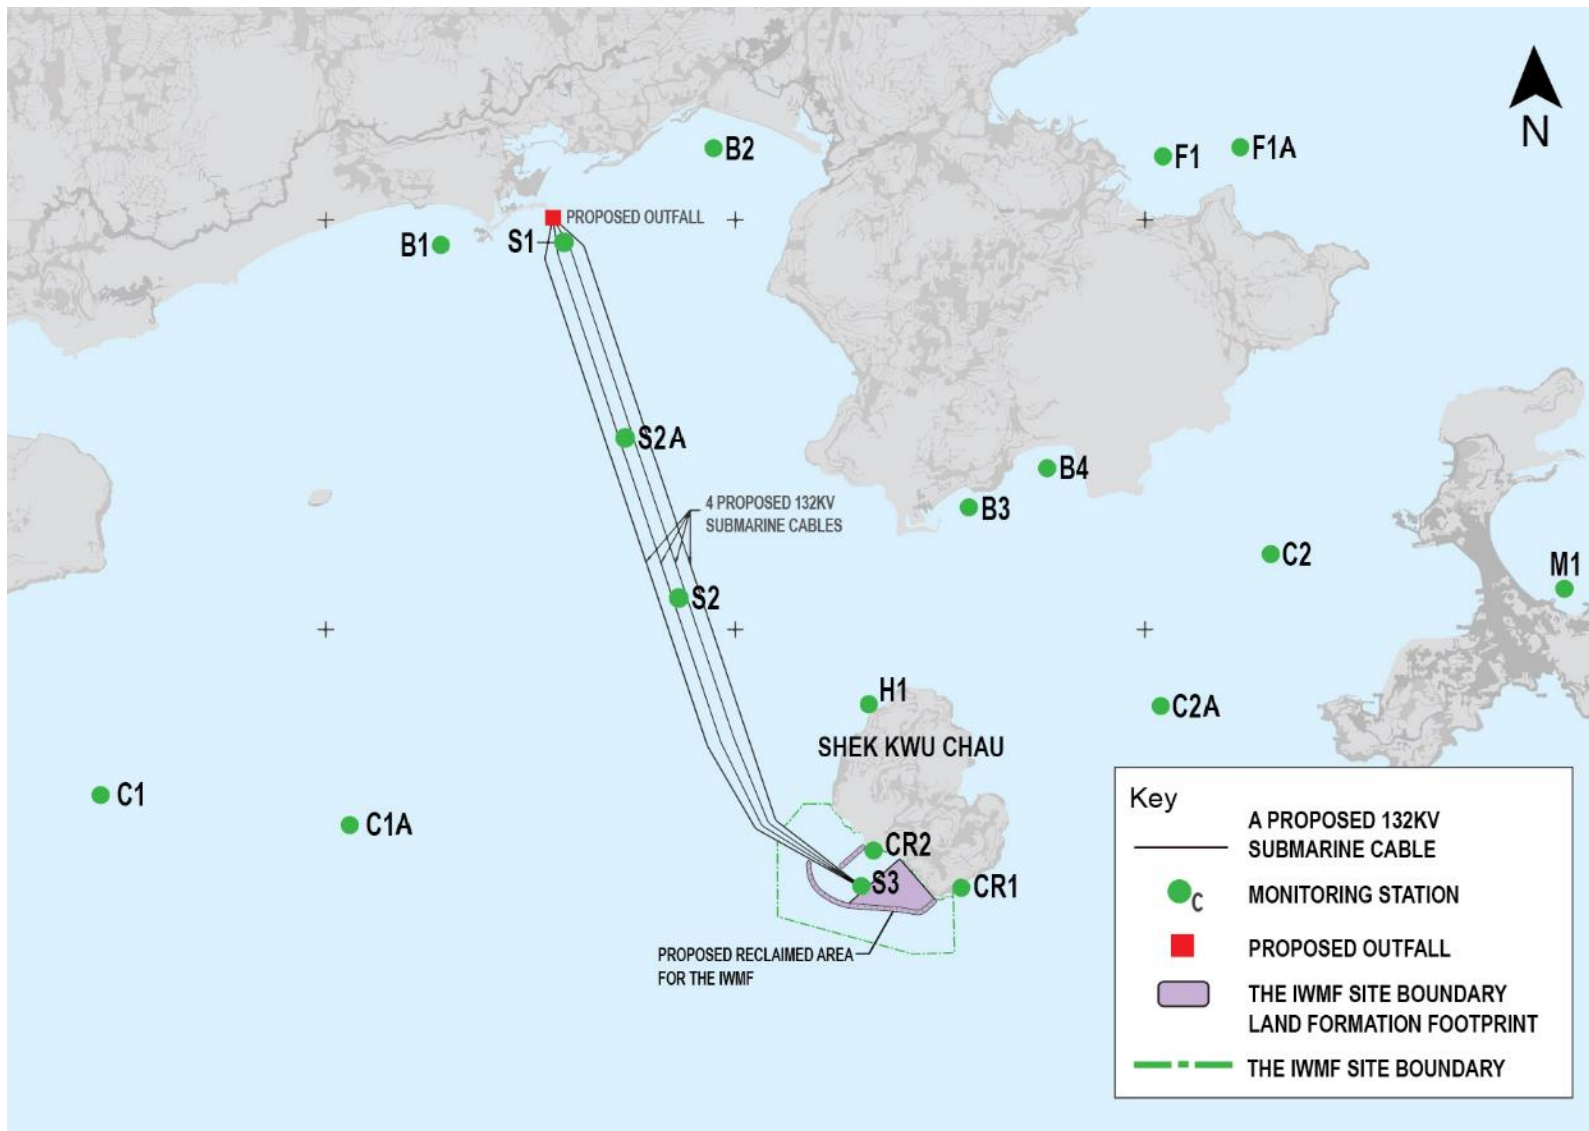
Figure 2.1 Water monitoring locations at Artificial Island near SKC

2.3.1 Impact water quality monitoring was conducted at eleven monitoring locations (B1-B4, H1, C1, C2, F1, CR1, CR2 & M1) during general water quality monitoring as shown in **Figure 2.1**. As per the relocation proposal verified by IEC and approved by EPD, the monitoring location C1, C2, S2, F1 are relocated at C1A, C2A, S2A, F1A as equivalent points respectively to clear up the concerns from stakeholders.

2.3.2 B1 to B4 are located at 4 beaches respectively at the southern shore of Lantau Island. Monitoring station H1 is located at the horseshoe crab habitat at northern SKC, while CR1 and CR2 are located at the coral communities at southwestern shore of SKC. Monitoring station F1 is located at the Cheung Sha Wan Fish Culture Zone while monitoring station M1 is located at Tung Wan at Cheung Chau. Monitoring station F1A is relocated for F1 at the Cheung Sha Wan Fish Culture Zone. S1, S2 and S3 are located at the northern landing site, midway and southern landing site of the proposed submarine cable, respectively. S2A is the relocated monitoring station of S2 which represents the midway landing site of the proposed submarine cable. S1, S2/S2A and S3 are required for monitoring due to the laying of submarine cable. Control stations C1 and C2 at far field locations are for comparison. Control stations C1A and C2A are relocated for C1 and C2 respectively as equivalent far field locations for comparison.
