Contract No. EP/SP/66/12  
Integrated Waste Management Facilities, Phase 1  
Monthly EM&A Report No.51

## Monthly EM&A Report No.51 (Period from 1 September to 30 September 2022)

(Clause 3.3, Further Environmental Permit FEP-01/429/2012/A)

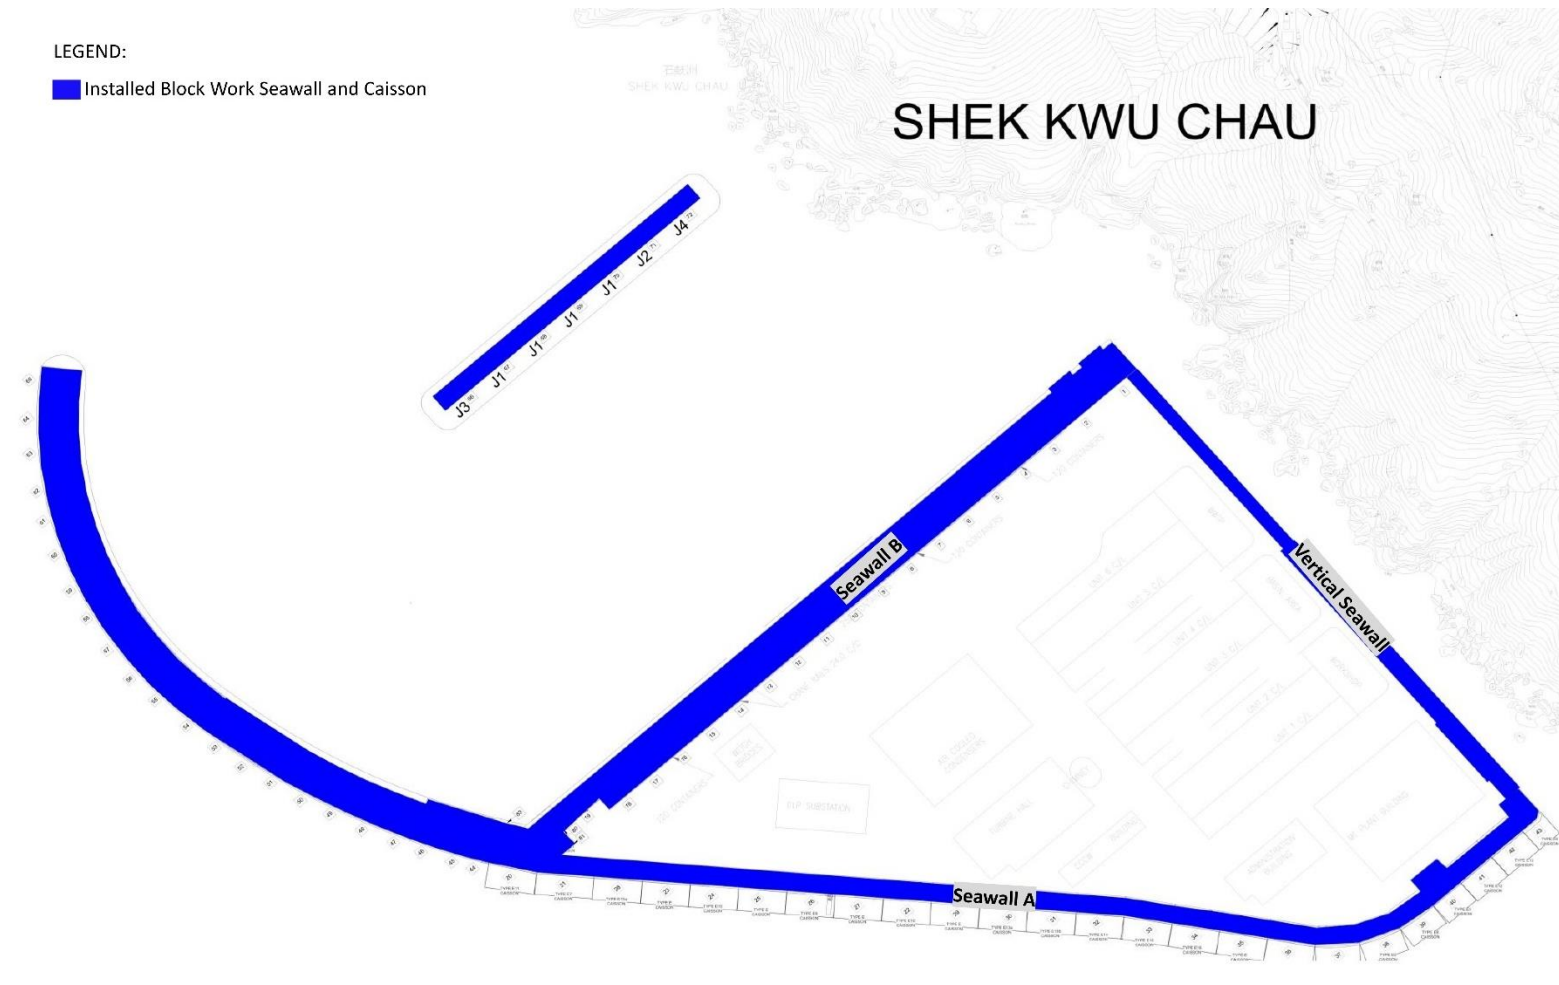
Figure 1.4 Location of Major Construction Activities Undertaken during the Reporting Month

Location of works	Construction activities undertaken	Remarks on progress
Reclamation area	<ul style="list-style-type: none"> <li>• Reclamation works</li> <li>• Installation of Instrumentation</li> <li>• Site Investigation works for foundation</li> <li>• Foundation works (including Driven H Pile and Socketed H Pile)</li> <li>• Pile cap construction</li> <li>• Structural steel work</li> </ul>	<ul style="list-style-type: none"> <li>• On-going</li> <li>• On-going</li> <li>• On-going</li> <li>• On-going</li> <li>• On-going</li> <li>• On-going</li> </ul>
Seawall portion	<ul style="list-style-type: none"> <li>• Installation of Chinese Pod</li> <li>• Caisson extension works, from +3mPD to +6mPD, at Seawall A and B</li> <li>• Construction of wave wall along the vertical seawall</li> </ul>	<ul style="list-style-type: none"> <li>• On-going</li> <li>• On-going</li> <li>• On-going</li> </ul>

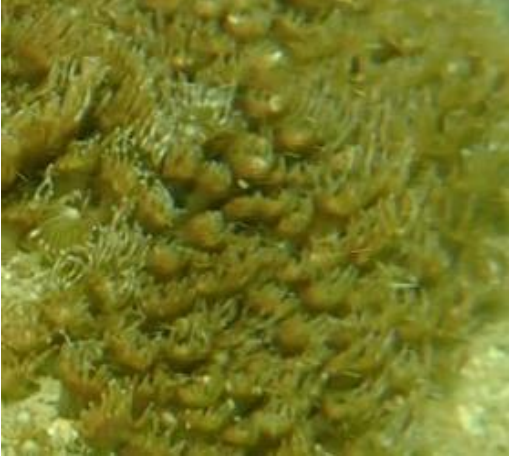
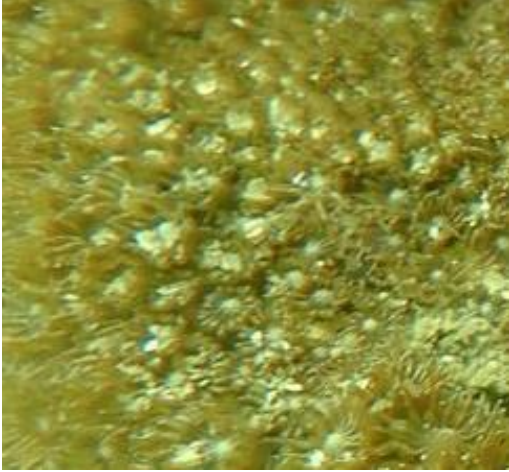
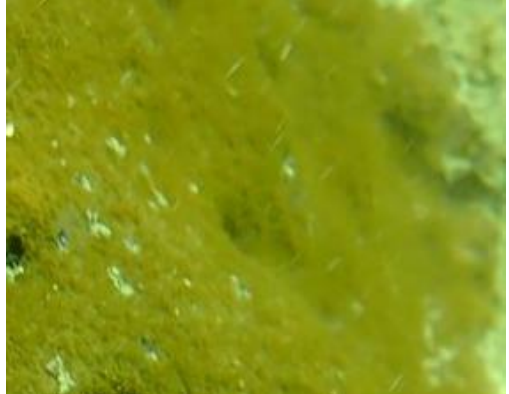
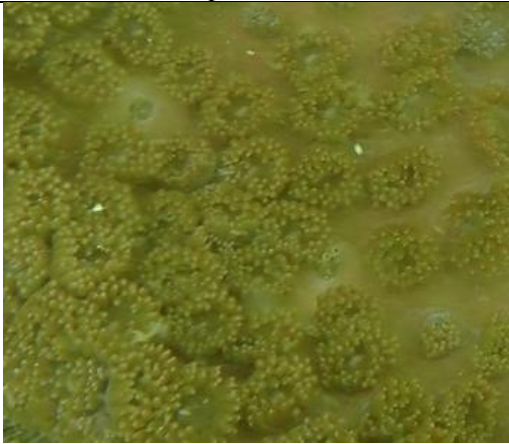
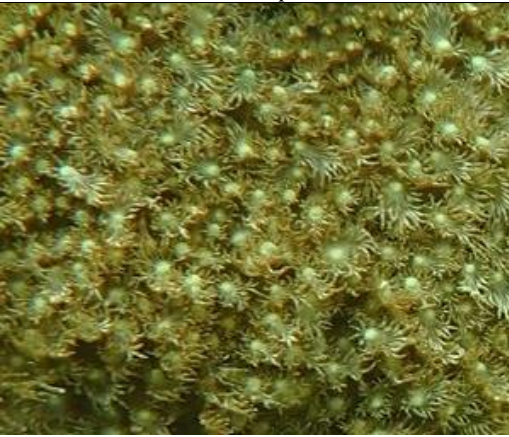
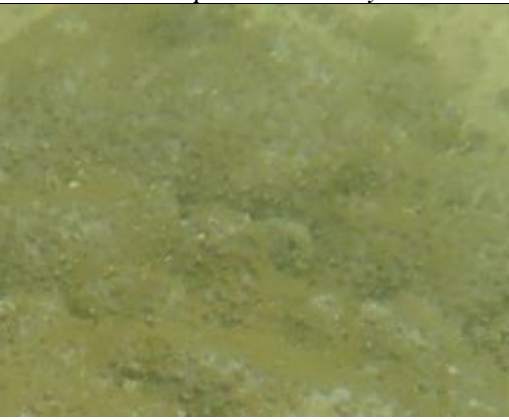
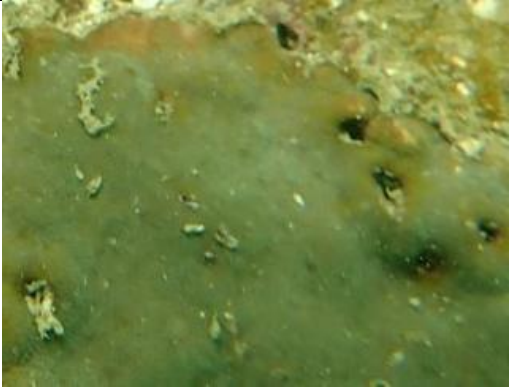
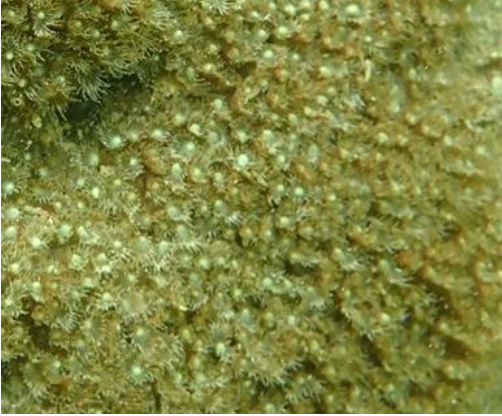
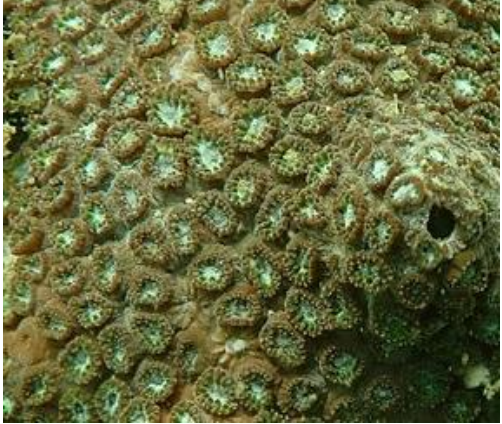
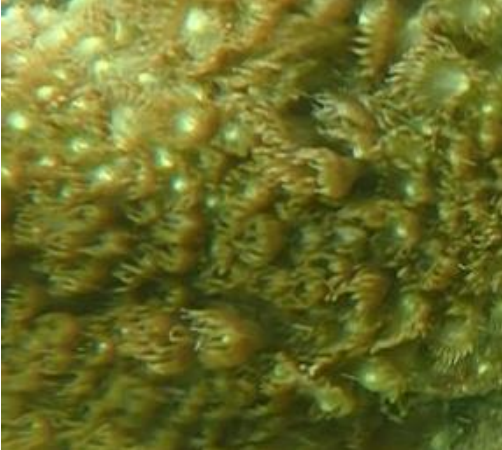
**Photo Plate 5.1 Ten (10) Monitored Corals at Control Site**

5.6.2 Ten (10) hard coral colonies were monitored at each Control site and Indirect Impact Site as suggested in the Construction Phase Monitoring Plan. The general health conditions (size, mortality, bleaching and sediment) were recorded and summarized in **Table 5.8** and **Table 5.9**. Photos of each coral colonies were taken during the monitoring activities shown in **Photo Plate 5.1** and **Photo Plate 5.2**.

Tag #	Species	Size (cm) – Max. Diameter	Condition	Mortality (%)		Bleaching (%)		Sediment (%)	
				Baseline	30/09	Baseline	30/09	Baseline	30/09
1	<i>Goniopora stutchburyi</i>	25	Good	0	0	0	0	0	0
2R	<i>Goniopora stutchburyi</i>	10	Good	0	0	0	0	0	0
3	<i>Psammocora superficialis</i>	18	Good	0	0	0	0	0	0
4	<i>Turbinaria peltata</i>	13	Good	0	0	0	0	0	0
5R	<i>Goniopora stutchburyi</i>	18	Good	0	0	0	0	0	0
6	<i>Cyphastrea serailia</i>	43	Good	0	0	0	0	0	0
7R	<i>Coscinaraea</i> sp.	15	Good	0	0	0	0	0	0
8	<i>Goniopora stutchburyi</i>	21	Good	0	0	0	0	0	0
9	<i>Goniopora stutchburyi</i>	11	Good	0	0	0	0	0	0
10R	<i>Goniopora stutchburyi</i>	20	Good	0	0	0	0	0	0

- 5.6.4 All tagged and re-tagged coral colonies showed good health condition during the 15<sup>th</sup> Quarterly Construction Phase Monitoring. There was no increased level of mortality, bleaching and sediment when compared with the baseline results.
- 5.6.5 No sediment, bleaching or increased mortality in the general condition of coral colonies were observed during the tenth construction phase monitoring period. No deterioration of the coral community was observed in the ecological monitoring results when compared with the baseline ecological monitoring results. There is no AL/LL exceedance during the monitoring period. Photos of each tagged corals colonies were taken and shown in **Photo Plates 5.1** and **Photo Plate 5.2**.

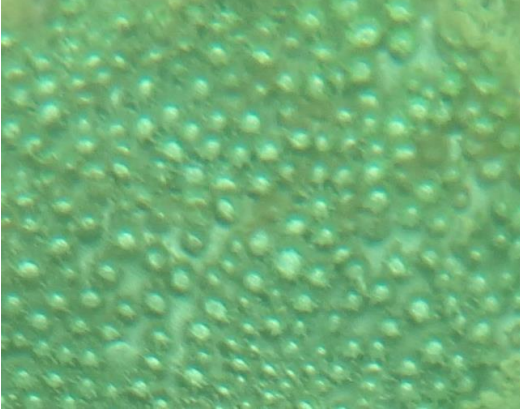
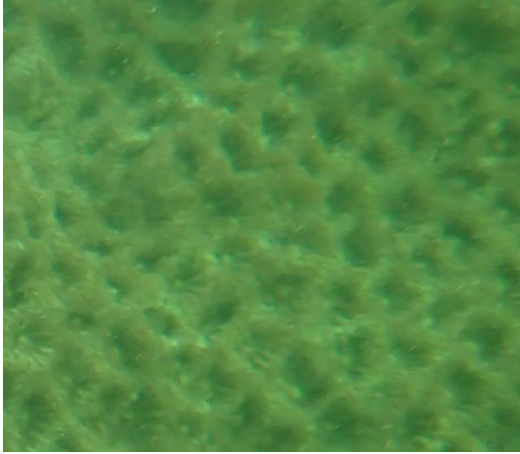
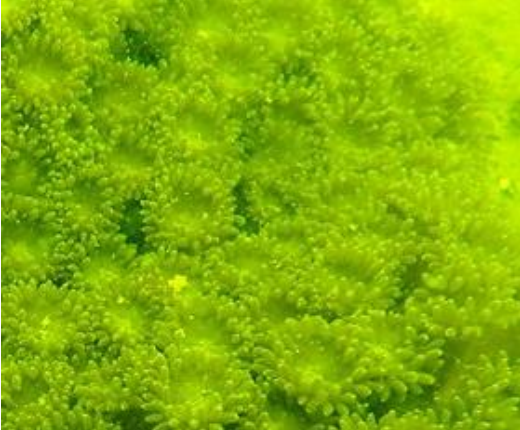
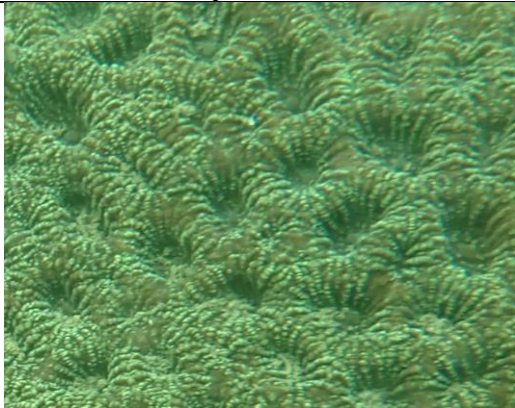
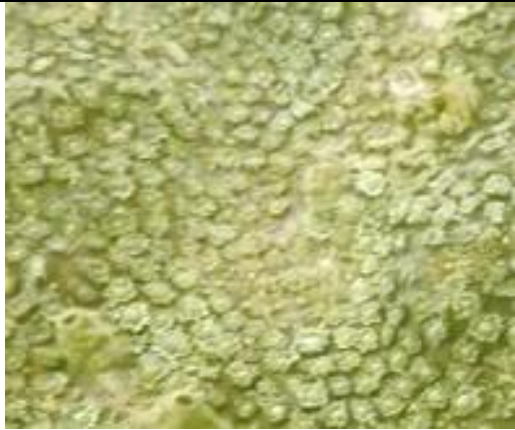
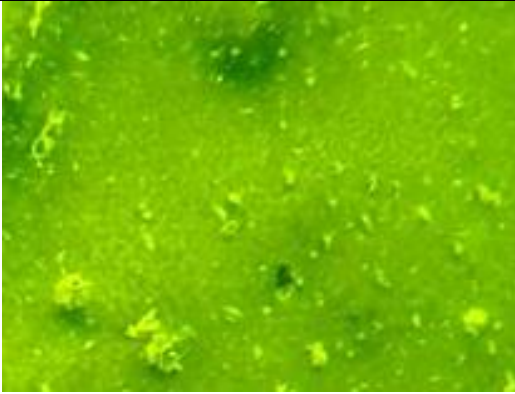
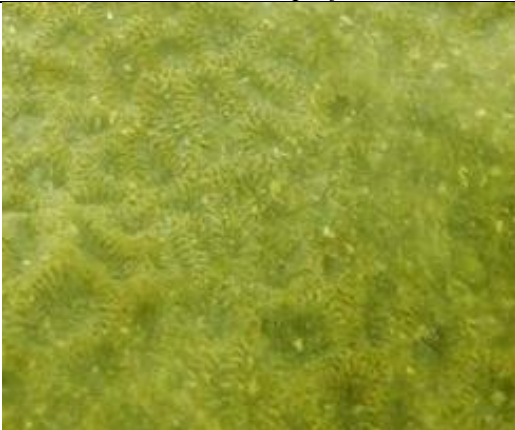
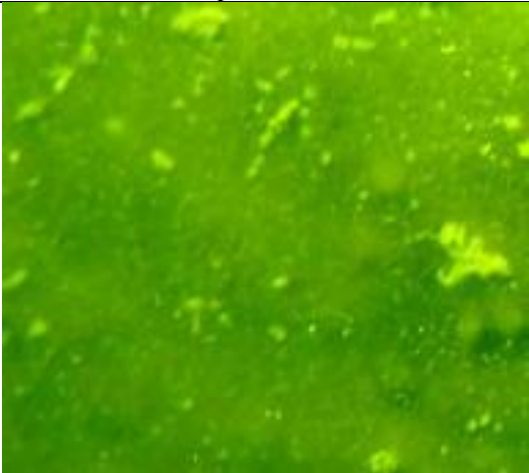
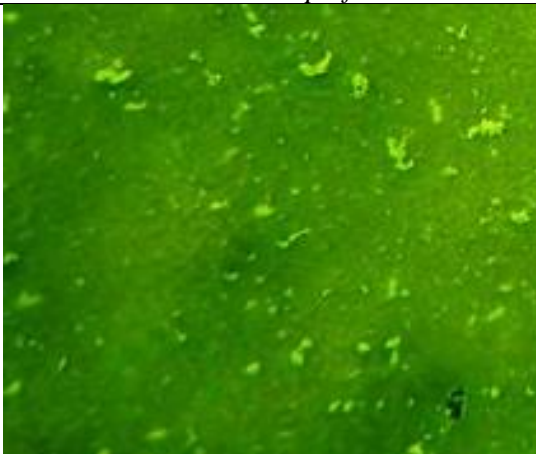
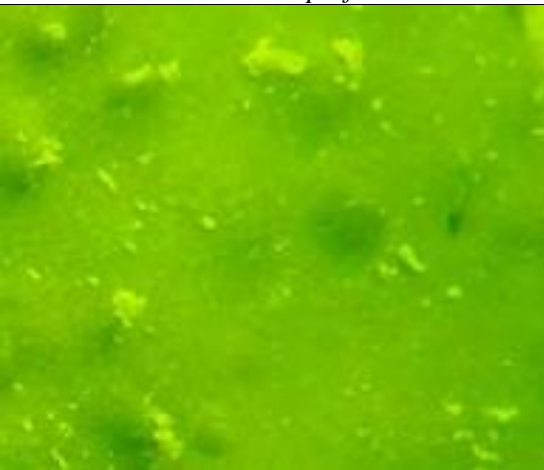
**Photo Plate 5.2 Ten (10) Monitored Corals at Indirect Impact Site**

Tag #	Species	Size (cm) – Max. Diameter	Condition	Mortality (%)		Bleaching (%)		Sediment (%)	
				Baseline	30/09	Baseline	30/09	Baseline	30/09
11R	<i>Cyphastrea serailia</i>	48	Good	0	0	0	0	0	0
12R	<i>Favites chinensis</i>	27	Good	0	0	0	0	0	0
13R	<i>Turbinaria peltata</i>	21	Good	0	0	0	0	0	0
14R	<i>Favites chinensis</i>	8	Good	0	0	0	0	0	0
15R	<i>Goniopora stutchburyi</i>	11	Good	0	0	0	0	0	0
16R	<i>Psammocora superficialis</i>	27	Good	0	0	0	0	0	0
17R	<i>Favites chinensis</i>	15	Good	0	0	0	0	0	0
18R	<i>Psammocora superficialis</i>	39	Good	0	0	0	0	0	0
19R	<i>Psammocora superficialis</i>	42	Good	0	0	0	0	0	0
20R	<i>Psammocora superficialis</i>	29	Good	0	0	0	0	0	0

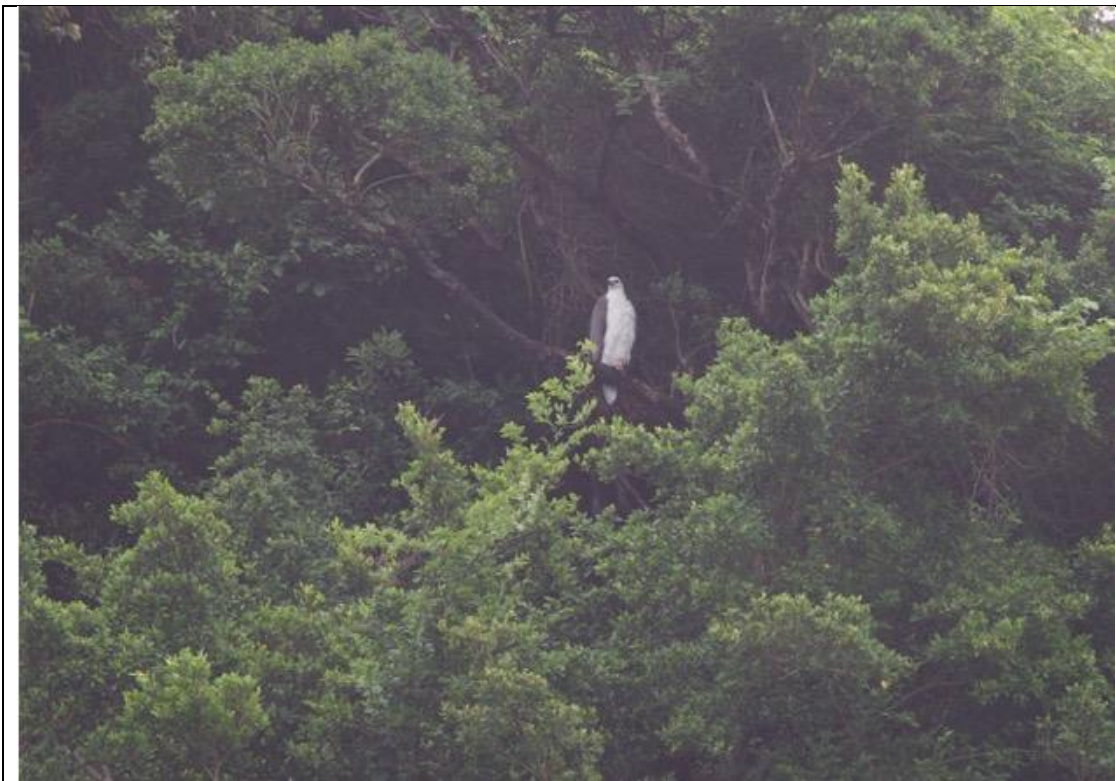
**Figure 7.2 Photo Records of WBSE on SKC during the Reporting Period**

Adult WBSE staying near the nest on 30<sup>th</sup> September 2022

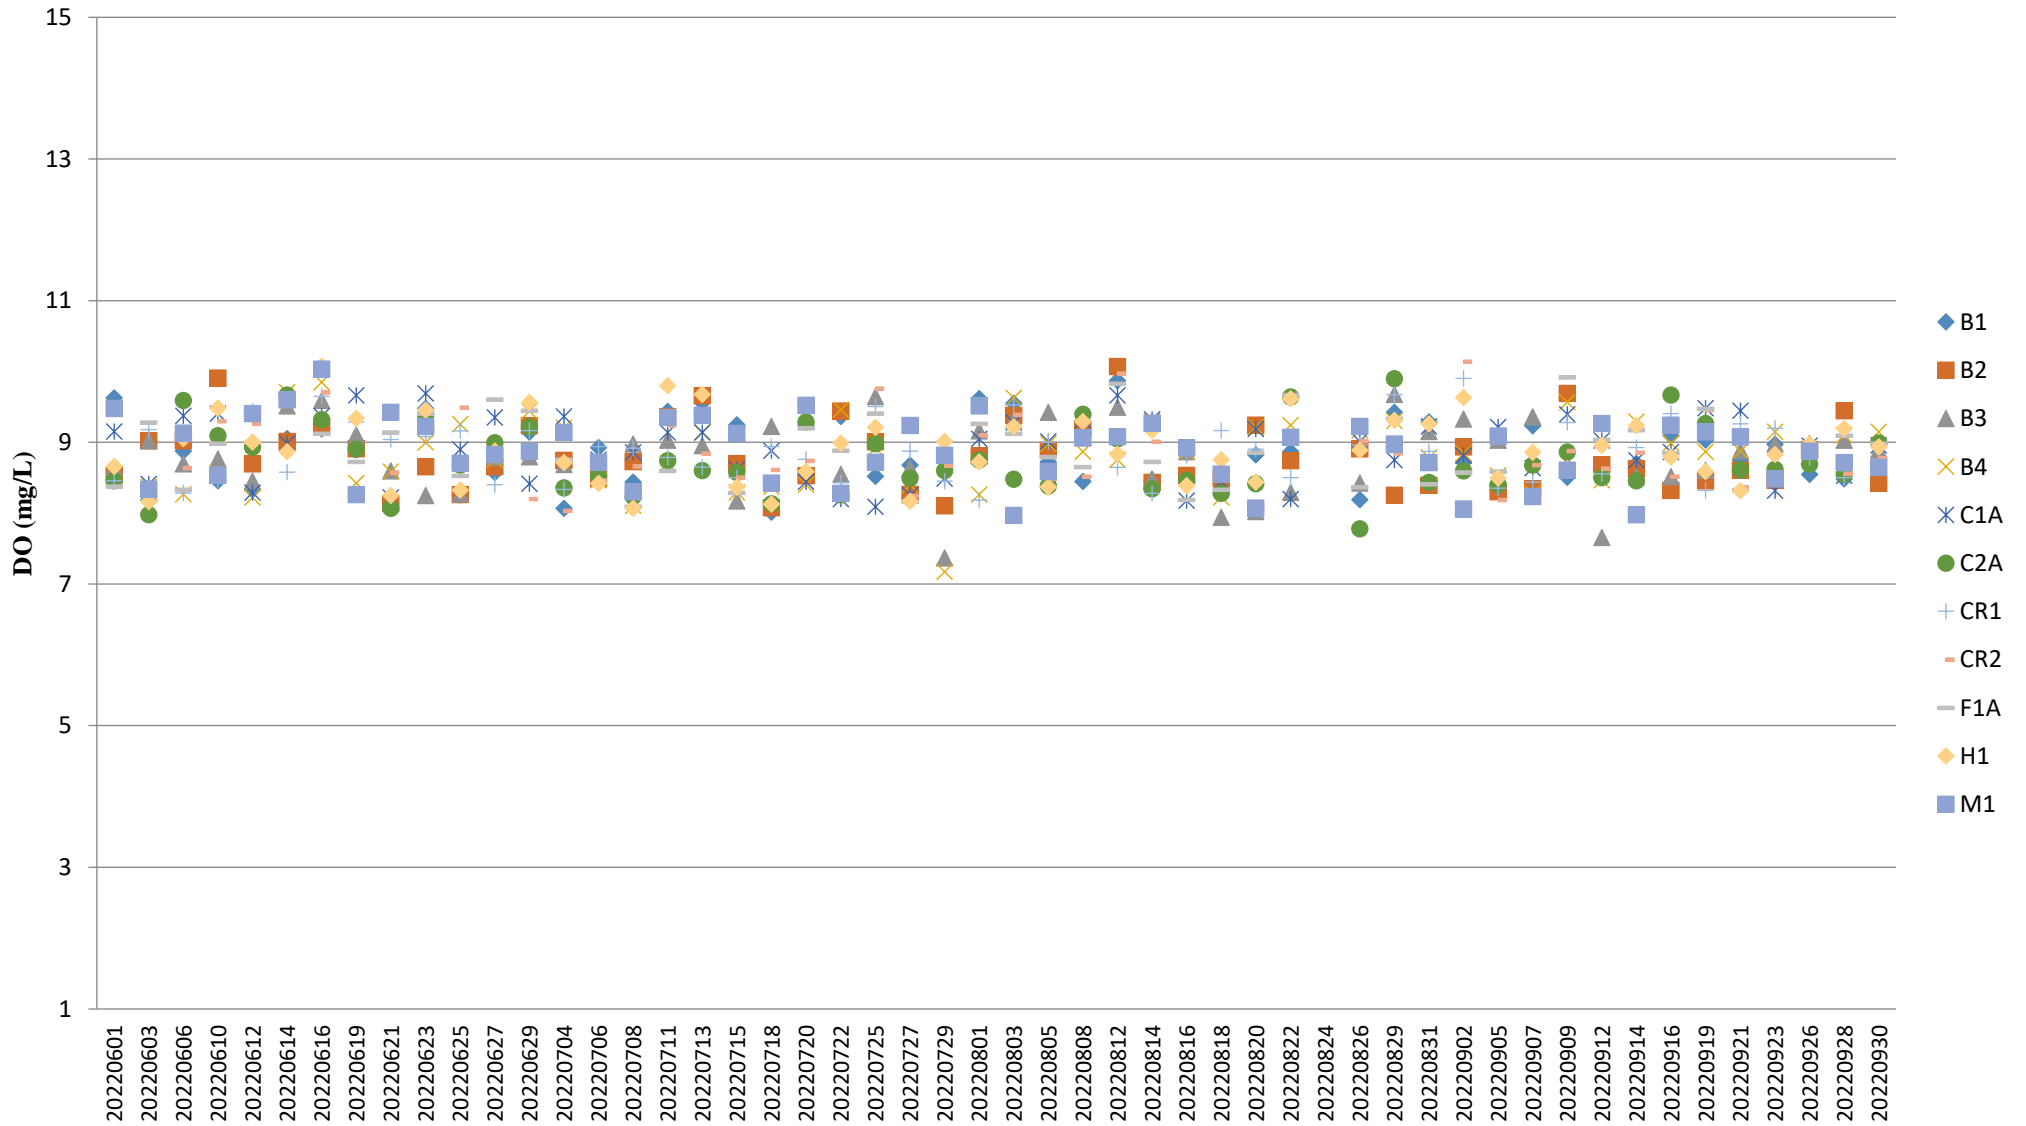
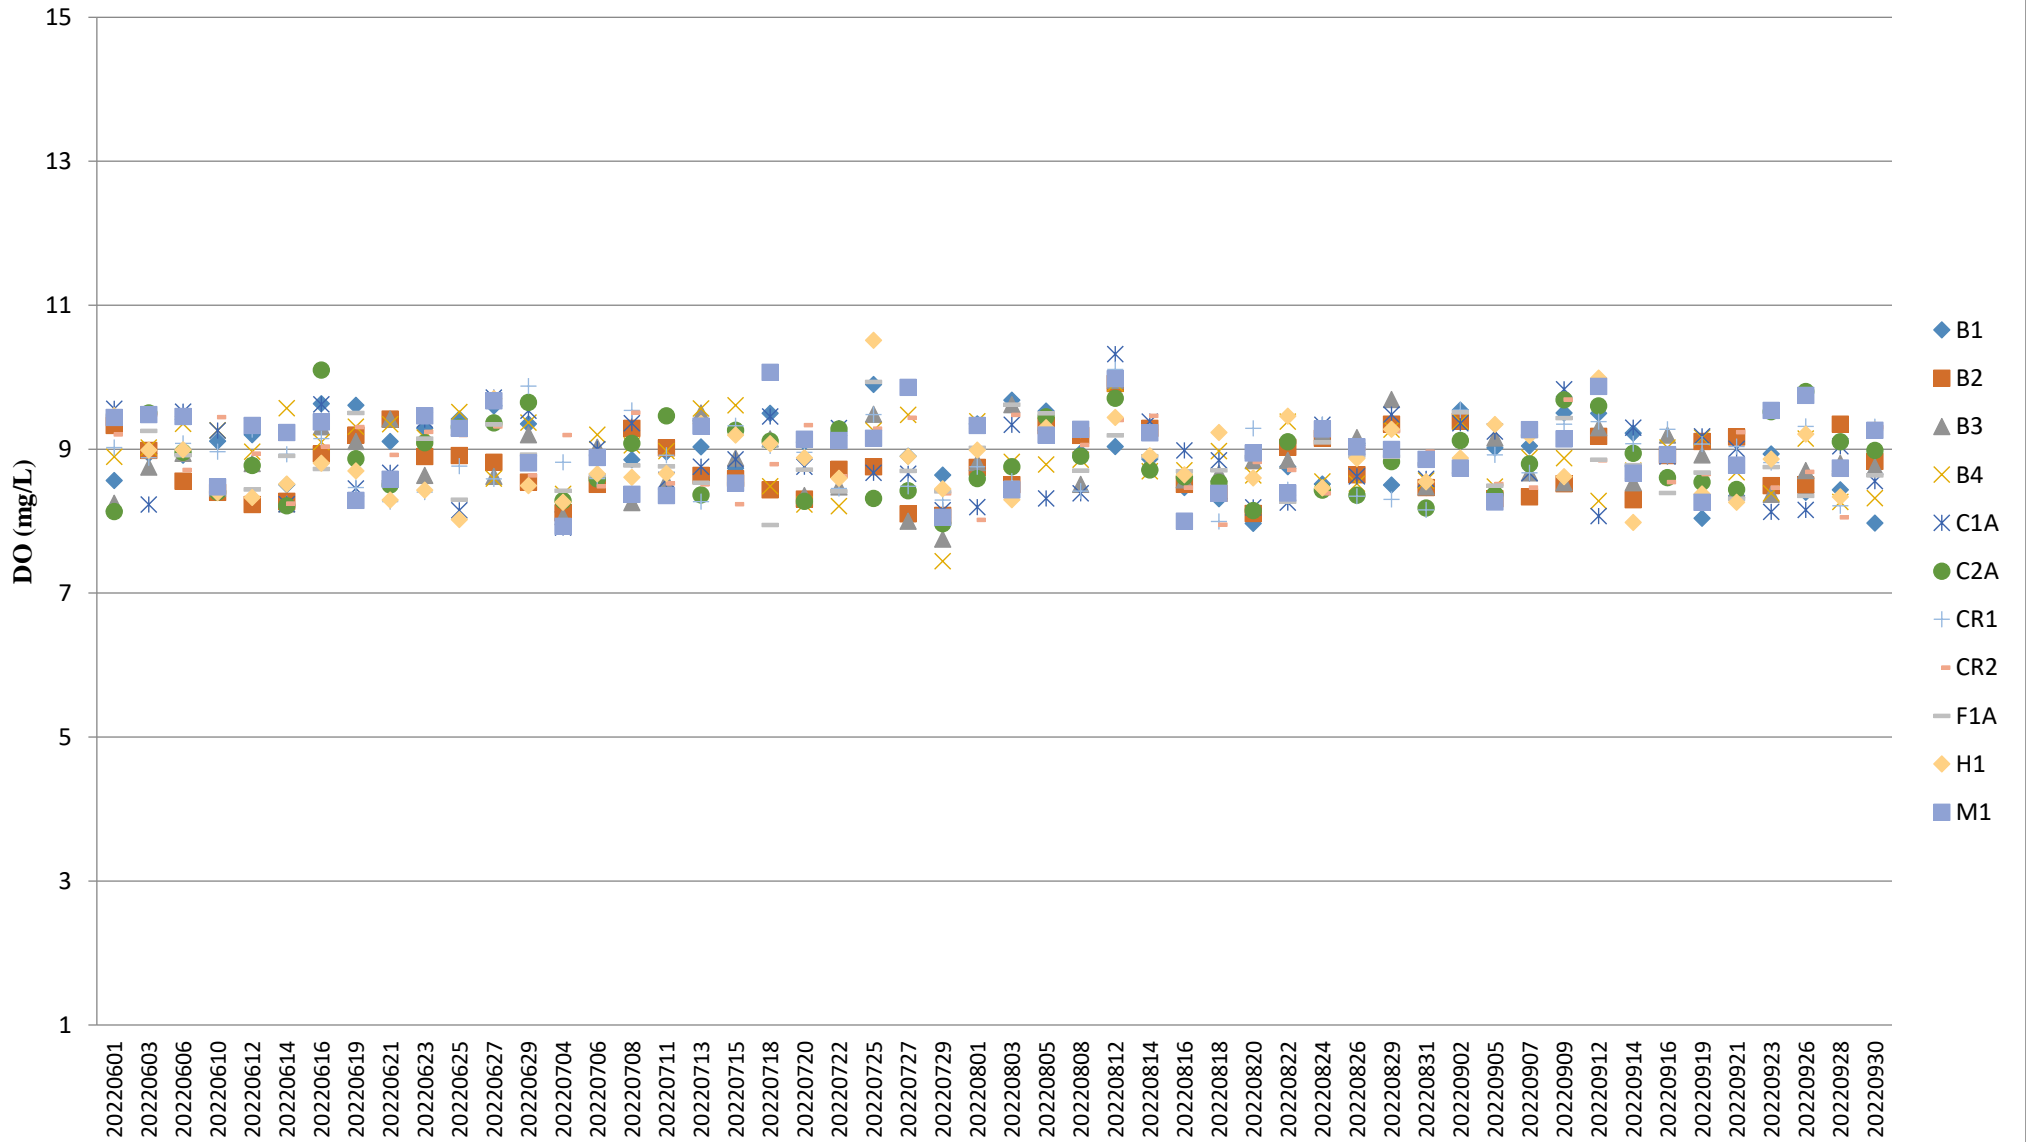
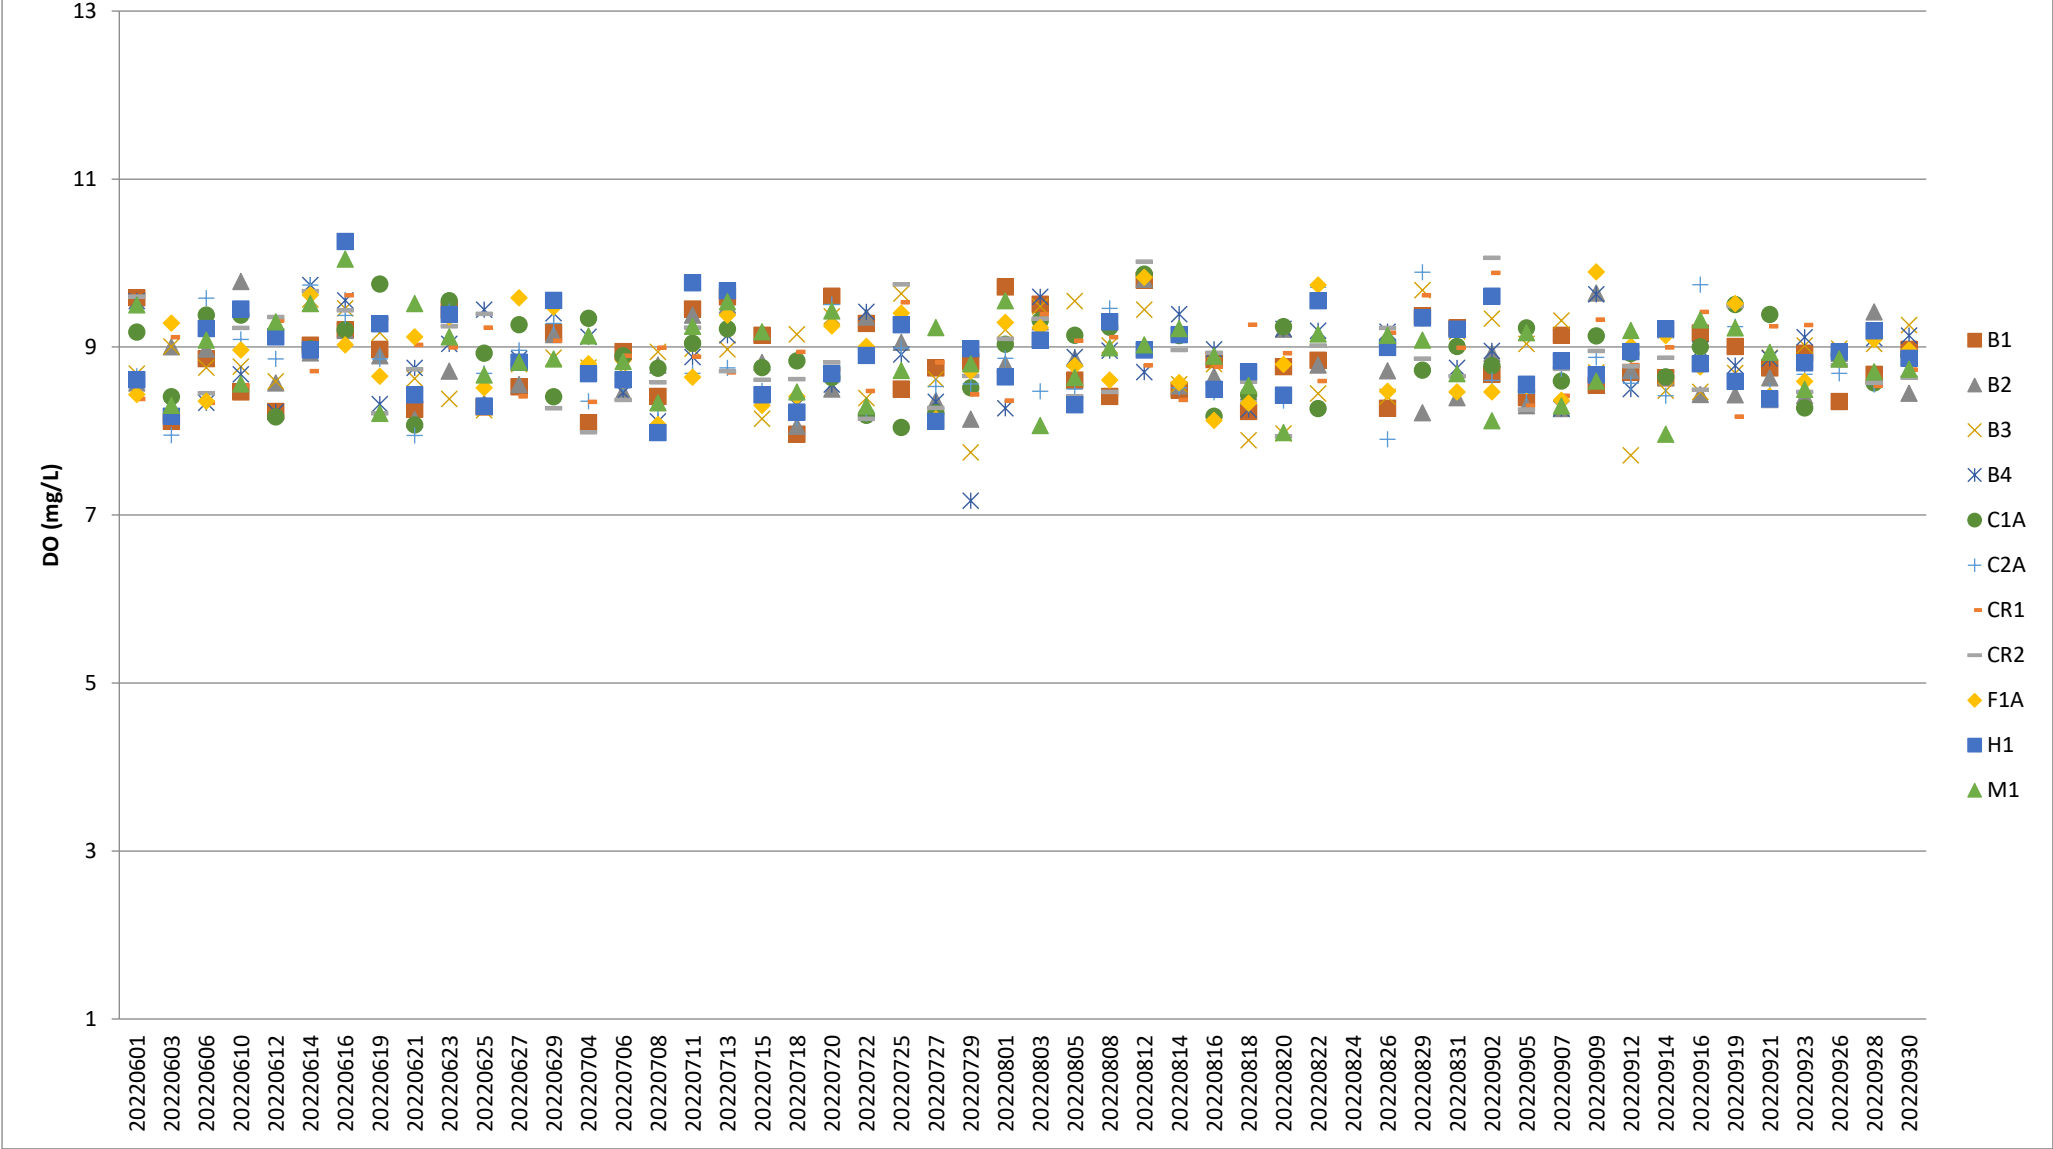
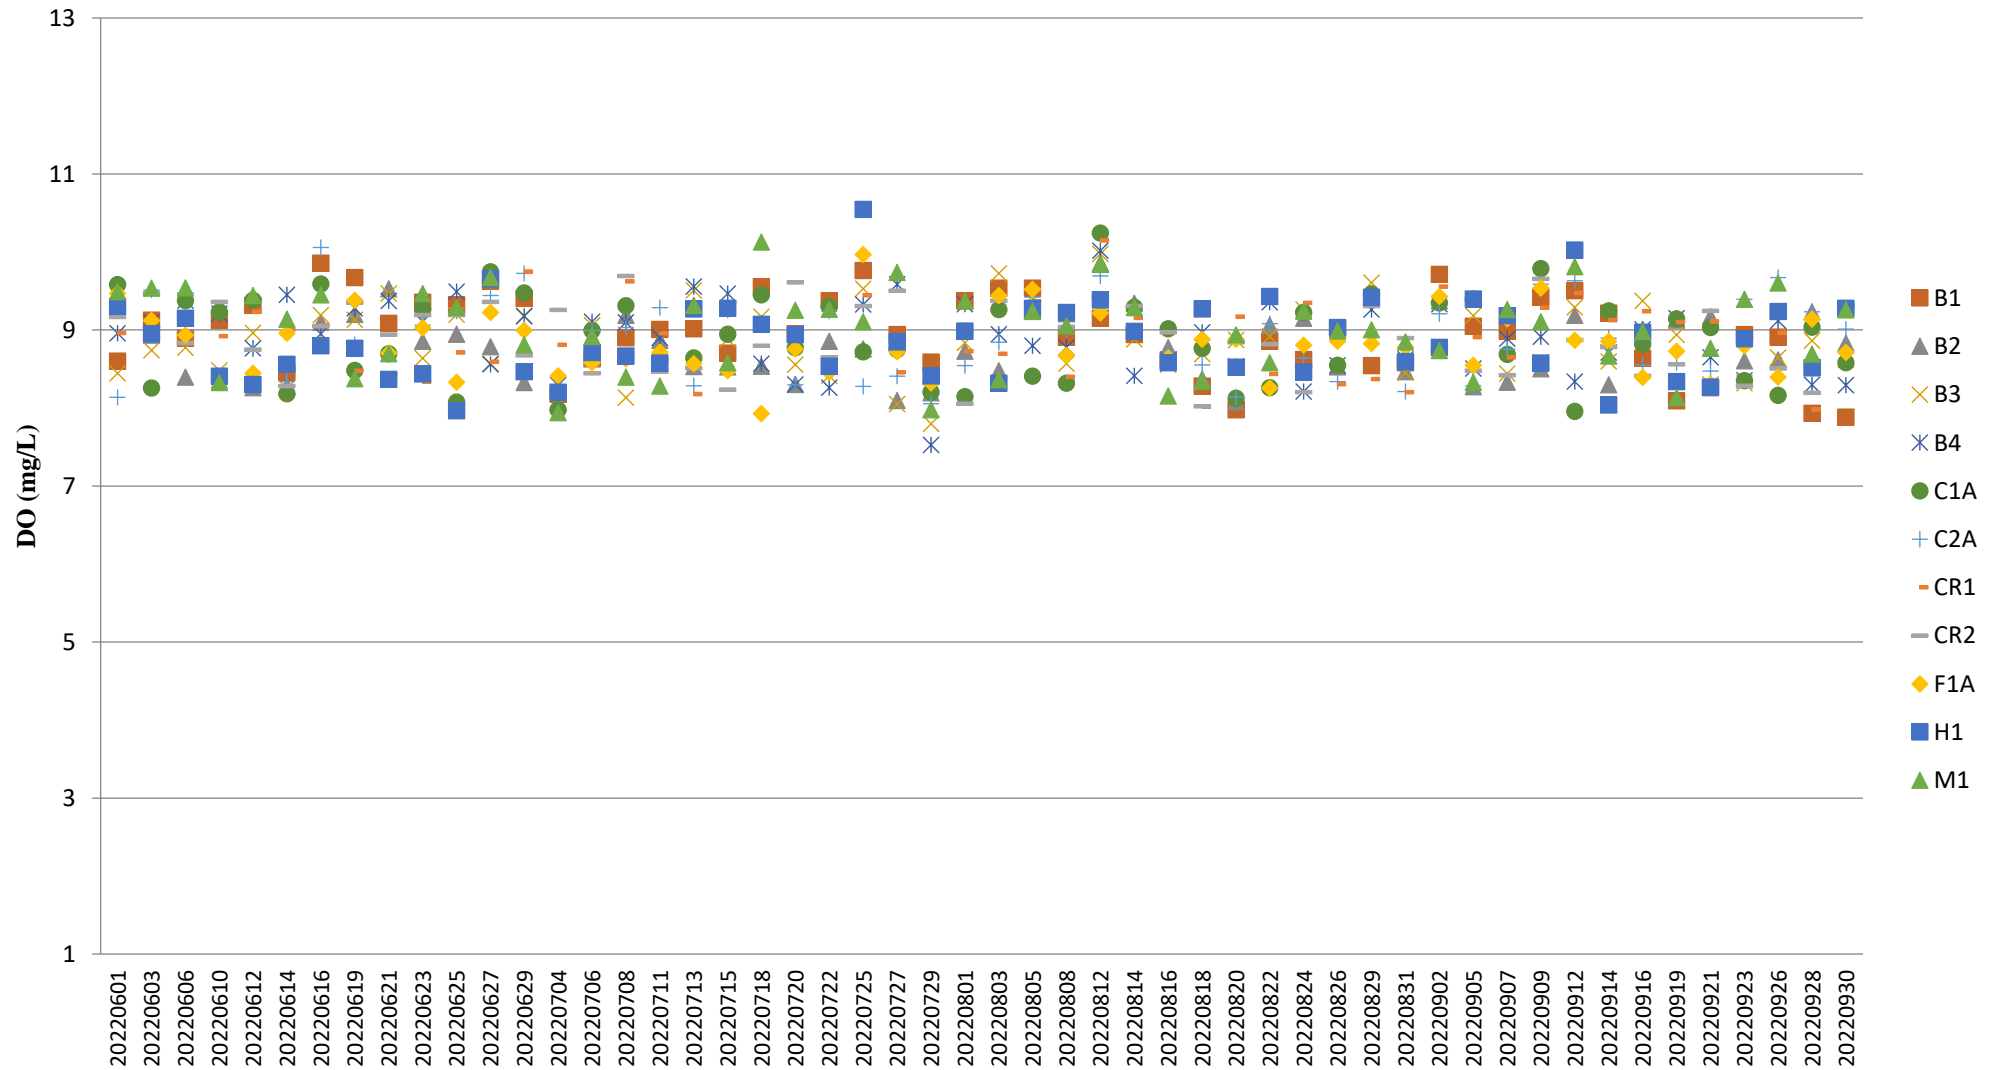
## Dissolved Oxygen (Surface & Middle) during MID-FLOOD

1. The Action and Limit Levels of dissolved oxygen can be referred to **Table 2.8** of the monthly EM&A report.

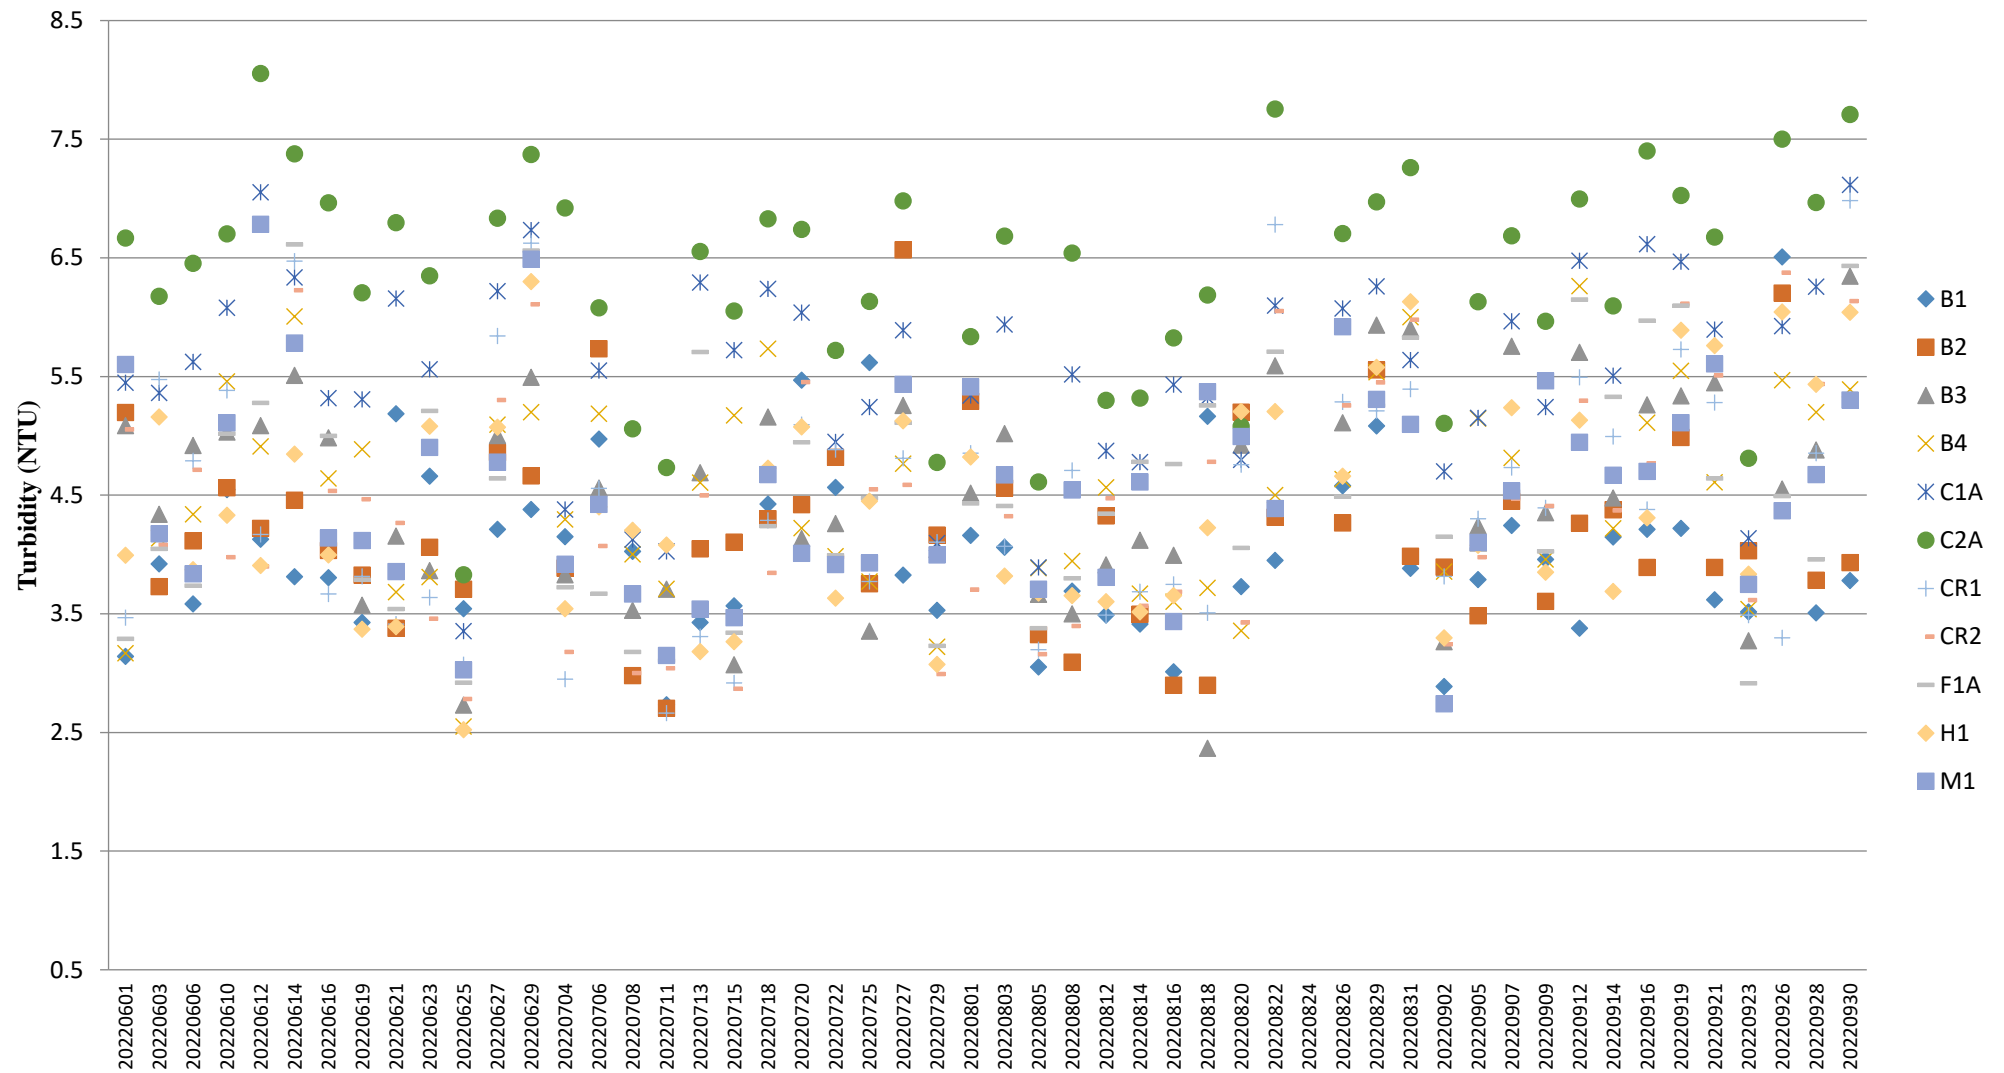
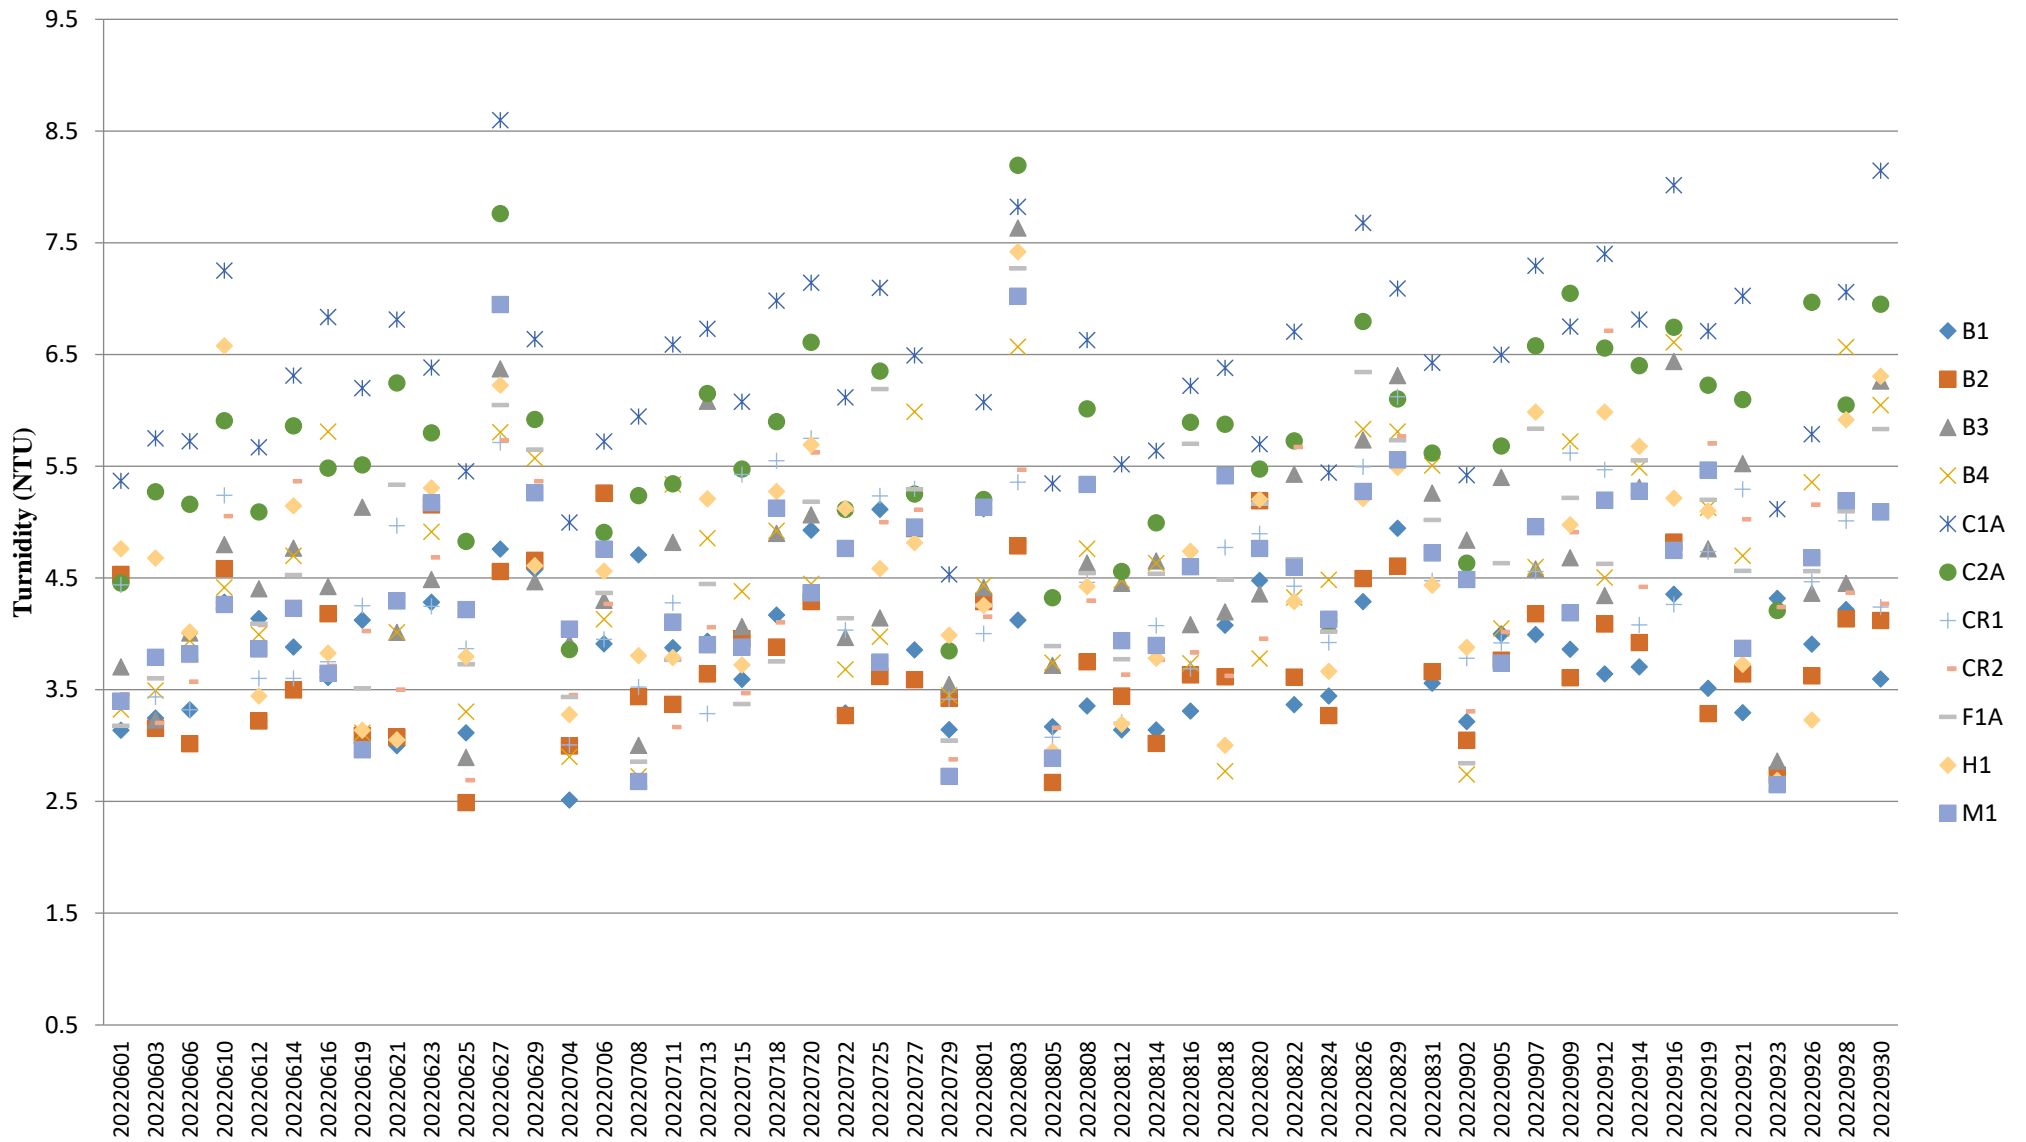
## Turbidity (Depth-averaged) during MID-FLOOD

1. The Action and Limit Levels of turbidity can be referred to **Table 2.8** of the monthly EM&A report.
