Contract No. EP/SP/66/12  
Integrated Waste Management Facilities, Phase 1  
Monthly EM&A Report No.51

## Monthly EM&A Report No.51 (Period from 1 September to 30 September 2022)

(Clause 3.3, Further Environmental Permit FEP-01/429/2012/A)

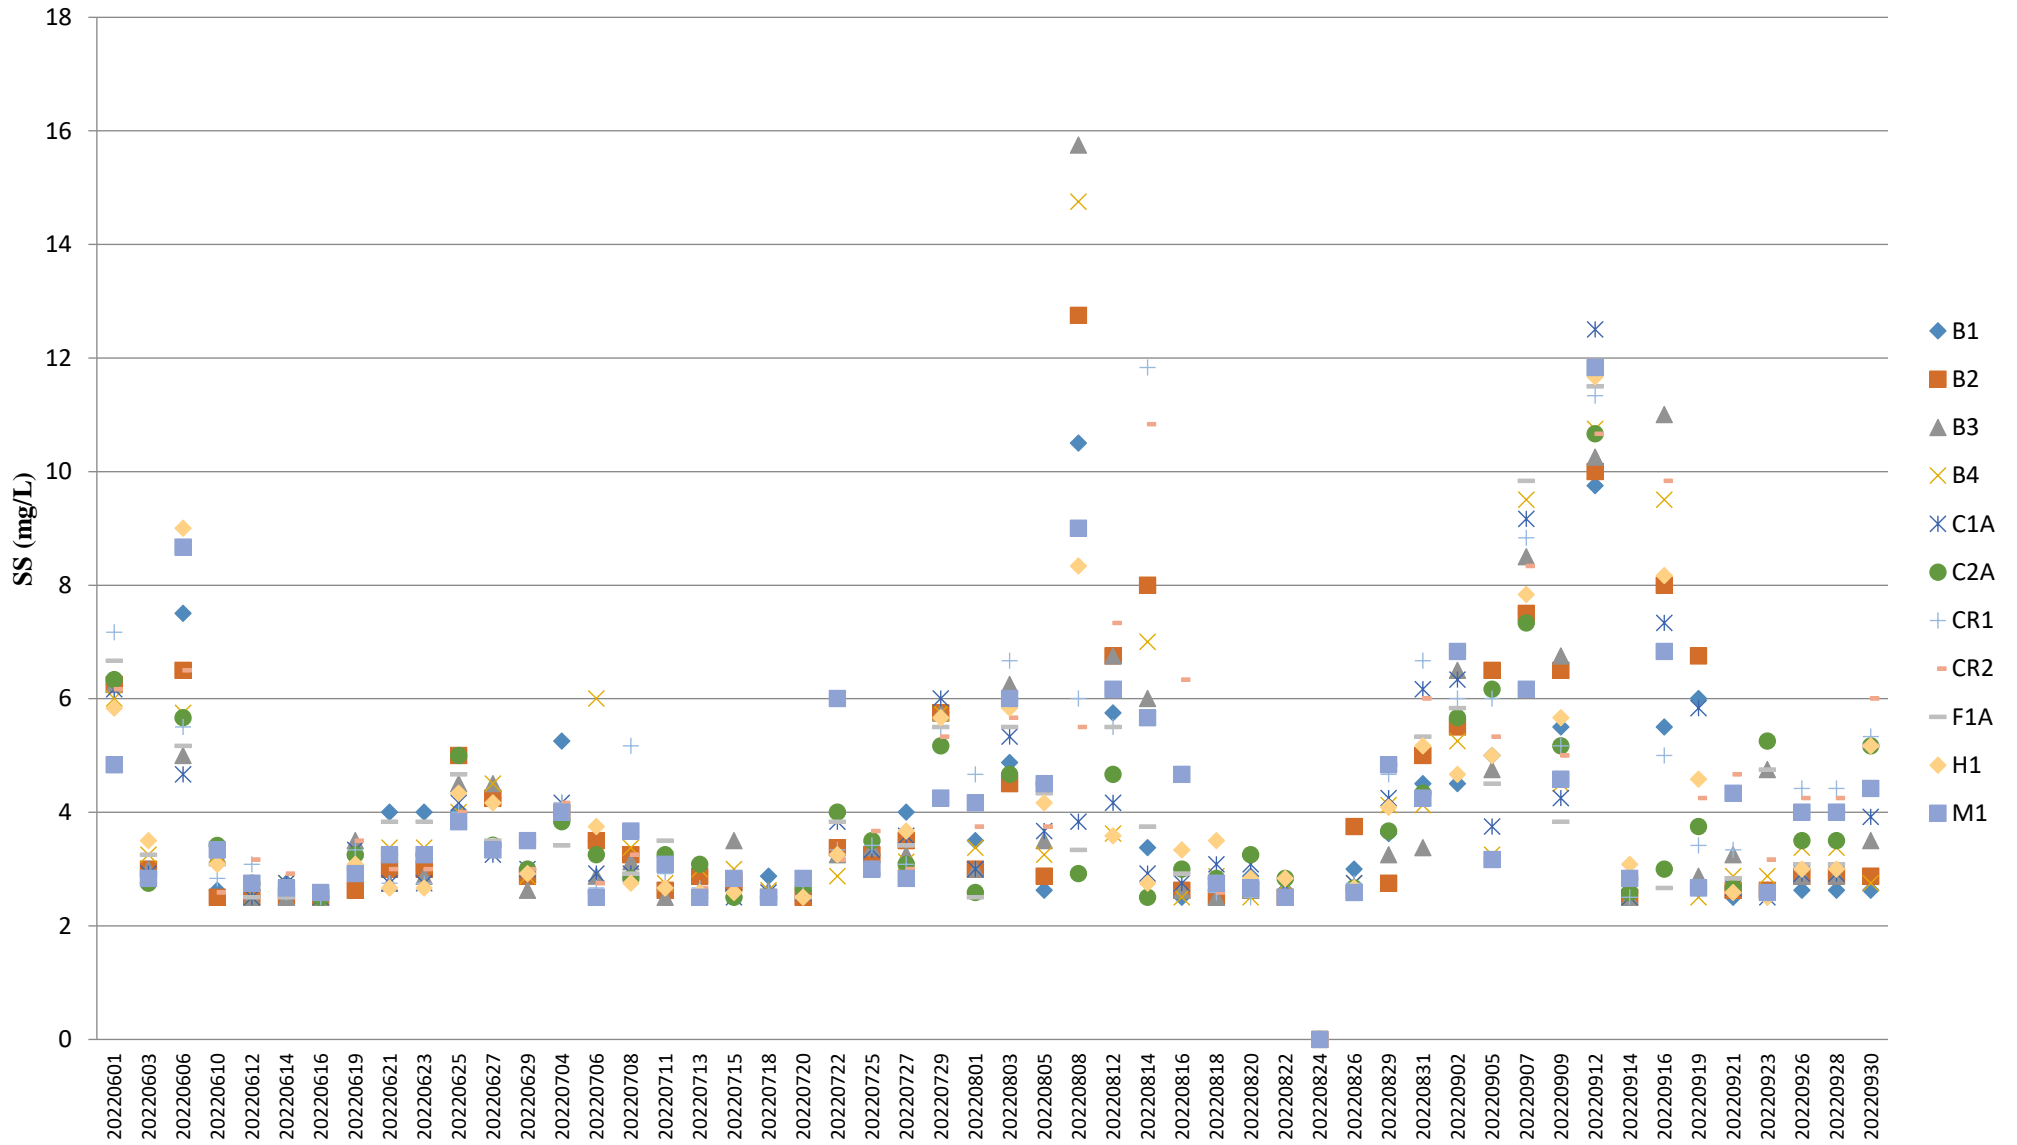
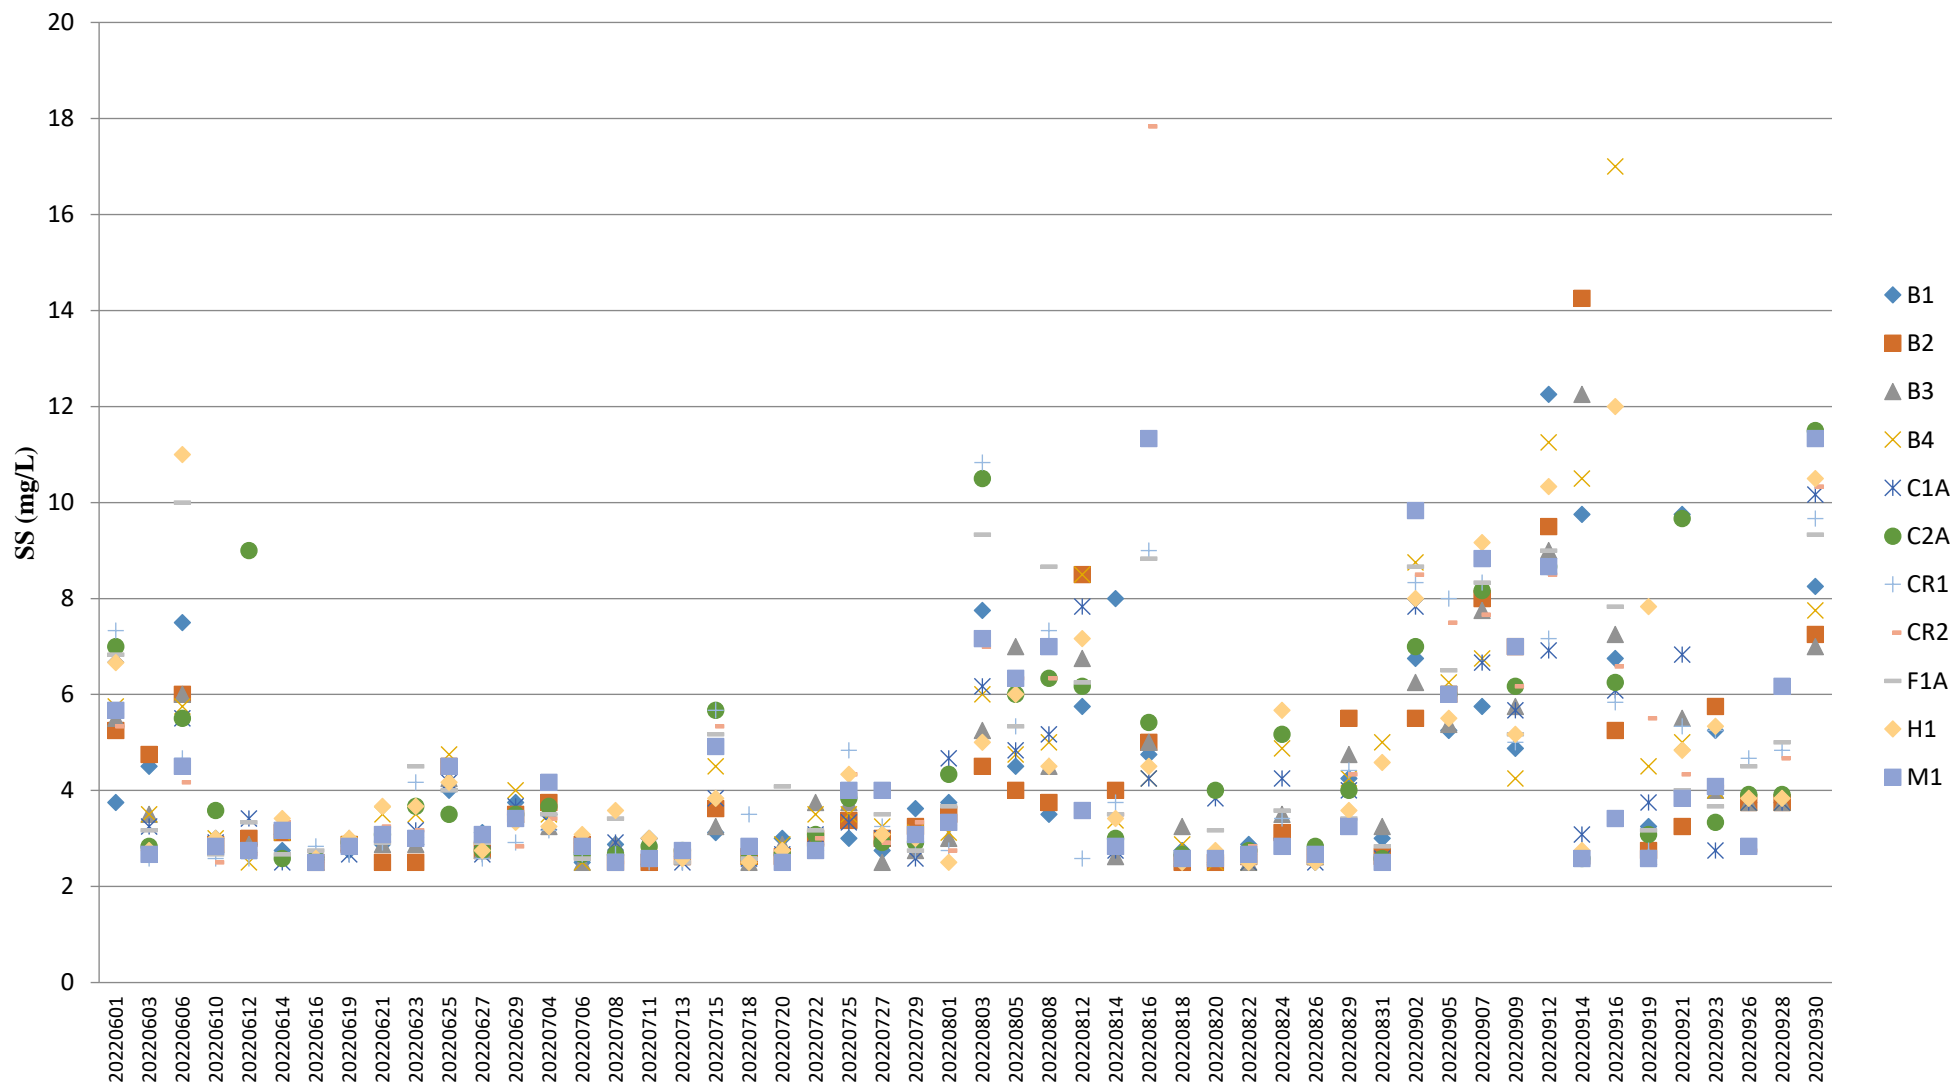
## Suspended Solids (Depth-averaged) during MID-FLOOD

1. The Action and Limit Levels of suspended solids can be referred to **Table 2.8** of the monthly EM&A report.

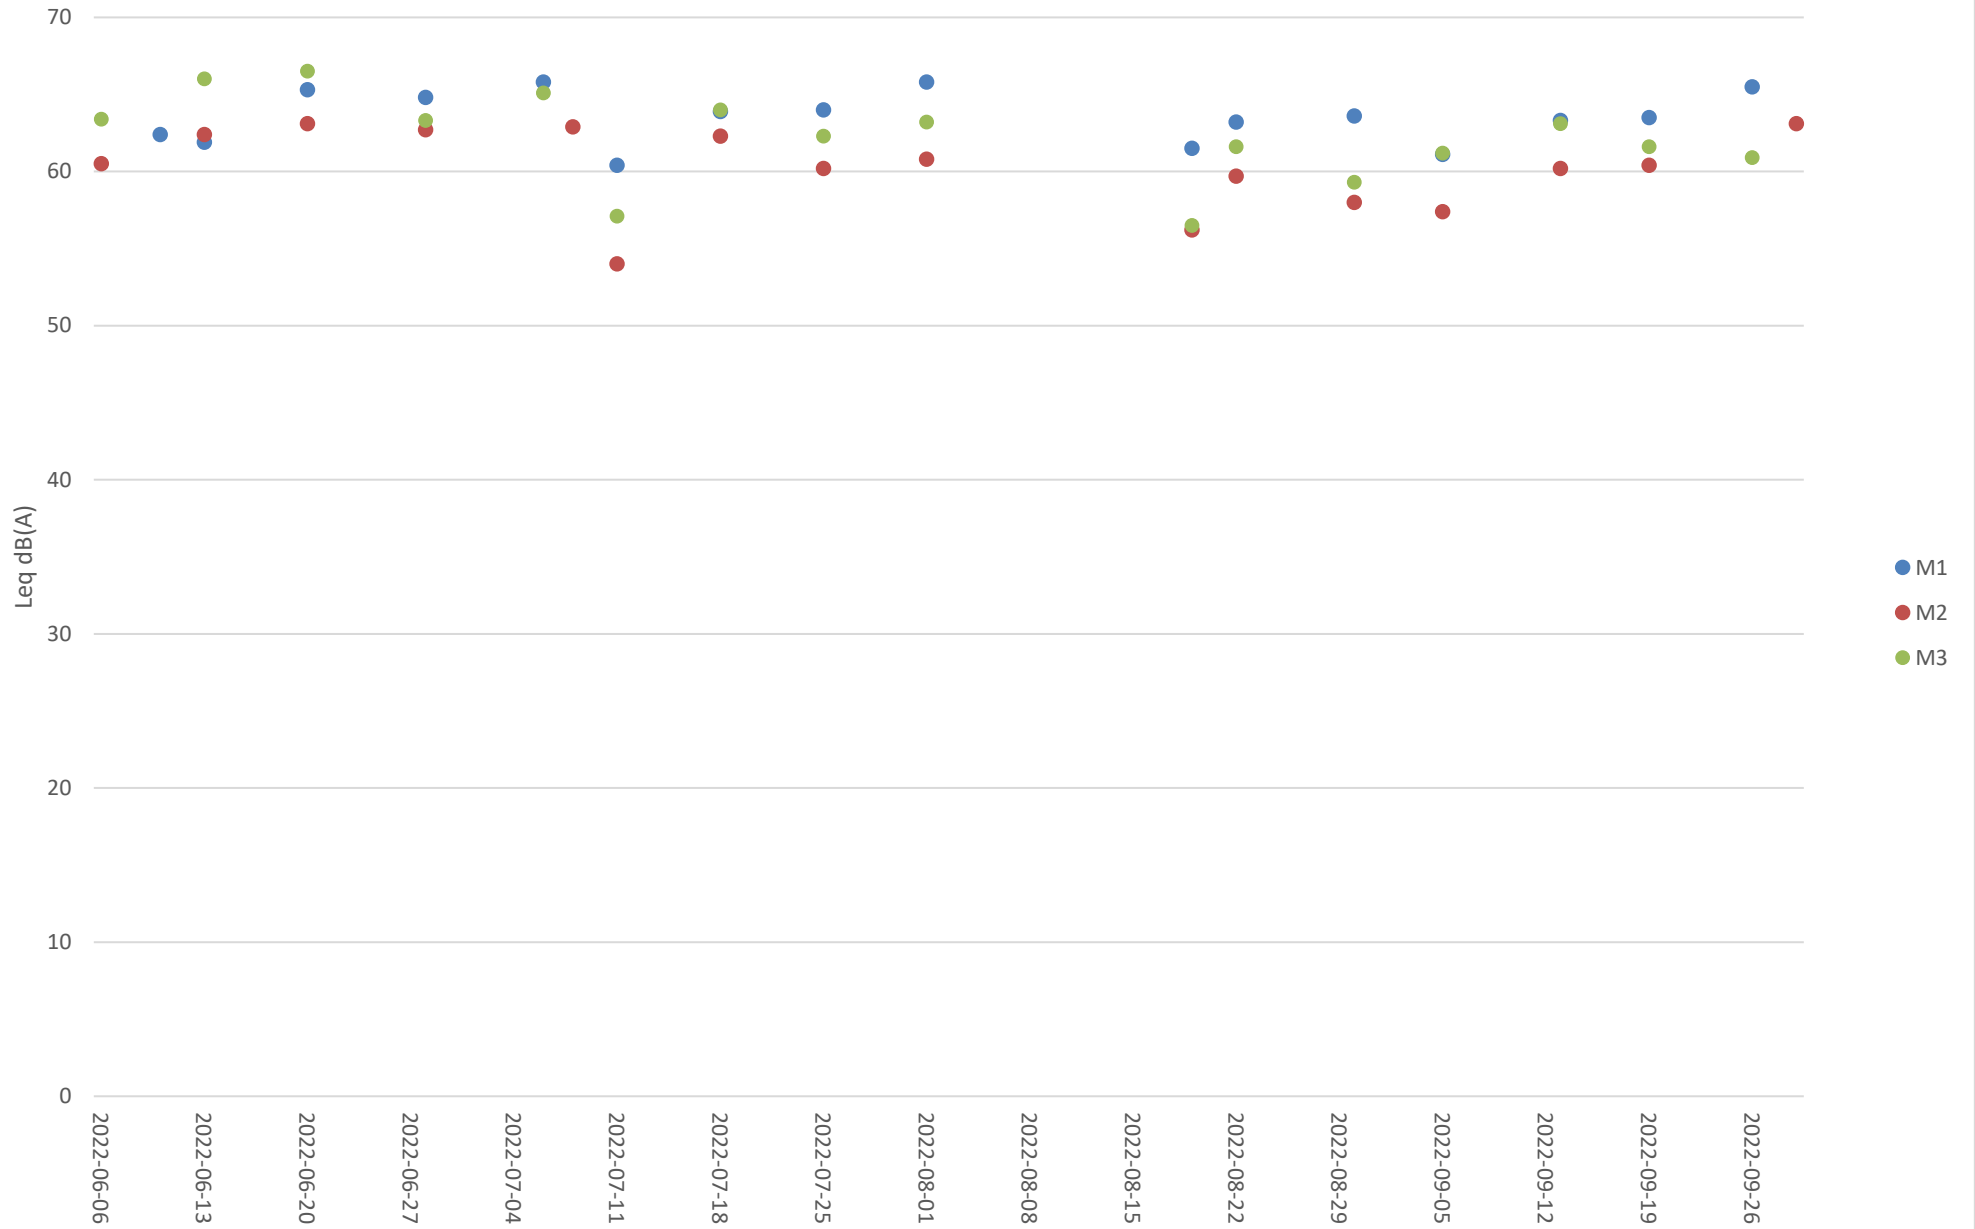
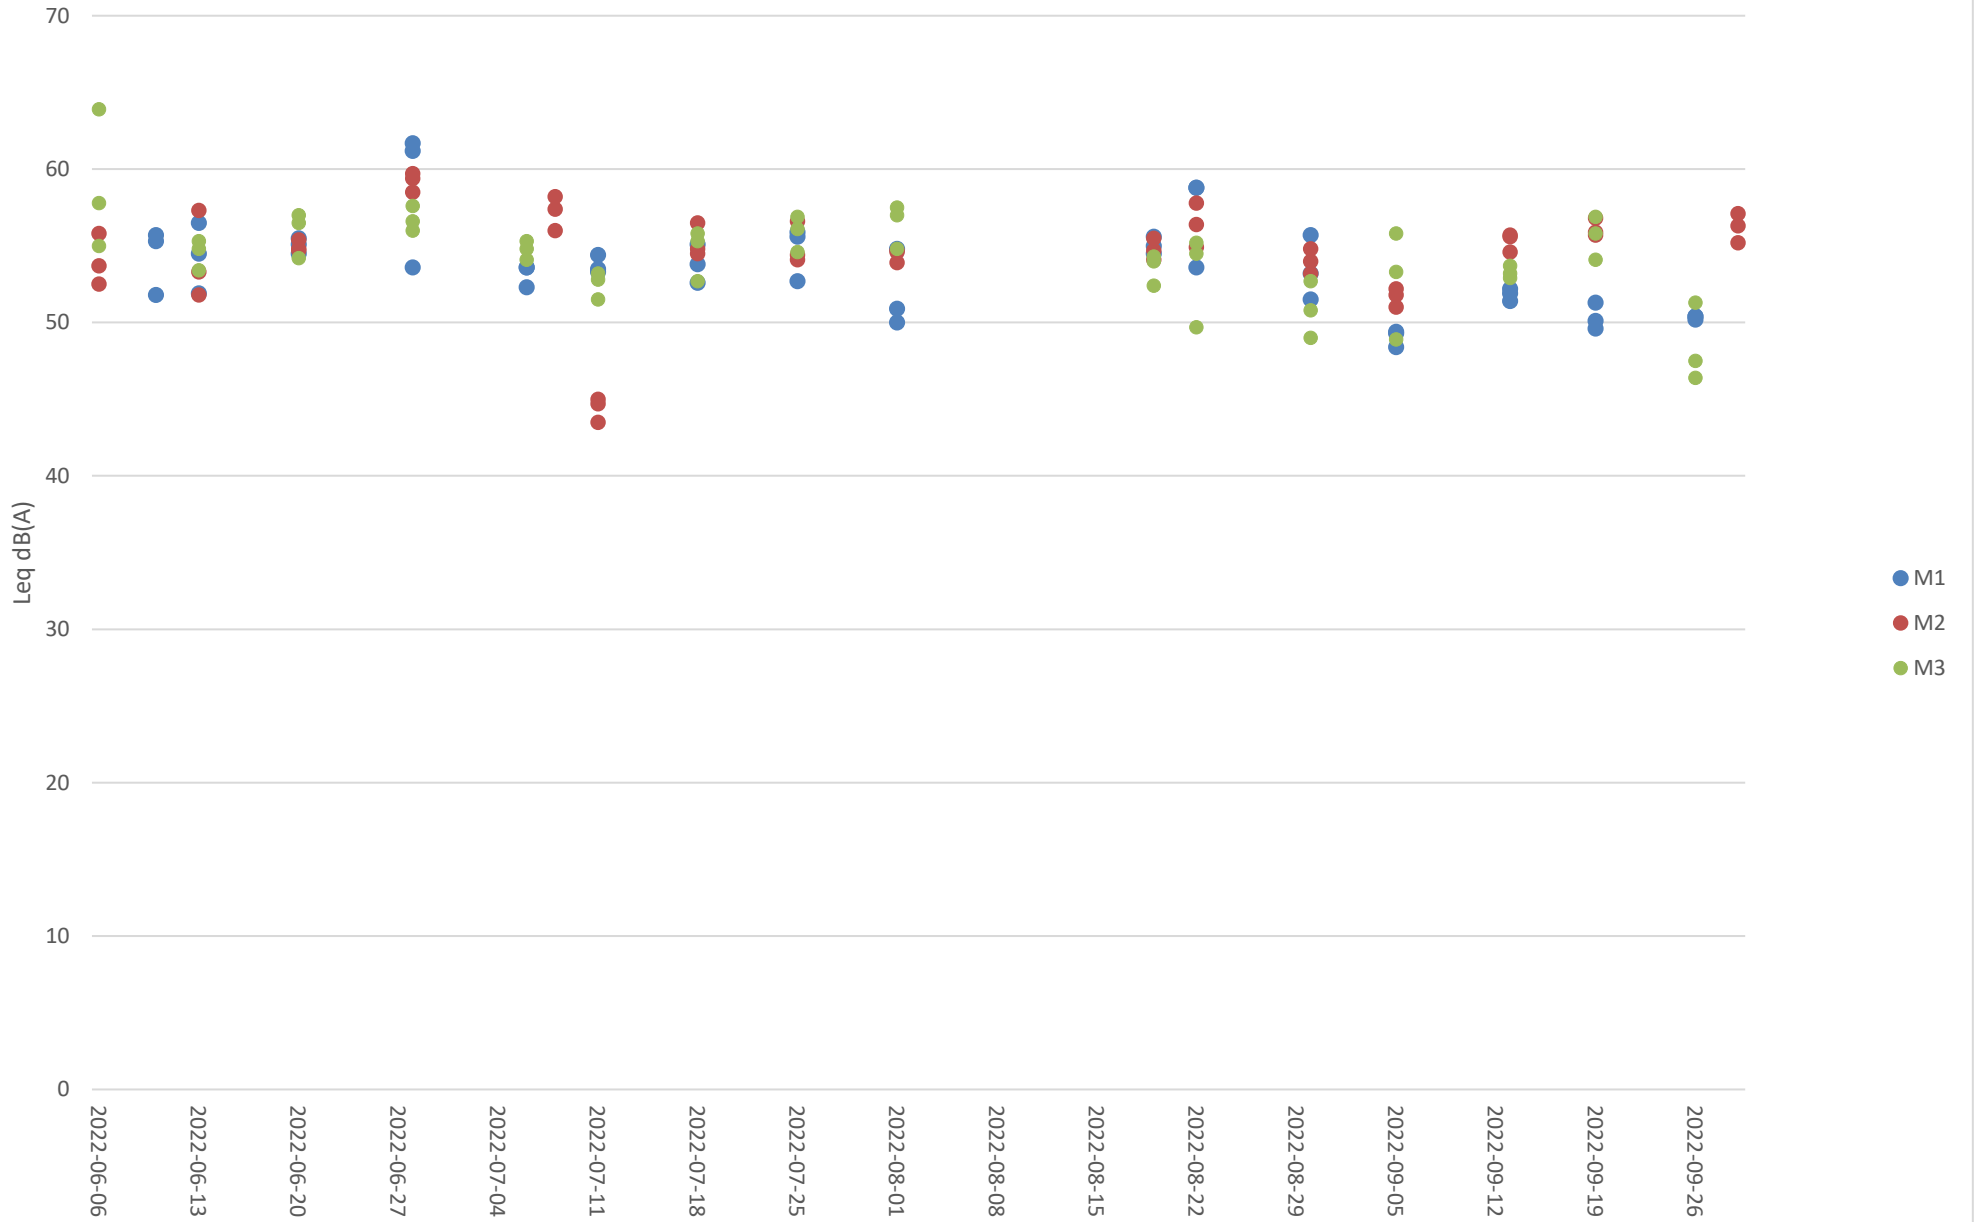
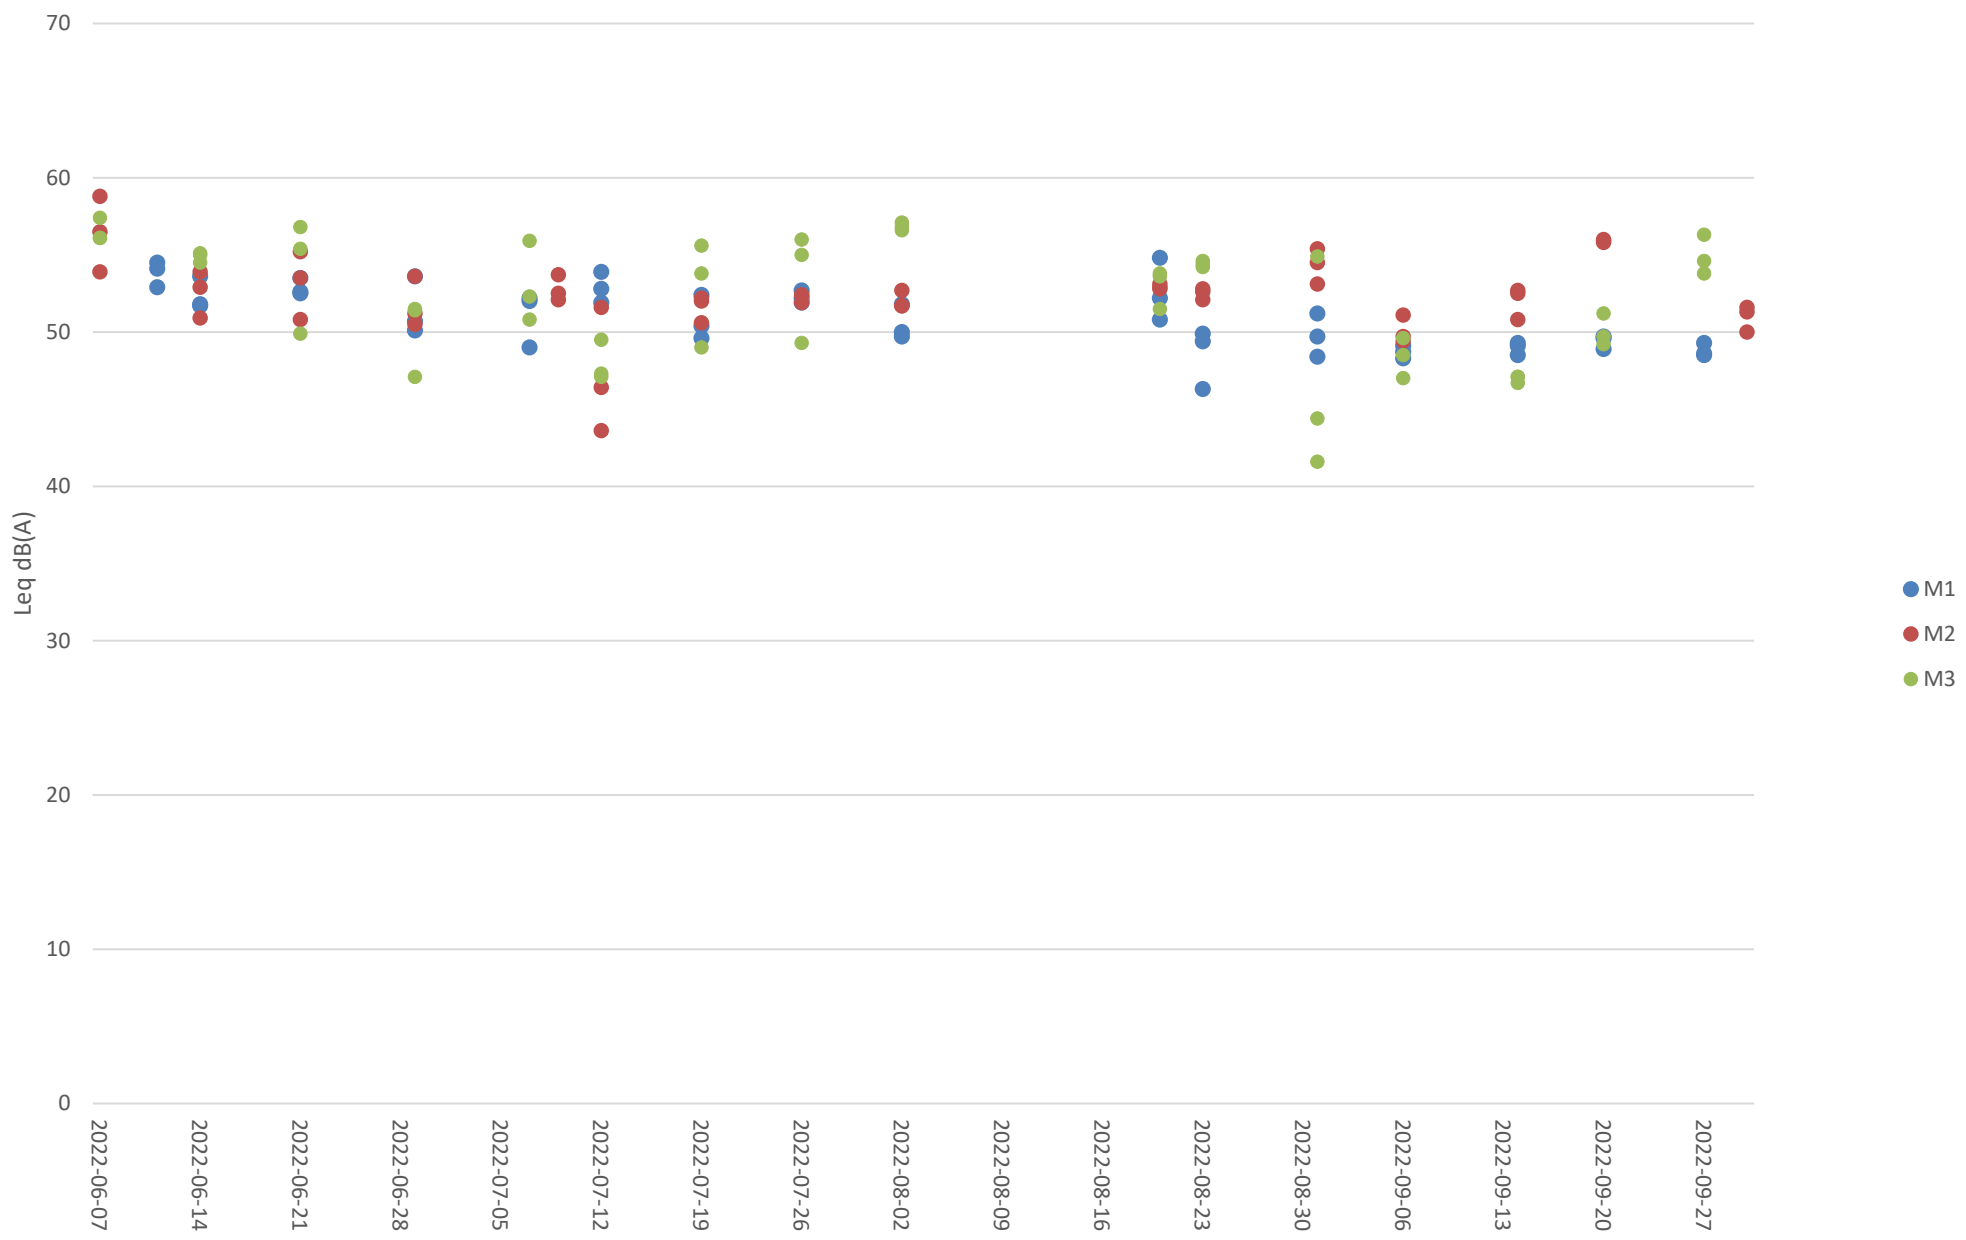
### Impact Noise Monitoring Results during Day Time (0700 - 1900 hours)

3.8.3 According to our field observations, the major noise source identified at the noise monitoring station in the reporting month are summarised in **Table 3.5**. Sound from the intermittent piling work was the noticeable noise source for monitoring stations M1, M2 and M3. Air conditioning units were also observed nearby monitoring stations M3.

<b>Monitoring Station</b>	<b>Major Noise Source</b>
M1	Sound from the intermittent piling work
M2	Sound from the intermittent piling work
M3	Sound from the intermittent piling work, air-conditioner
