Contract No. EP/SP/66/12
Integrated Waste Management Facilities, Phase 1
Monthly EM&A Report No.60

Monthly EM&A Report No.60 (Period from 1 June to 30 June 2023)

(Clause 3.3, Further Environmental Permit FEP-01/429/2012/A)

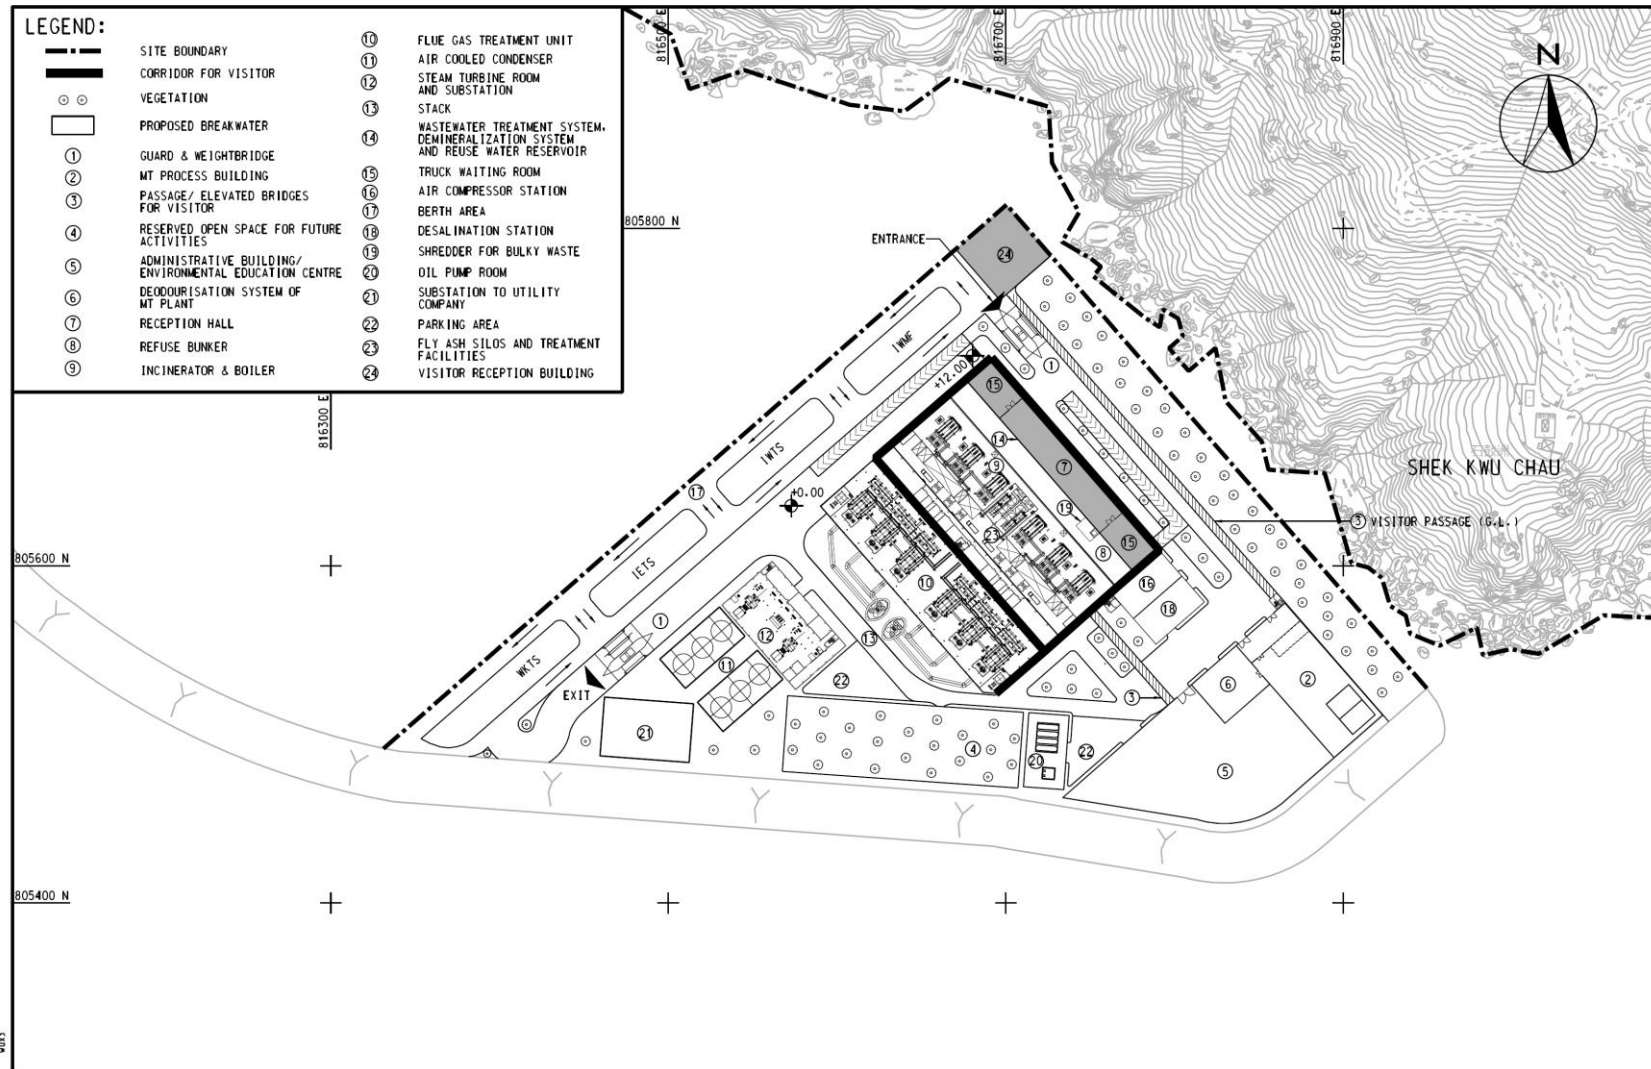
Figure 1.2 General Layout of the IWMF at the Artificial Island near SKC

1.1.5 The location of the IWMF near Shek Kwu Chau (SKC) and general layout of IWMF are shown in **Figure 1.1** and **Figure 1.2** respectively.

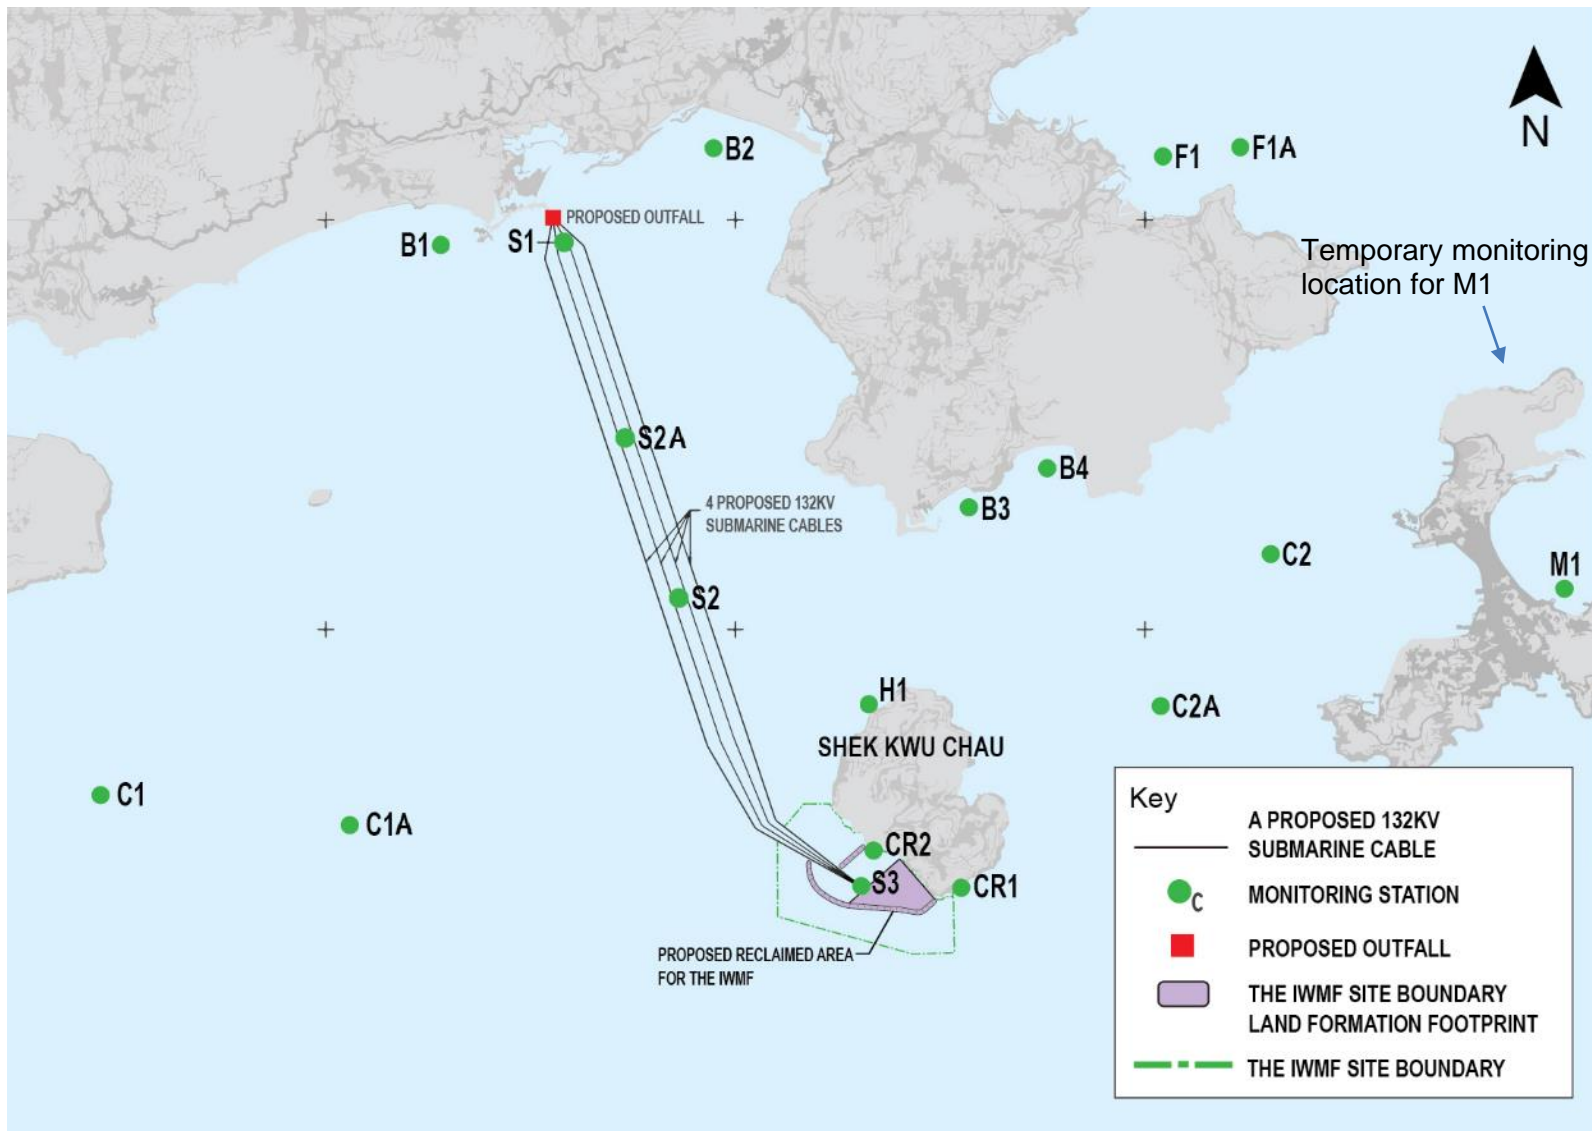
Figure 2.1 Water monitoring locations at Artificial Island near SKC

- 2.3.1 Impact water quality monitoring was conducted at eleven monitoring locations (B1-B4, H1, C1, C2, F1, CR1, CR2 & M1) during general water quality monitoring in the reporting period as shown in **Figure 2.1**. As per the relocation proposal verified by IEC and approved by EPD, the monitoring location C1, C2, S2, F1 are relocated at C1A, C2A, S2A, F1A as equivalent points respectively to clear up the concerns from stakeholders.

2.3.2 B1 to B4 are located at 4 beaches respectively at the southern shore of Lantau Island. Monitoring station H1 is located at the horseshoe crab habitat at northern SKC, while CR1 and CR2 are located at the coral communities at southwestern shore of SKC. Monitoring station F1 is located at the Cheung Sha Wan Fish Culture Zone while monitoring station M1 is located at Tung Wan at Cheung Chau. Monitoring station F1A is relocated for F1 at the Cheung Sha Wan Fish Culture Zone. S1, S2 and S3 are located at the northern landing site, midway and southern landing site of the proposed submarine cable, respectively. S2A is the relocated monitoring station of S2 which represents the midway landing site of the proposed submarine cable. S1, S2/S2A and S3 are required for monitoring due to the laying of submarine cable. Control stations C1 and C2 at far field locations are for comparison. Control stations C1A and C2A are relocated for C1 and C2 respectively as equivalent far field locations for comparison.

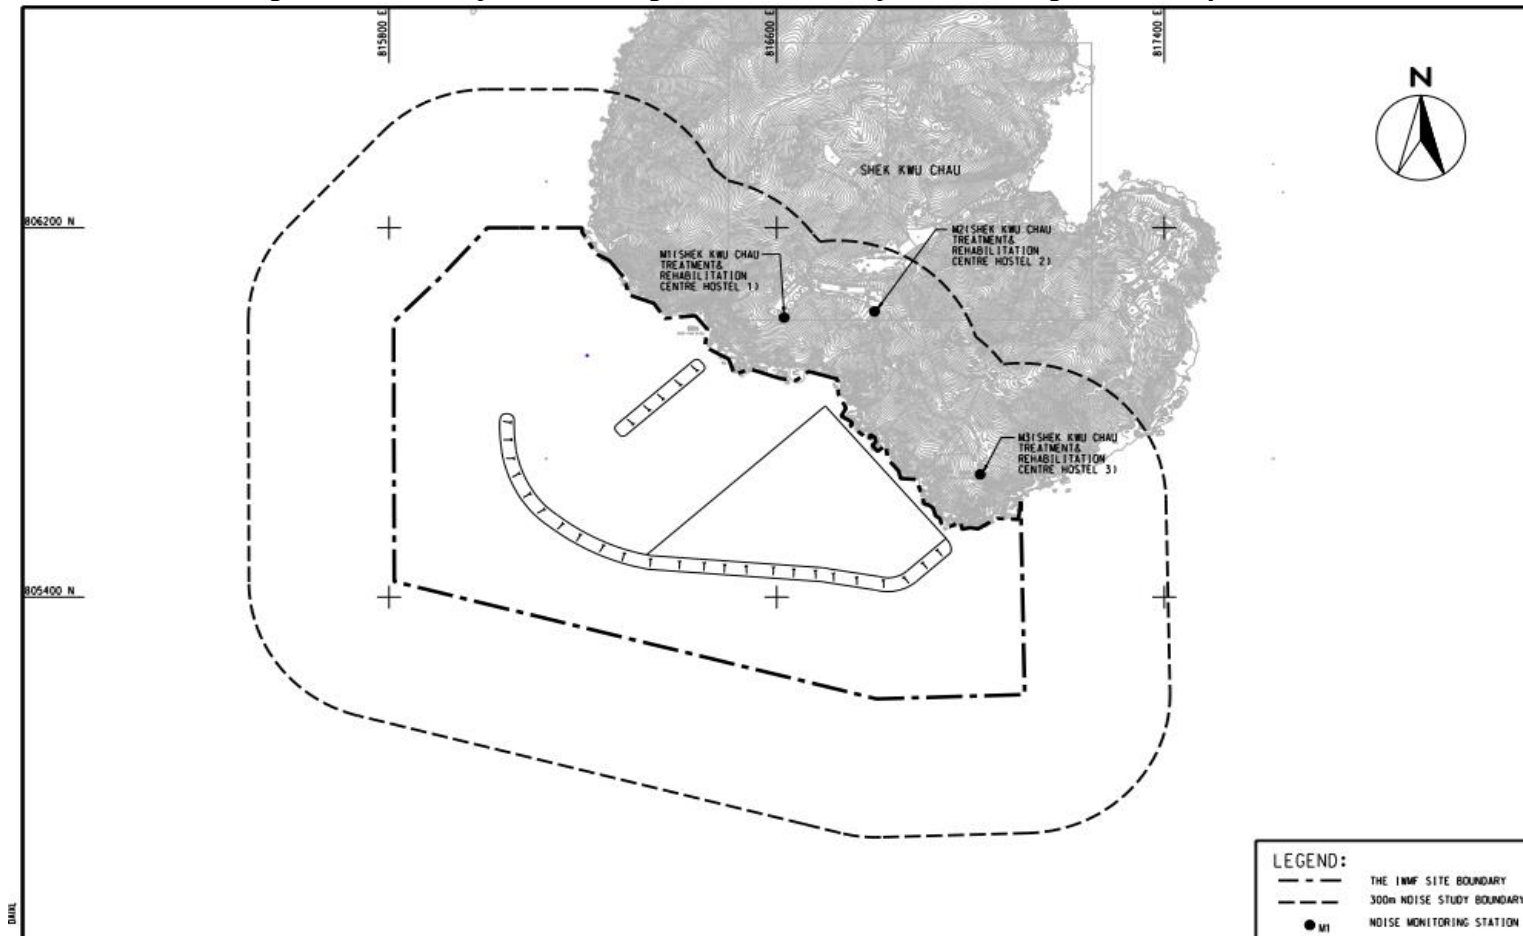
Figure 3.1 Noise monitoring locations at SKC

3.3.1 Three noise monitoring locations for impact monitoring and additional impact monitoring at the nearby sensitive receivers are shown in **Figure 3.1**.

3.3.2 M1, M2 and M3 are Shek Kwu Chau Treatment and Rehabilitation Centre Hostel 1, 2 and 3 respectively of The Society for the Aid and Rehabilitation of Drug Abusers (SARDA) located at southern part of Shek Kwu Chau.

3.3.3 Measurements at M1 & M3 were conducted at a point 1m from the exterior of the sensitive receivers building façade and at a position 1.2m above the ground. Measurement setup at M3 has been varying with minor adjustment to minimize the disturbance to the users of Treatment Centre. Measurement at M2 was conducted at a point 1m from building façade of the ceiling of 1st floor level for avoidance of mutual disturbance with users of Treatment Centre. The minor adjustment of monitoring locations, which were in favour to mutual convenience with the users of Treatment Centre, were found with no effect on monitoring result based on on-site observation and experience from the Baseline monitoring of the Project. The noise monitoring stations are summarized in **Table 3.2** below.

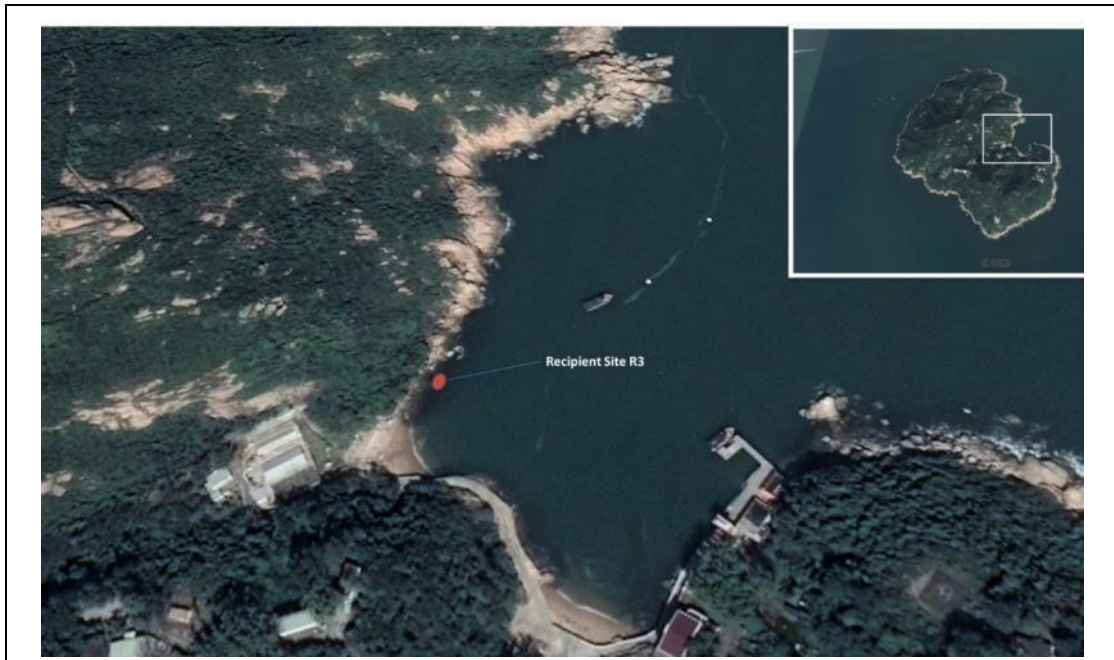
Figure 5.3 Tagged Translocation Corals at Recipient Site R3 near SKC

5.3.1 Location of the ten tagged coral colonies at each of the proposed indirect impact site (re-tagging after typhoon Mangkhut), control site (baseline) and recipient site R3 (translocation) are shown in **Figure 5.1**, **Figure 5.2** and **Figure 5.3** respectively:

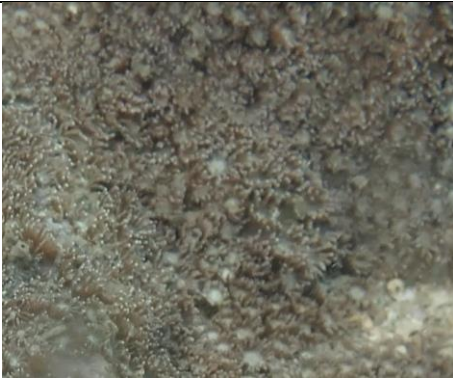
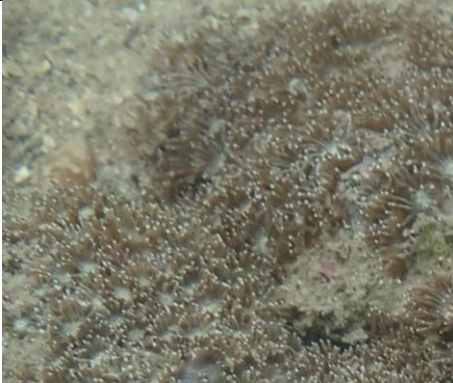
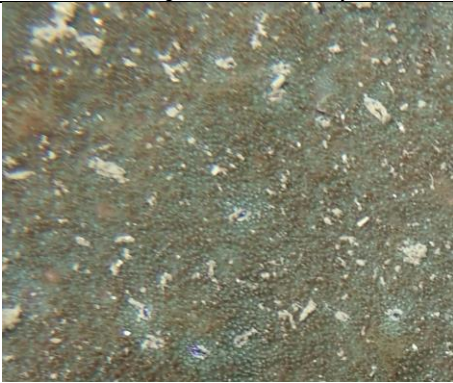
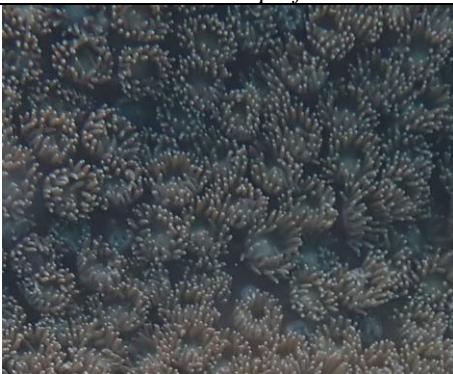
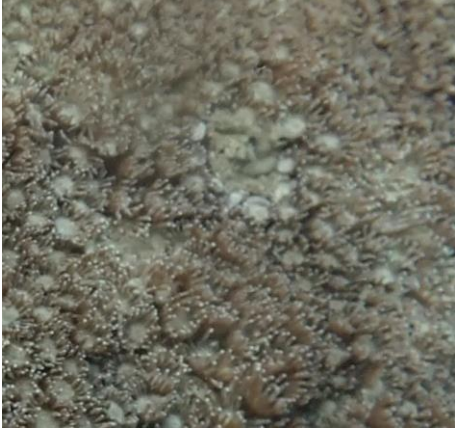
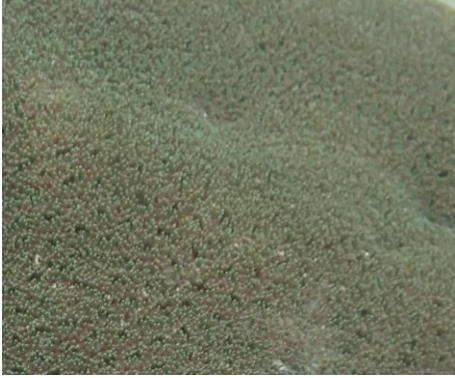
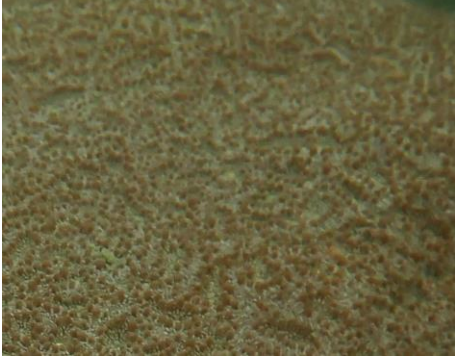
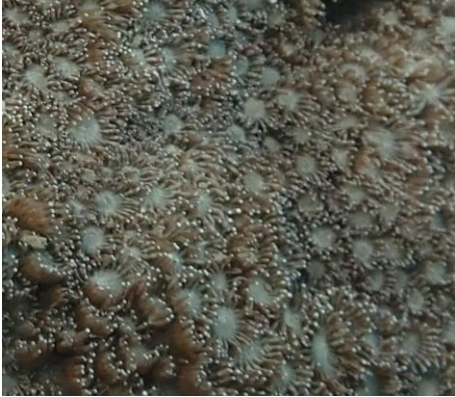
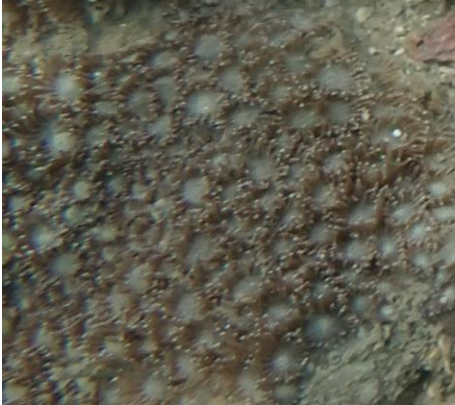
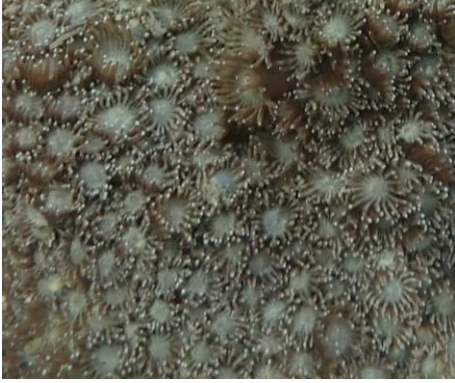
Photo Plate 5.1 Ten (10) Monitored Corals at Control Site

5.6.2 Ten (10) hard coral colonies were monitored at each Control site and Indirect Impact Site as suggested in the Construction Phase Monitoring Plan. The general health conditions (size, mortality, bleaching and sediment) were recorded and summarized in **Table 5.8** and **Table 5.9**. Photos of each coral colonies were taken during the monitoring activities shown in **Photo Plate 5.1** and **Photo Plate 5.2**.

- 5.6.5 No sediment, bleaching or increased mortality in the general condition of coral colonies were observed during the tenth construction phase monitoring period. No deterioration of the coral community was observed in the ecological monitoring results when compared with the baseline ecological monitoring results. There is no AL/LL exceedance during the monitoring period. Photos of each tagged corals colonies were taken and shown in **Photo Plates 5.1** and **Photo Plate 5.2**.

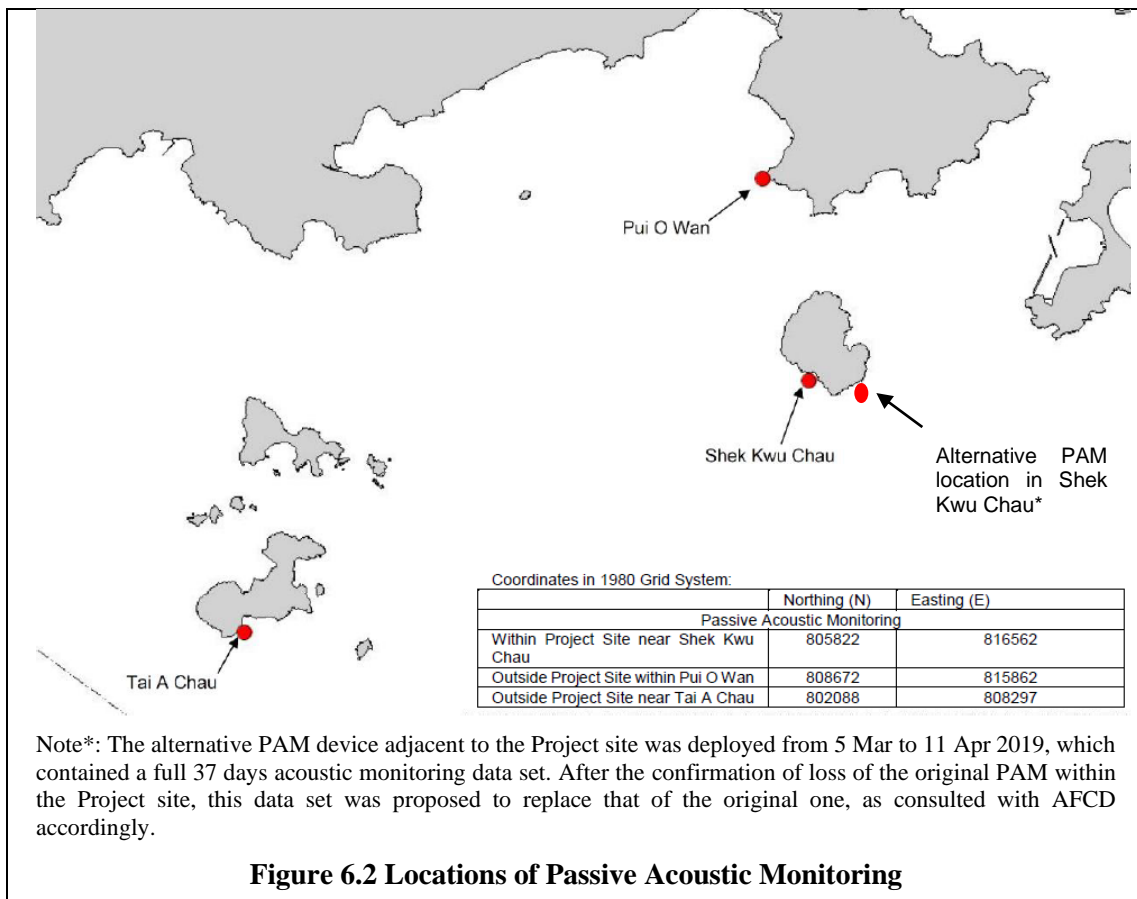
The PAM aims to study the usage of an area by Finless Porpoise by using an array of automated static porpoise detectors (e.g. C-POD) which would be deployed at different locations to detect the unique ultra-high frequency sounds produced by Finless Porpoise. During the construction period, the PAM survey will be conducted including placement of two passive porpoise detectors outside the Project Area as control site (i.e. within Pui O Wan and to the south of Tai A Chau) and one porpoise detector within the Project Area (i.e. near Shek Kwu Chau) as shown in **Figure 6.2** below.

6.2.3 These three detectors will be deployed on-site to carry out 24-hours monitoring for a period listed as **Table 6.2** below during the construction phase.

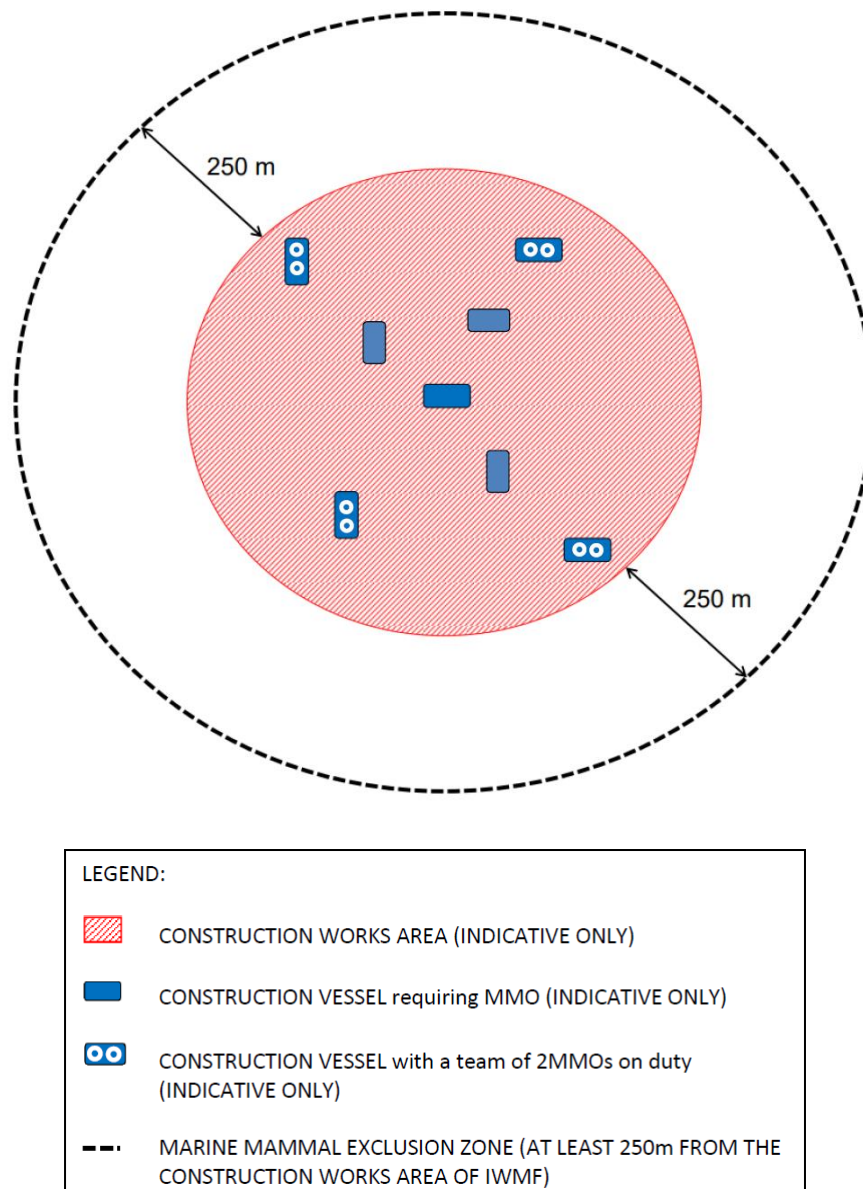
Figure 6.4 Illustration of Typical MMEZ

6.3.1.3 A MMEZ with 250 m distance from the boundary of a work area shall be established during the above situation. A typical MMEZ is indicated in **Figure 6.4** for reference. The MMEZ serves as a monitoring approach to provide appropriate and immediate actions once finless porpoise or Chinese White Dolphin is sighted within the MMEZ. All MMEZ will be monitored by competent Marine Mammal Observers (MMOs) to be provided by the Environmental Team (ET) for the IWMF and trained by the Marine Mammal Monitoring Specialist of the ET who is independent from KSZHJV.

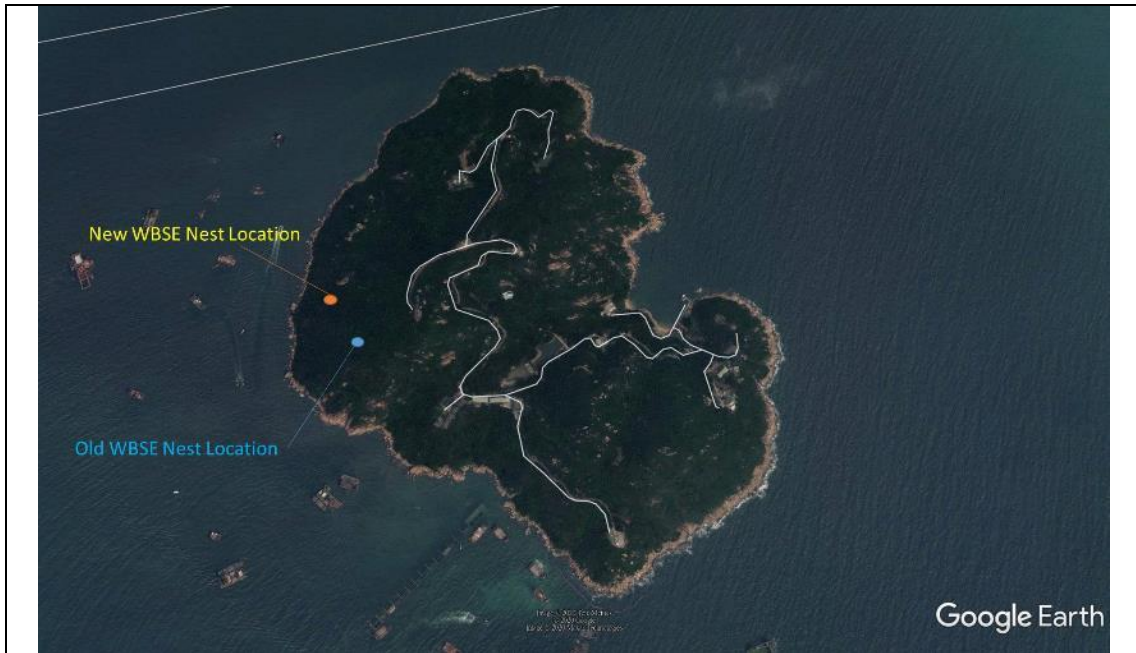
Figure 7.1 Location of WBSE Nest on SKC

7.1.2 The Pre-Construction WBSE monitoring was started on 30 January 2018 and the location of WBSE nest was confirmed on 21 February 2018 and it is located at the western part of SKC Island (**Figure 7.1**). Two adults and two chicks were also recorded on 5 March 2018 survey till the end of the Pre-construction monitoring on 15 May 2018. Construction Phase monitoring were carried out followed by the commencement of the Construction Phase on 28 June 2018.

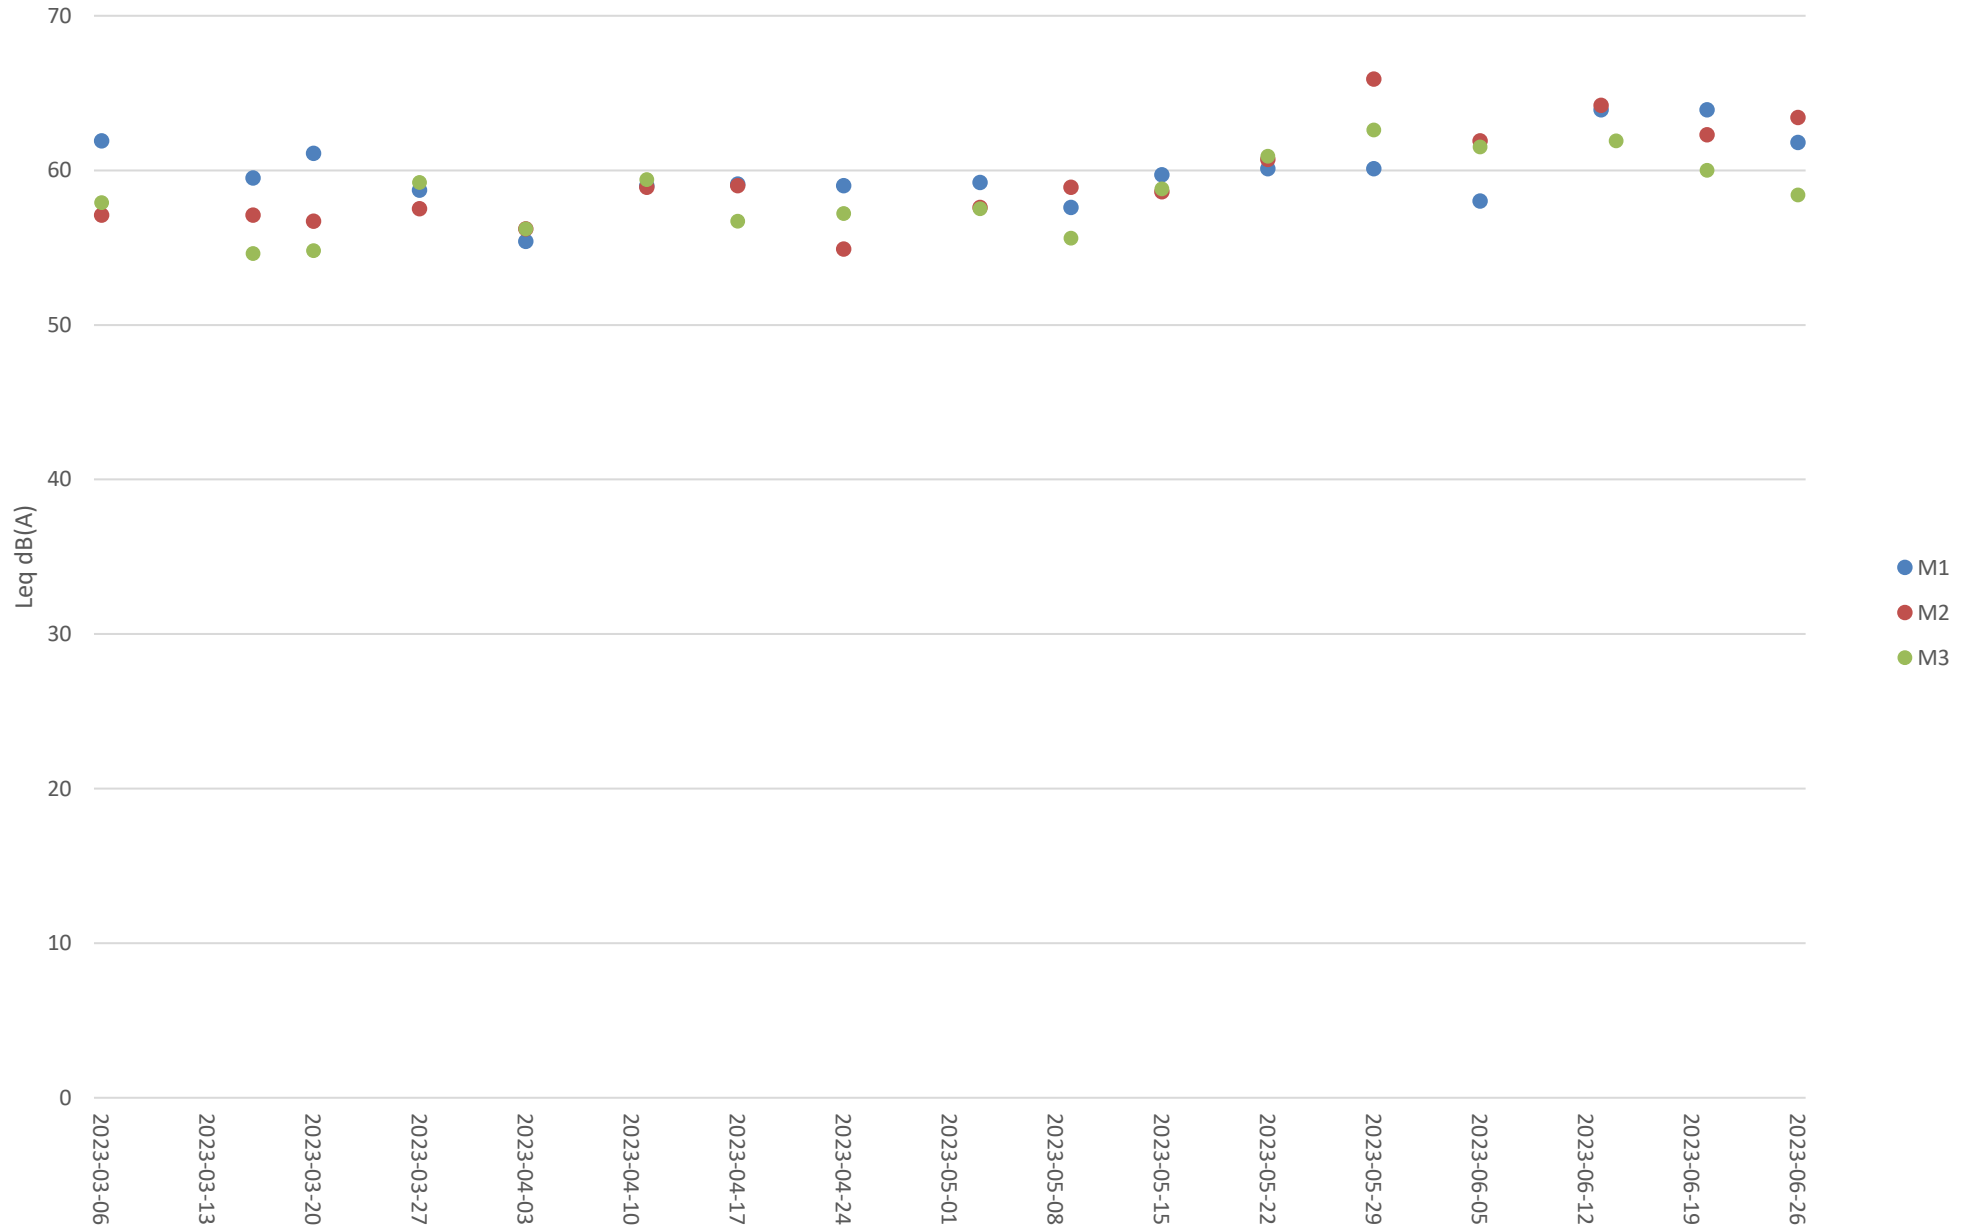
Impact Noise Monitoring Results during Day Time (0700 - 1900 hours)

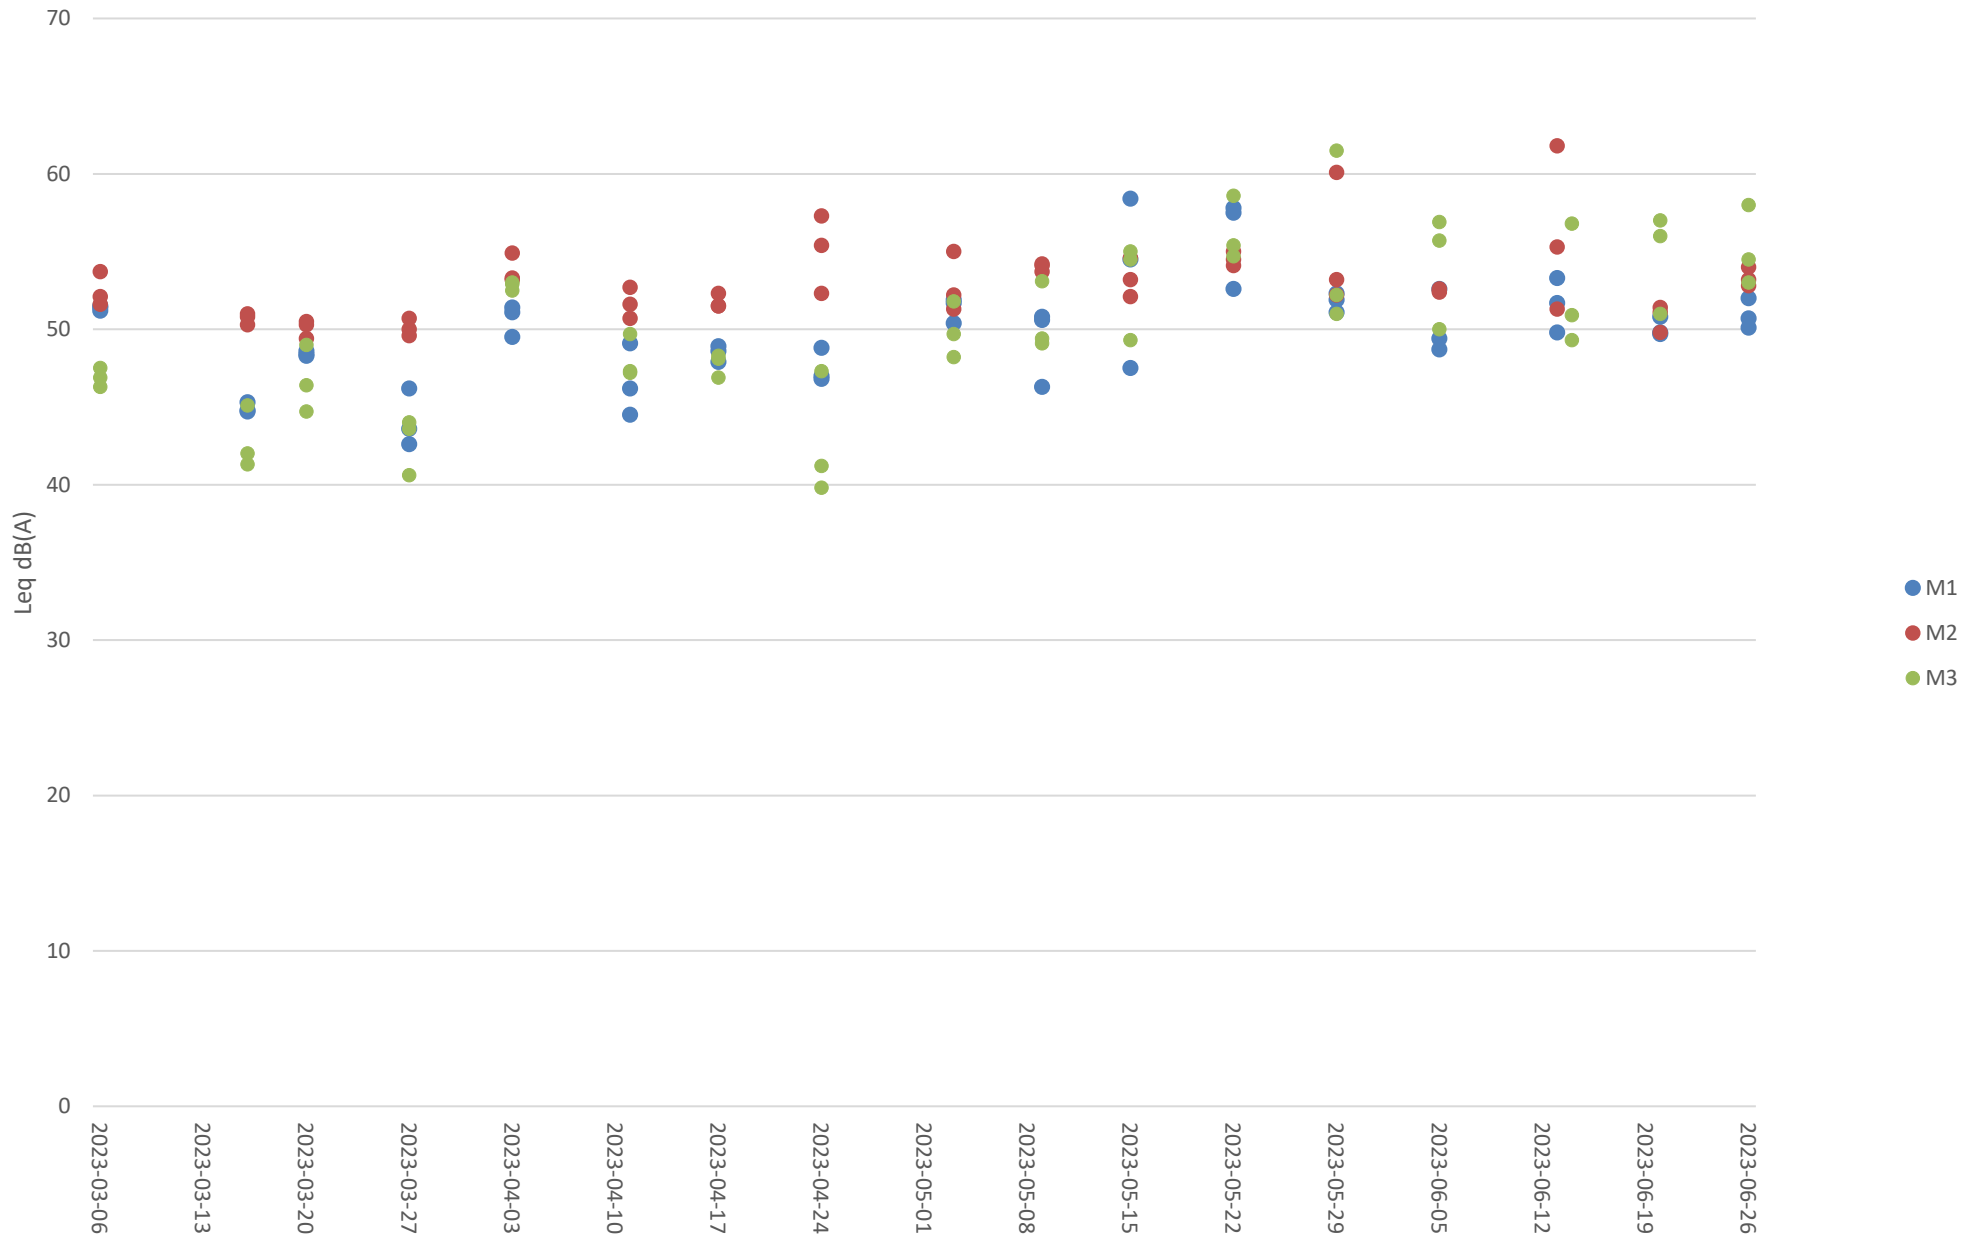
Additional Impact Noise Monitoring Results during Evening Time (1900 - 2300 hours)

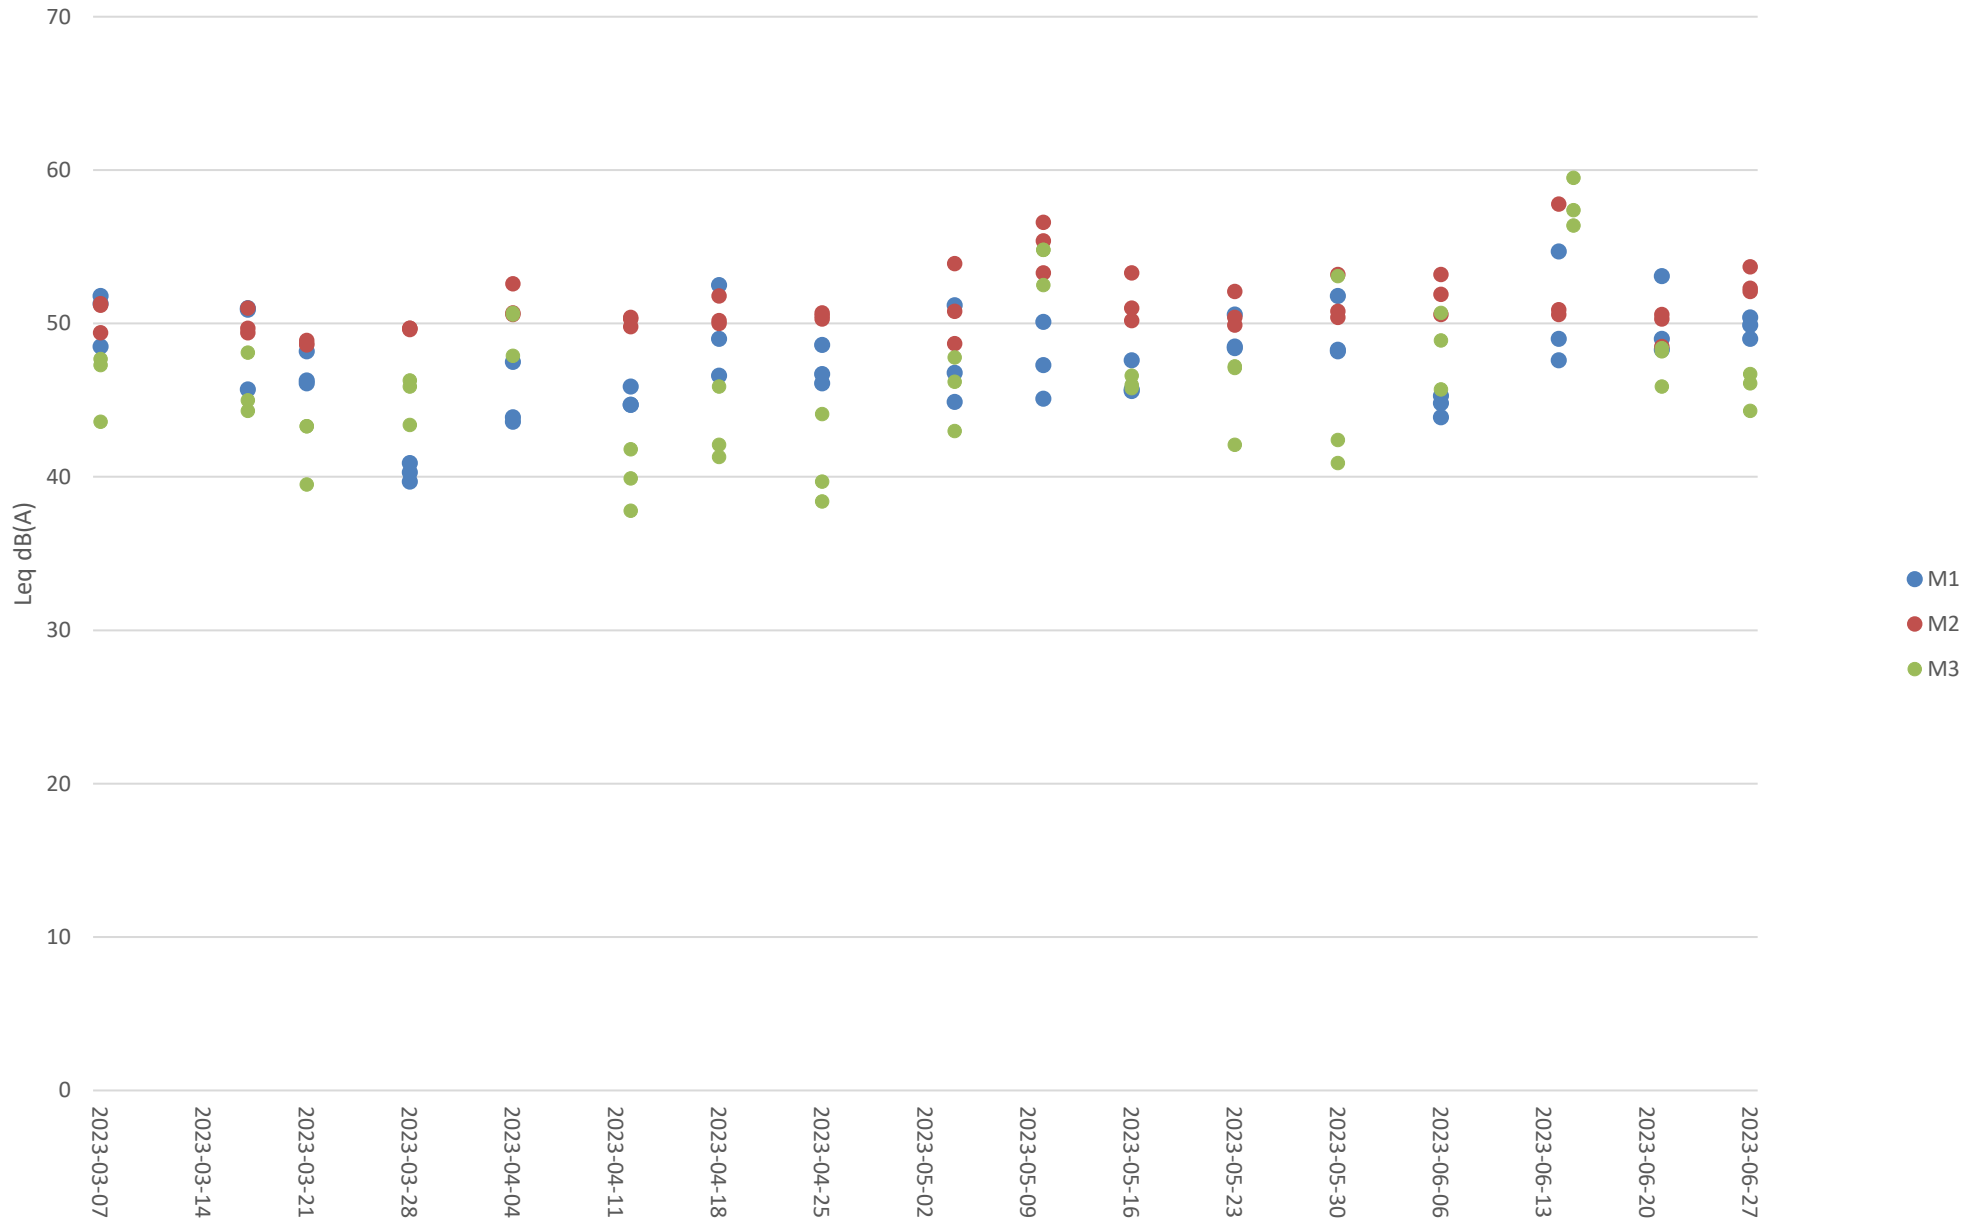
Additional Impact Noise Monitoring Results during Night Time (2300 - 0700 hours)

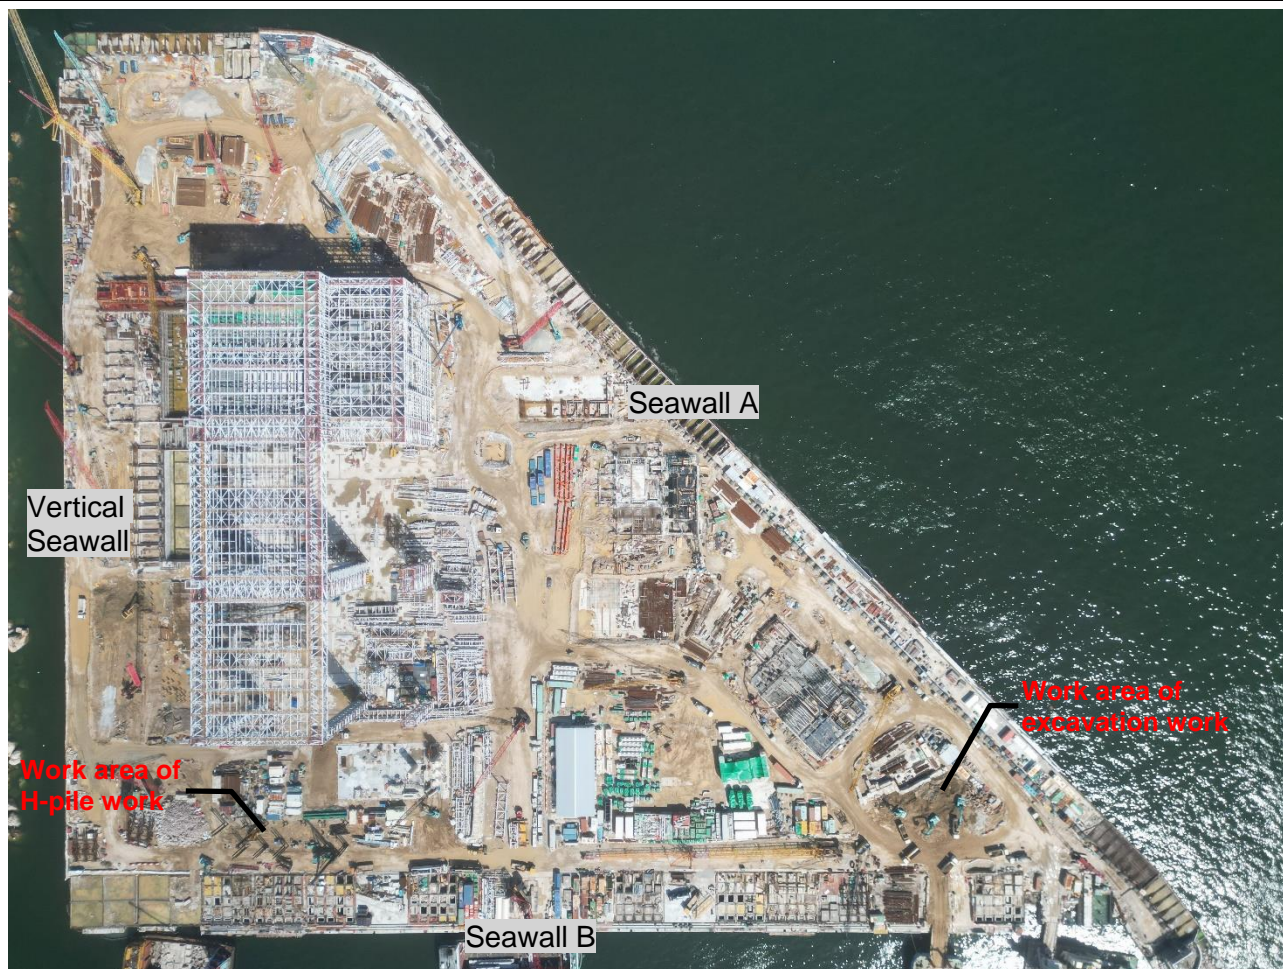
Figure 1: Location of Work Area

With reference to the work schedule provided by the Contractor, construction works conducted in recent time mainly involves excavation works near bunker 3 of Process Building, socketed H-pile works near Administration Building and elevated driveway and substructure works and superstructure works in other work areas. Among the various construction works, excavation works near bunker 3 of Process Building and socketed H-pile works near Administration Building and elevated driveway were the two construction works that possibly generate construction dust because of their work nature. The work areas of the excavation and H-pile work are indicated in **Figure 1**.
