Contract No. EP/SP/66/12
Integrated Waste Management Facilities, Phase 1
Monthly EM&A Report No.60

Monthly EM&A Report No.60 (Period from 1 June to 30 June 2023)

(Clause 3.3, Further Environmental Permit FEP-01/429/2012/A)

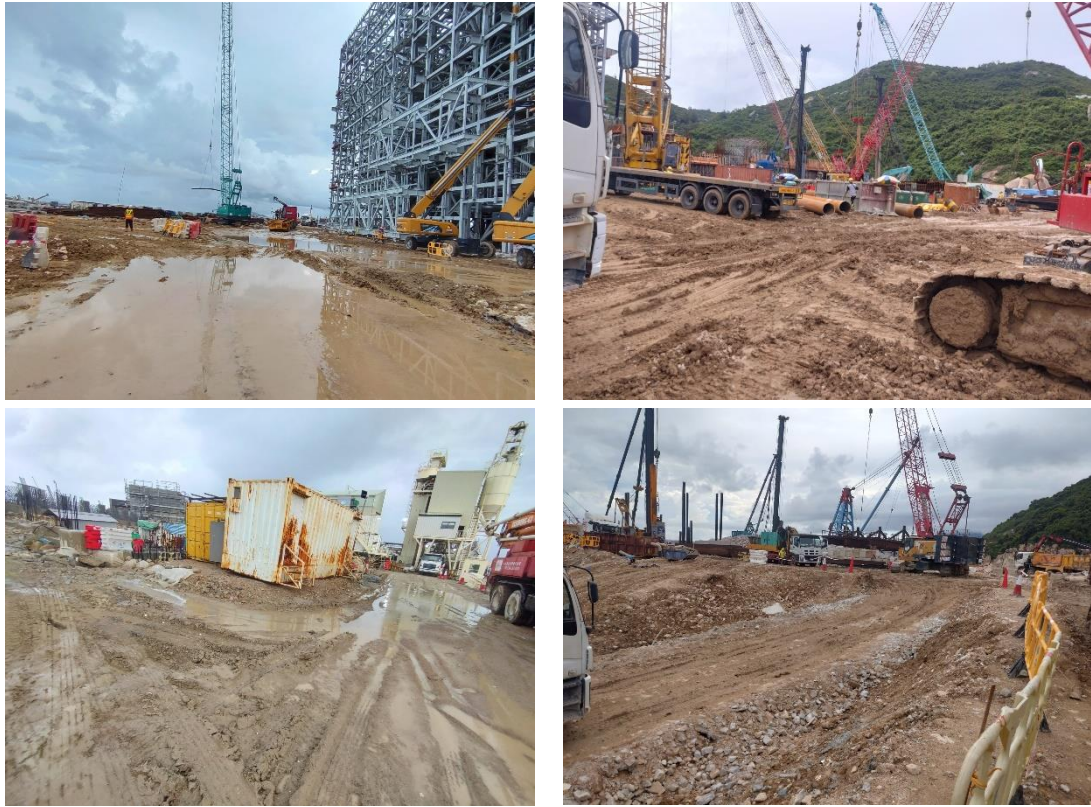
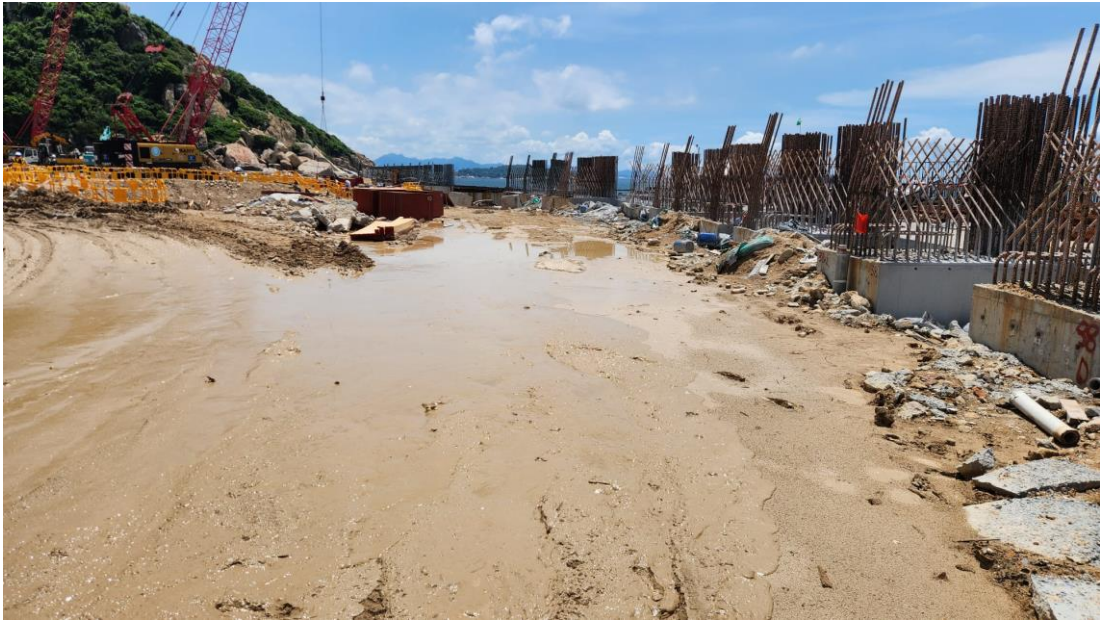
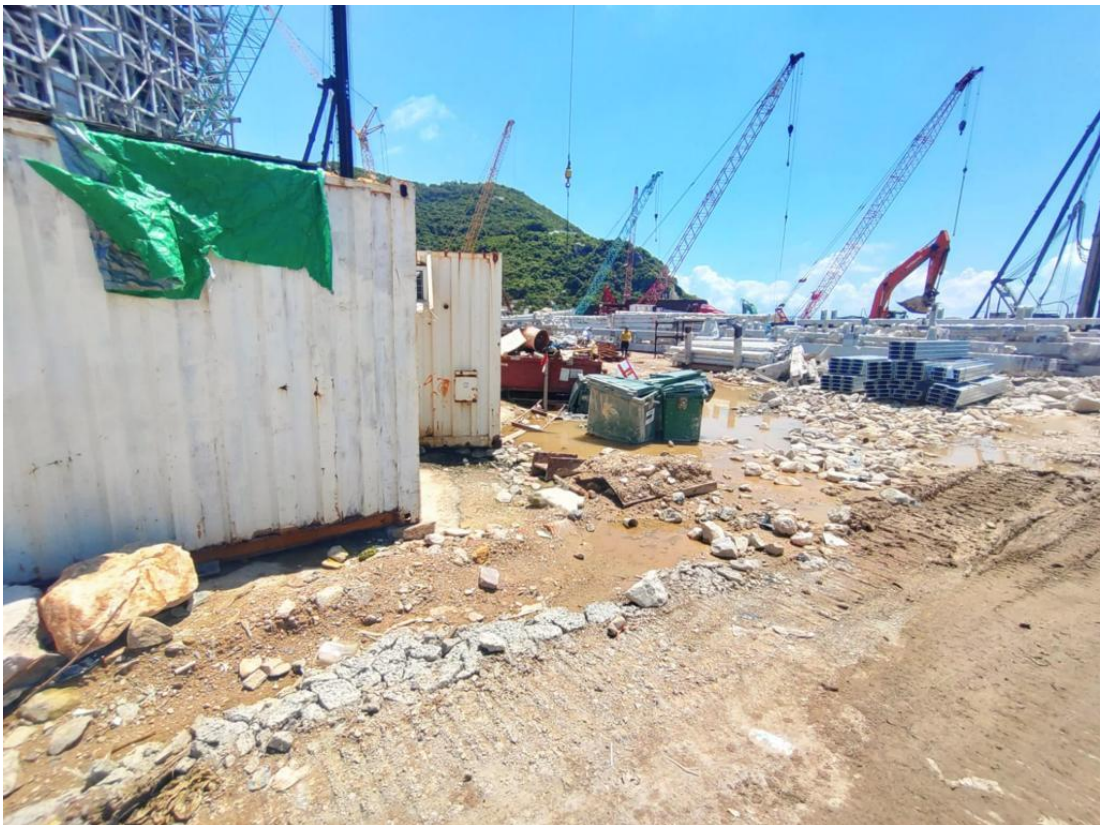
Figure 2: Site Photos of Main Haul Roads within Site Boundary

Figure 3: Site Photo of Main Haul Road Taken during Site Inspection on 06 June 2023

Figure 4: Site Photo of Main Haul Road Taken during Site Inspection on 12 June 2023

Figure 5: Site Photo of Main Haul Road Taken during Site Inspection on 19 June 2023

Figure 6: Site Photo of Main Haul Road Taken during Site Inspection on 26 June 2023

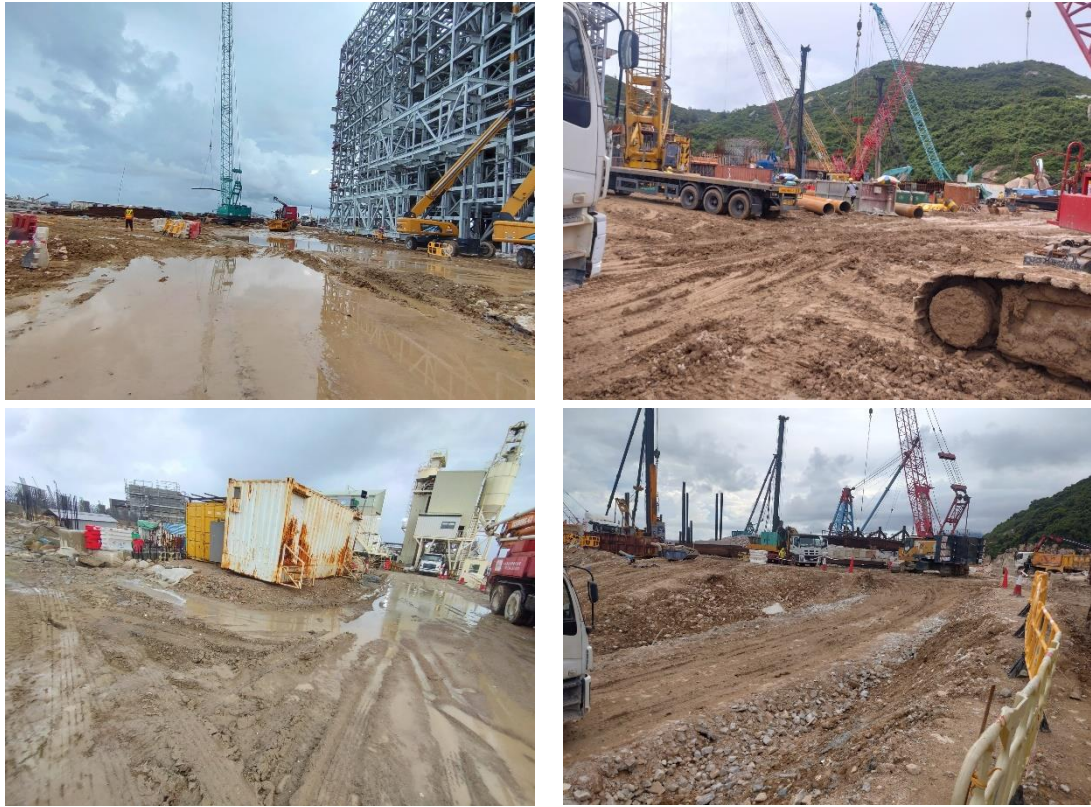
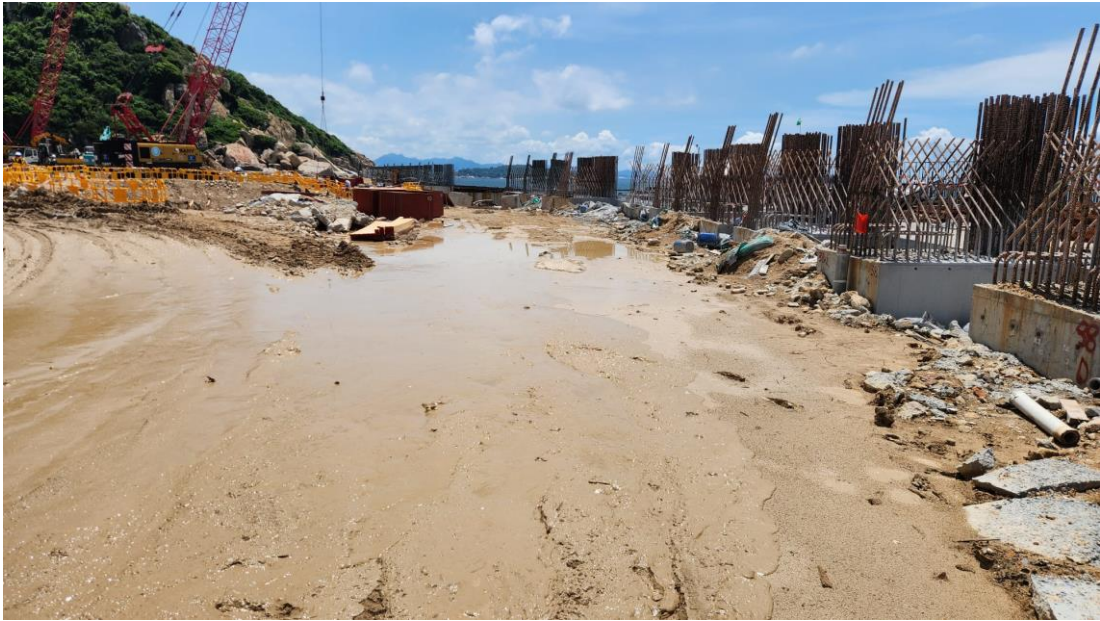
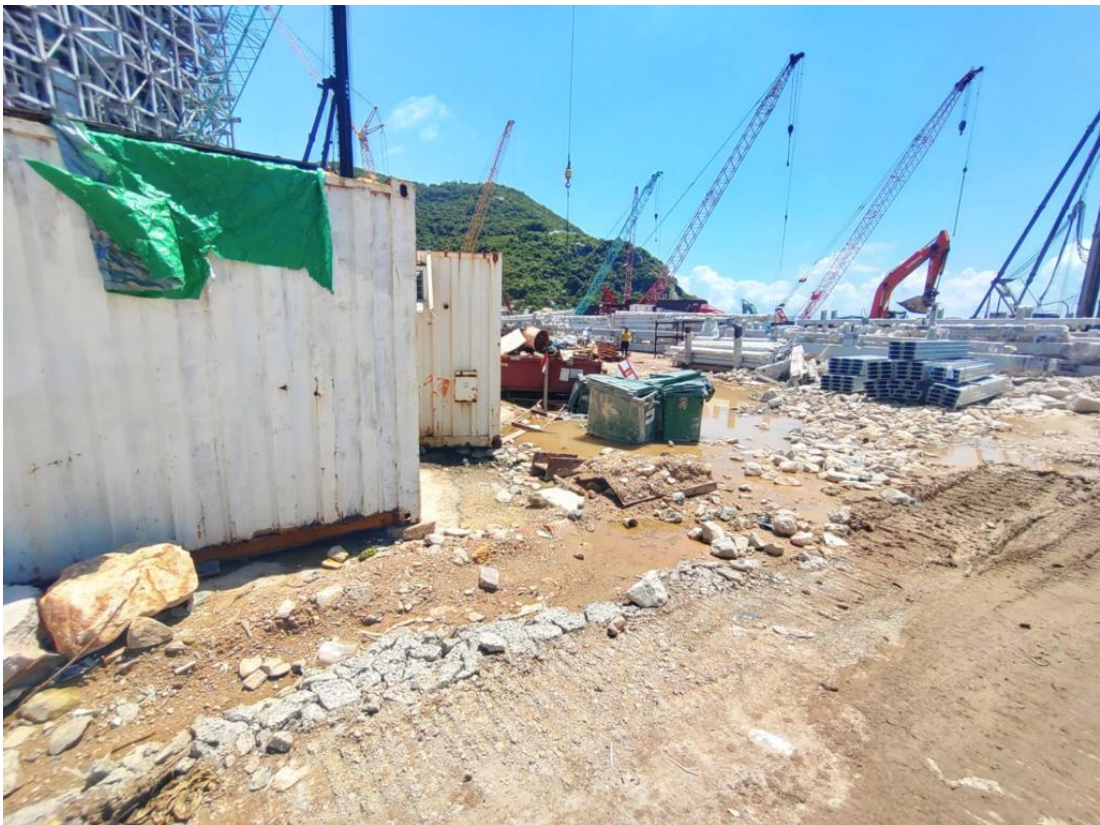
Figure 2: Site Photos of Main Haul Roads within Site Boundary

Figure 3: Site Photo of Main Haul Road Taken during Site Inspection on 06 June 2023

Figure 4: Site Photo of Main Haul Road Taken during Site Inspection on 12 June 2023

Figure 5: Site Photo of Main Haul Road Taken during Site Inspection on 19 June 2023

Figure 6: Site Photo of Main Haul Road Taken during Site Inspection on 26 June 2023

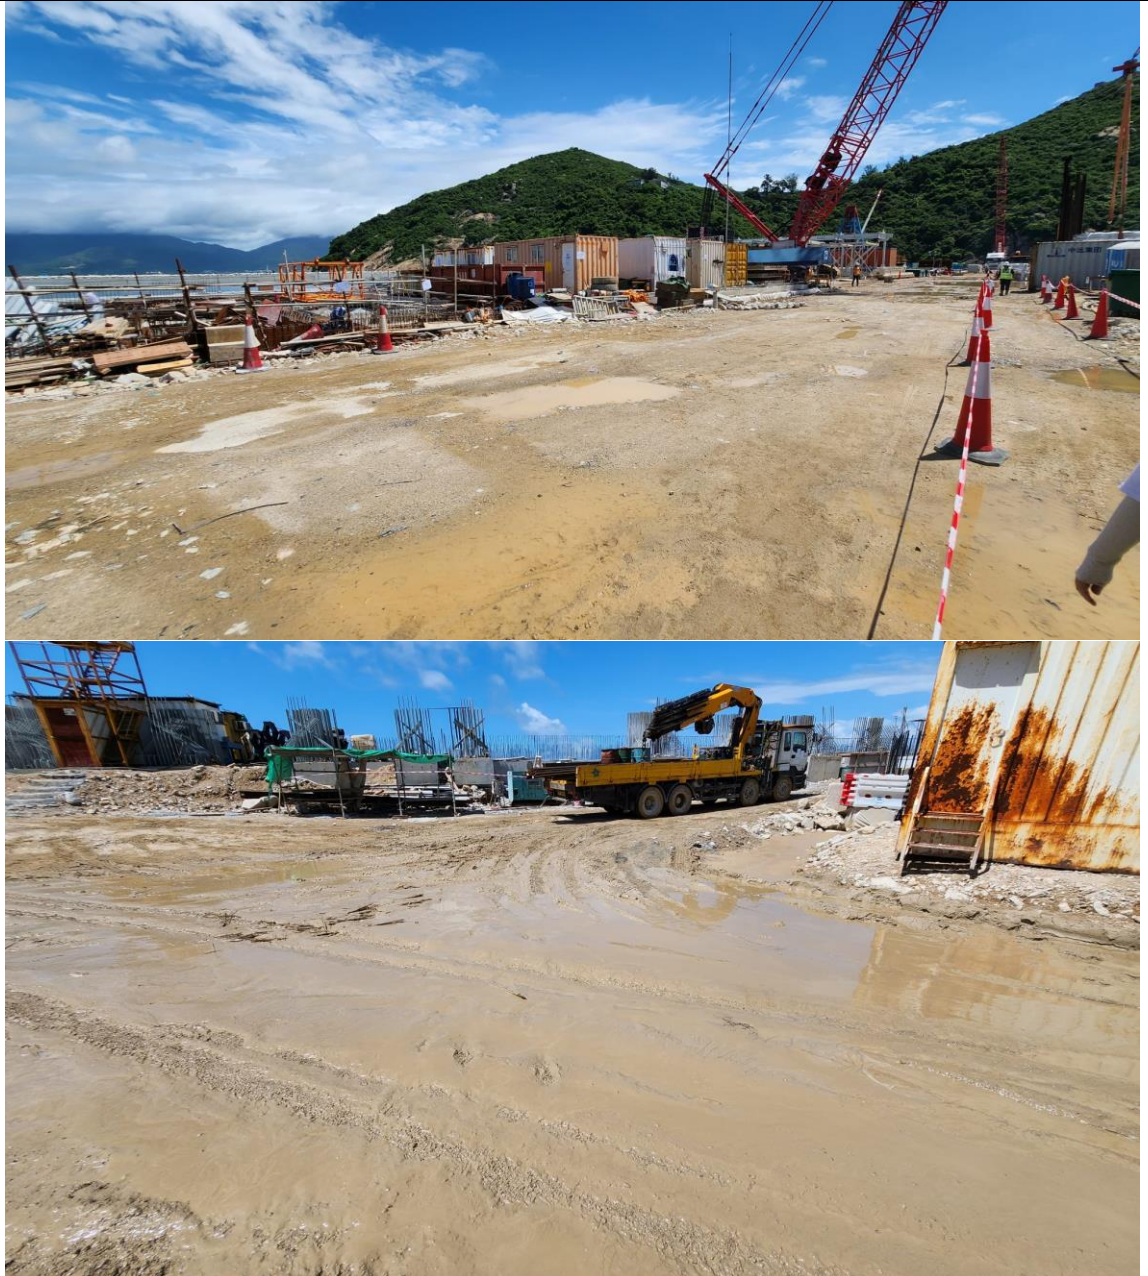
Date	Status / Observation
04 July 2023 (Weekly site inspection)	No fugitive dust generated from construction work or vehicle movement was observed during the site inspection. Almost all main haul roads remain in slurry condition during site inspection. Site photos of the condition of main haul roads during site inspection are given in Figure 9 . Water spraying to main haul road was observed during site inspection and the photo record is given in Figure 10 .

Figure 9: Site Photo of Main Haul Road Taken during Site Inspection on 04 July 2023

Figure 10: Photo Record of Spraying Water to Main Haul Road
