Contract No. EP/SP/66/12 Integrated Waste Management Facilities, Phase 1 Monthly EM&A Report No.62

# Monthly EM&A Report No.62 (Period from 1 August to 31 August 2023)

(Clause 3.3, Further Environmental Permit FEP-01/429/2012/A)

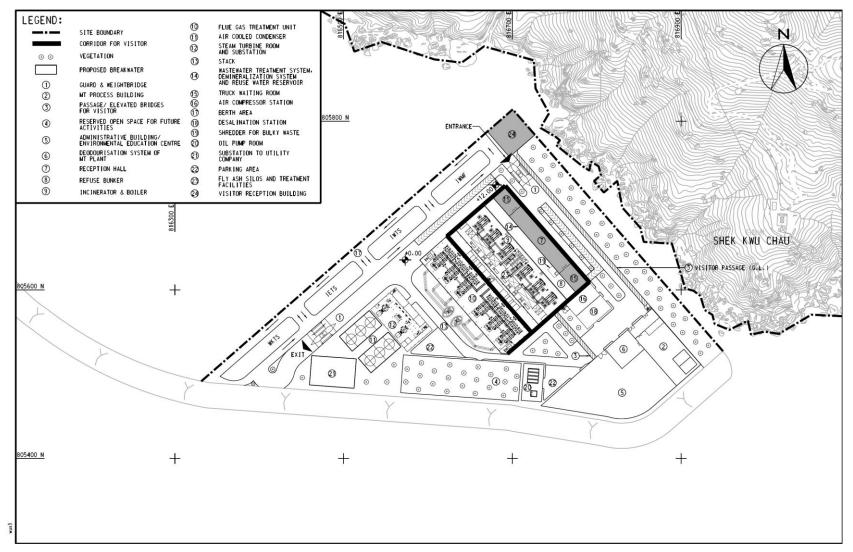
Figure 1.2 General Layout of the IWMF at the Artificial Island near SKC

1.1.5 The location of the IWMF near Shek Kwu Chau (SKC) and general layout of IWMF are shown in **Figure 1.1** and **Figure 1.2** respectively.

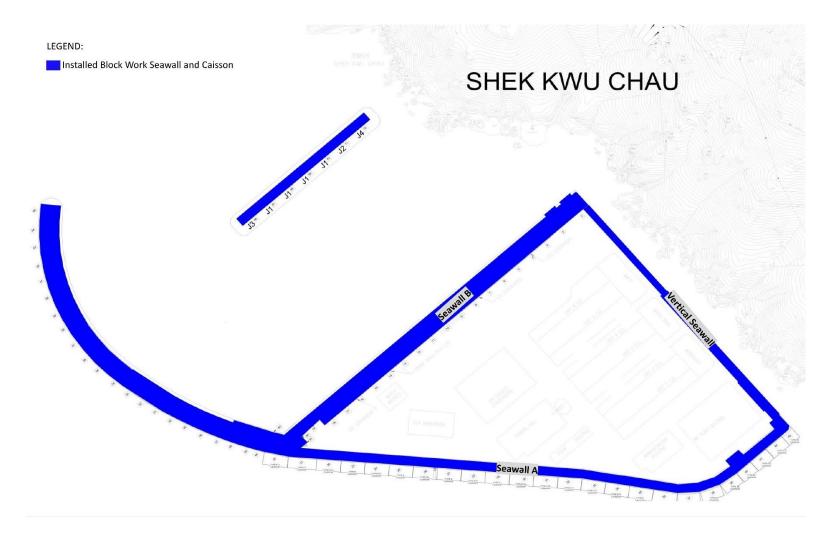
Figure 1.4 Location of Major Construction Activities Undertaken during the Reporting Month

Location of works	Construction activities undertaken	Remarks on progress
Reclamation area	Installation of Instrumentation	On-going
	Site Investigation works for foundation	On-going
	Foundation works (including Driven H Pile and Socketed H Pile)	On-going
	Pile cap construction	On-going
	Structural steel work	On-going
	Superstructure construction	On-going
Seawall portion	• Caisson extension works, from +3mPD	On-going
	to +6mPD, at Seawall A and B	
	• Construction of wave wall along the vertical seawall above +3mPD	On-going

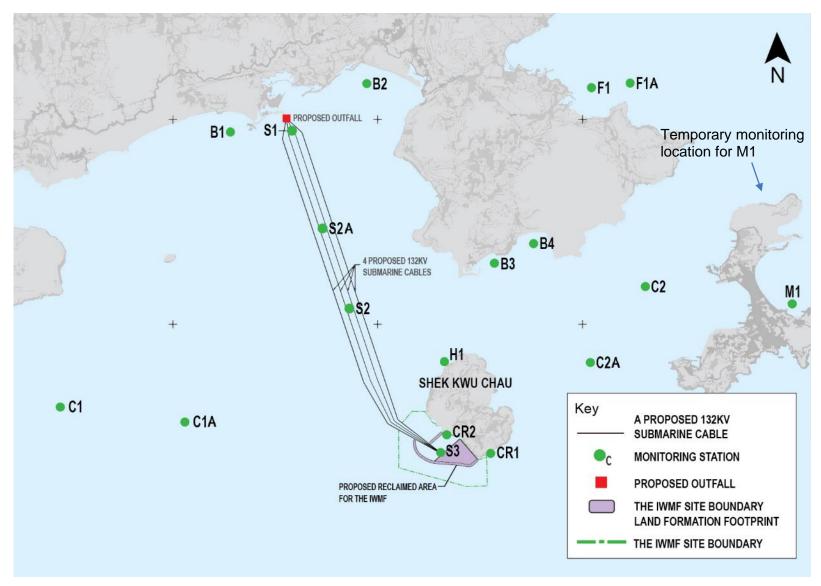
Figure 2.1 Water monitoring locations at Artificial Island near SKC

- 2.3 Water Quality Monitoring Locations
- 2.3.1 Impact water quality monitoring was conducted at eleven monitoring locations (B1-B4, H1, C1, C2, F1, CR1, CR2 & M1) during general water quality monitoring in the reporting period as shown in **Figure 2.1**. As per the relocation proposal verified by IEC and approved by EPD, the monitoring location C1, C2, S2, F1 are relocated at C1A, C2A, S2A, F1A as equivalent points respectively to clear up the concerns from stakeholders.

- 2.3.2 B1 to B4 are located at 4 beaches respectively at the southern shore of Lantau Island. Monitoring station H1 is located at the horseshoe crab habitat at northern SKC, while CR1 and CR2 are located at the coral communities at southwestern shore of SKC. Monitoring station F1 is located at the Cheung Sha Wan Fish Culture Zone while monitoring station M1 is located at Tung Wan at Cheung Chau. Monitoring station F1A is relocated for F1 at the Cheung Sha Wan Fish Culture Zone. S1, S2 and S3 are located at the northern landing site, midway and southern landing site of the proposed submarine cable, respectively. S2A is the relocated monitoring station of S2 which represents the midway landing site of the proposed submarine cable. S1, S2/S2A and S3 are required for monitoring due to the laying of submarine cable. Control stations C1 and C2 at far field locations are for comparison. Control stations C1A and C2A are relocated for C1 and C2 respectively as equivalent far field locations for comparison.

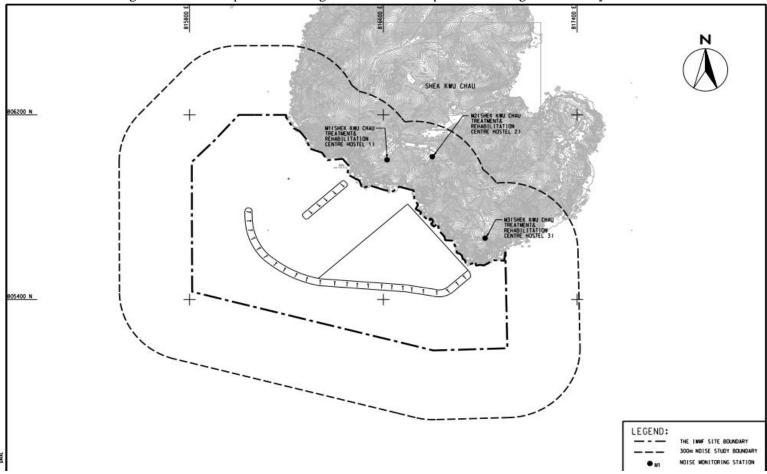
Figure 3.1 Noise monitoring locations at SKC

3.3.1 Three noise monitoring locations for impact monitoring and additional impact monitoring at the nearby sensitive receivers are shown in **Figure 3.1.**

- 3.3.2 M1, M2 and M3 are Shek Kwu Chau Treatment and Rehabilitation Centre Hostel 1, 2 and 3 respectively of The Society for the Aid and Rehabilitation of Drug Abusers (SARDA) located at southern part of Shek Kwu Chau.

- 3.3.3 Measurements at M1 & M3 were conducted at a point 1m from the exterior of the sensitive receivers building façade and at a position 1.2m above the ground. Measurement setup at M3 has been varying with minor adjustment to minimize the disturbance to the users of Treatment Centre. Measurement at M2 was conducted at a point 1m from building façade of the ceiling of 1st floor level for avoidance of mutual disturbance with users of Treatment Centre. The minor adjustment of monitoring locations, which were in favour to mutual convenience with the users of Treatment Centre, were found with no effect on monitoring result based on on-site observation and experience from the Baseline monitoring of the Project. The noise monitoring stations are summarized in **Table 3.2** below.

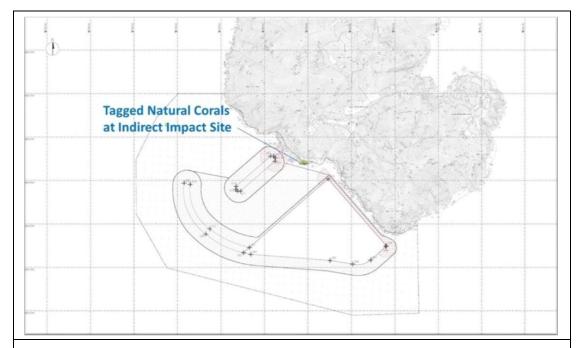
Figure 5.1 Tagged Natural Corals at Indirect Impact Site Near SKC for re-tagging after typhoon Mangkhut

5.3.1 Location of the ten tagged coral colonies at each of the proposed indirect impact site (re-tagging after typhoon Mangkhut), control site (baseline) and recipient site R3 (translocation) are shown in **Figure 5.1**, **Figure 5.2** and **Figure 5.3** respectively:

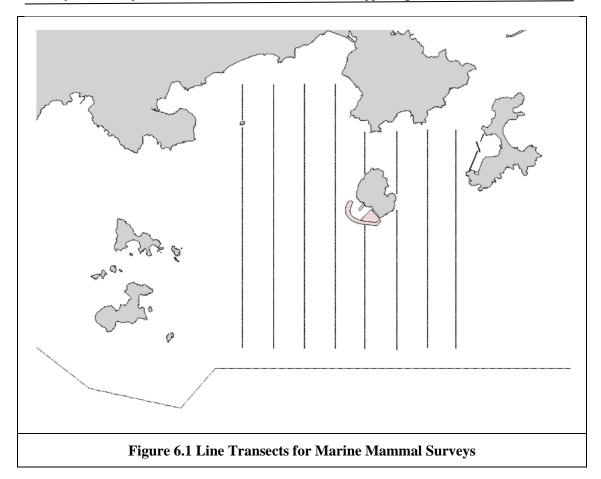
- 6.2.1.2 Eight transect lines are set at Southeast Lantau survey area, including Shek Kwu Chau, waters between Shek Kwu Chau and the Soko Islands, inshore waters of Lantau Island (e.g. Pui O Wan) as well as southwest corner of Cheung Chau as shown in **Figure 6.1** below:

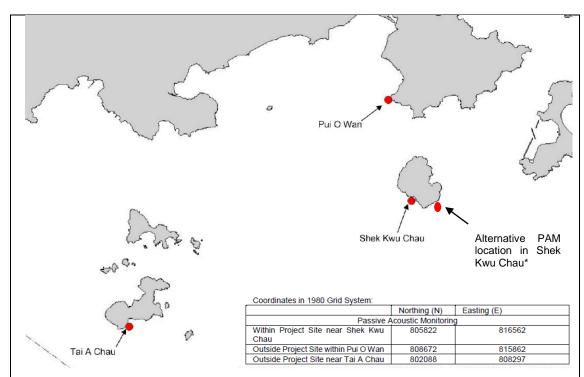
Figure 6.2 Locations of Passive Acoustic Monitoring

The PAM aims to study the usage of an area by Finless Porpoise by using an array of automated static porpoise detectors (e.g. C-POD) which would be deployed at different locations to detect the unique ultra-high frequency sounds produced by Finless Porpoise. During the construction period, the PAM survey will be conducted including placement of two passive porpoise detectors outside the Project Area as control site (i.e. within Pui O Wan and to the south of Tai A Chau) and one porpoise detector within the Project Area (i.e. near Shek Kwu Chau) as shown in **Figure 6.2** below.

Note\*: The alternative PAM device adjacent to the Project site was deployed from 5 Mar to 11 Apr 2019, which contained a full 37 days acoustic monitoring data set. After the confirmation of loss of the original PAM within the Project site, this data set was proposed to replace that of the original one, as consulted with AFCD accordingly.

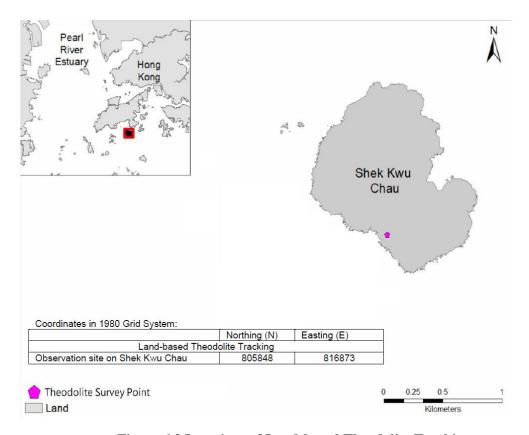
Figure 6.3 Locations of Land-based Theodolite Tracking

- 6.2.4 Land-based Theodolite Tracking
- 6.2.4.1 The Land-based Theodolite Tracking study would use the same station as in the AFCD monitoring study (same as the baseline monitoring location), which is situated at the southwest side of Shek Kwu Chau (GPS position: 22°11.47' N and 113°59.33' E) as shown in below **Figure 6.3**. The station was selected based on its height above sea level (at least 20 metres), close proximity to shore, and relatively unobstructed views of the entire Project Area to the southwest of Shek Kwu Chau. The height of the Shek Kwu Chau Station established by the HKCRP team is 74.6 m high at mean low water, and only a few hundred metres to the IWMF reclamation site, which is ideal for the purpose for the present behavioural and movement monitoring of finless porpoises as well during construction phase considering there as an un-obstructed vantage point at a height above the Project Site.

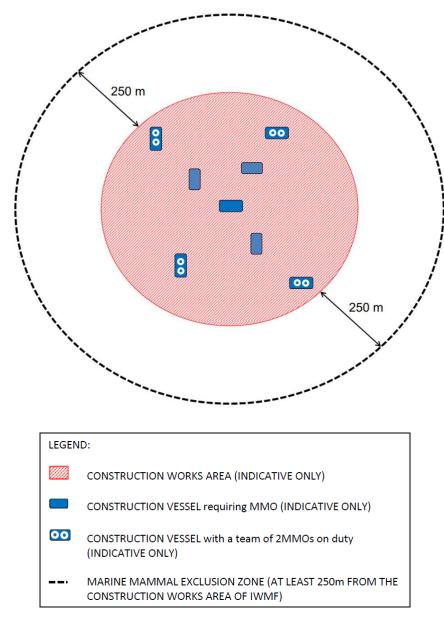
Figure 6.4 Illustration of Typical MMEZ

6.3.1.3 A MMEZ with 250 m distance from the boundary of a work area shall be established during the above situation. A typical MMEZ is indicated in **Figure 6.4** for reference. The MMEZ serves as a monitoring approach to provide appropriate and immediate actions once finless porpoise or Chinese White Dolphin is sighted within the MMEZ. All MMEZ will be monitored by competent Marine Mammal Observers (MMOs) to be provided by the Environmental Team (ET) for the IWMF and trained by the Marine Mammal Monitoring Specialist of the ET who is independent from KSZHJV.
