Contract No. EP/SP/66/12  
Integrated Waste Management Facilities, Phase 1  
Monthly EM&A Report No.63

## Monthly EM&A Report No.63 (Period from 1 September to 30 September 2023)

(Clause 3.3, Further Environmental Permit FEP-01/429/2012/A)

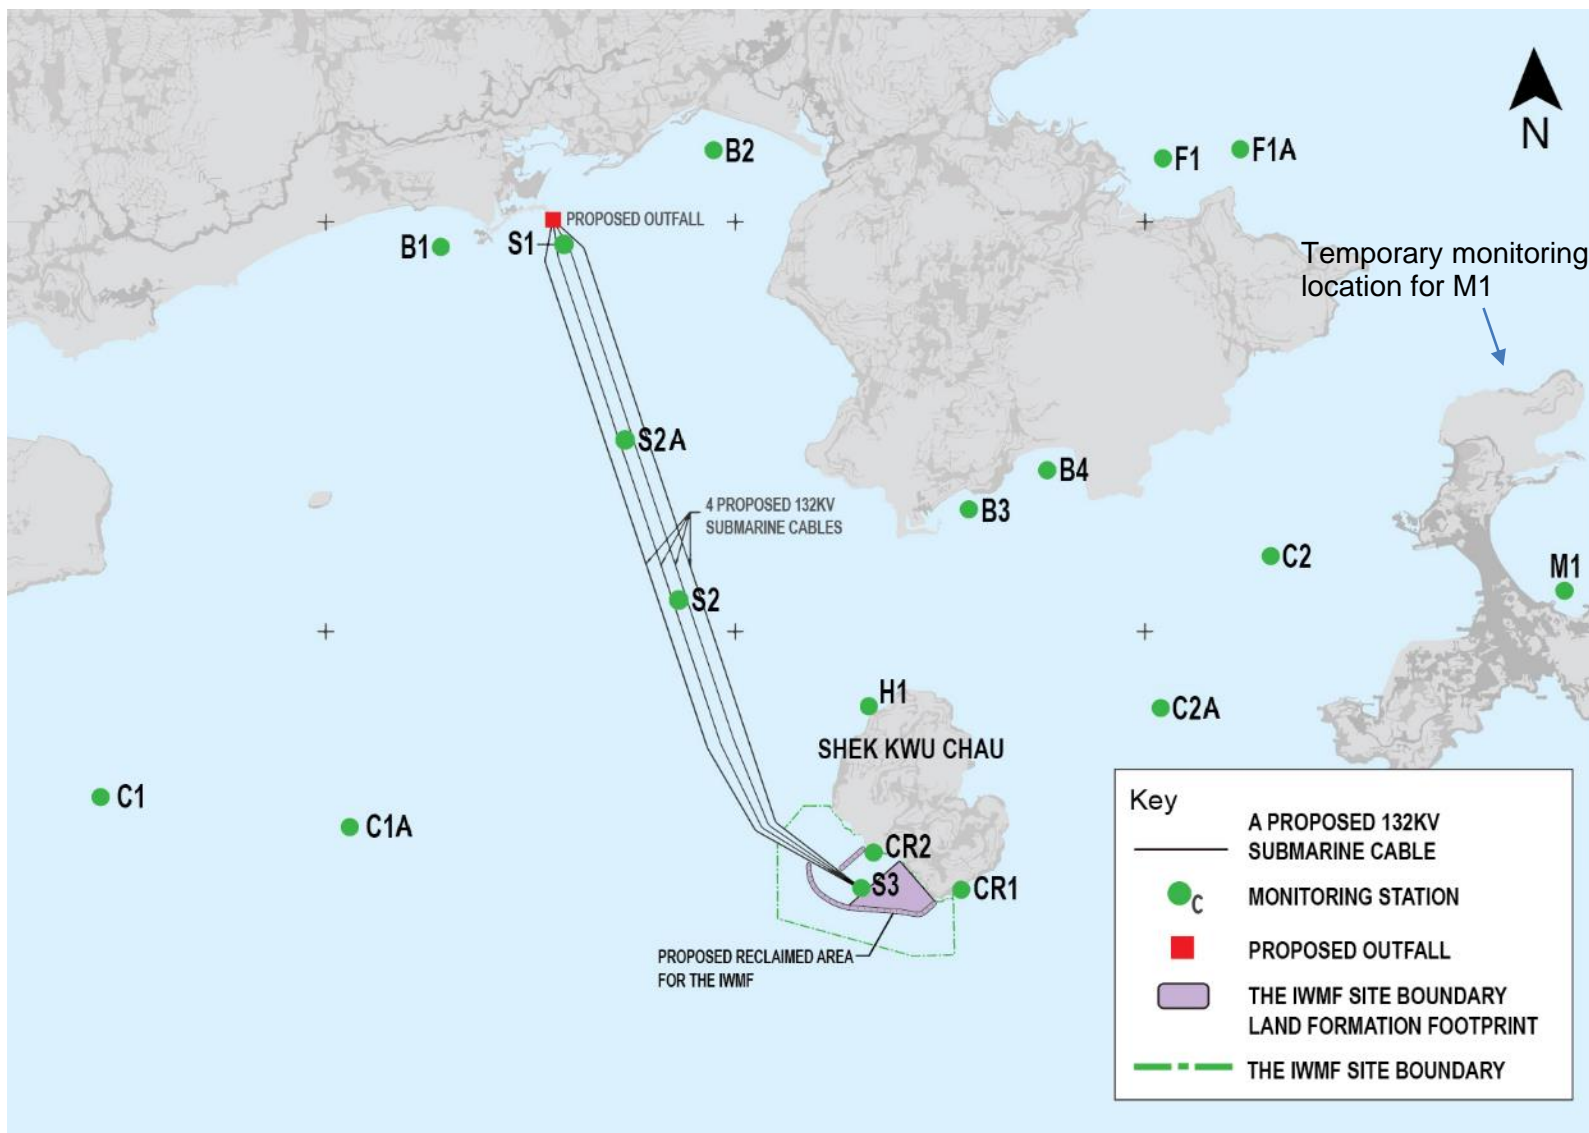
Figure 2.1 Water monitoring locations at Artificial Island near SKC

- 2.3.1 Impact water quality monitoring was conducted at eleven monitoring locations (B1-B4, H1, C1, C2, F1, CR1, CR2 & M1) during general water quality monitoring in the reporting period as shown in **Figure 2.1**. As per the relocation proposal verified by IEC and approved by EPD, the monitoring location C1, C2, S2, F1 are relocated at C1A, C2A, S2A, F1A as equivalent points respectively to clear up the concerns from stakeholders.

2.3.2 B1 to B4 are located at 4 beaches respectively at the southern shore of Lantau Island. Monitoring station H1 is located at the horseshoe crab habitat at northern SKC, while CR1 and CR2 are located at the coral communities at southwestern shore of SKC. Monitoring station F1 is located at the Cheung Sha Wan Fish Culture Zone while monitoring station M1 is located at Tung Wan at Cheung Chau. Monitoring station F1A is relocated for F1 at the Cheung Sha Wan Fish Culture Zone. S1, S2 and S3 are located at the northern landing site, midway and southern landing site of the proposed submarine cable, respectively. S2A is the relocated monitoring station of S2 which represents the midway landing site of the proposed submarine cable. S1, S2/S2A and S3 are required for monitoring due to the laying of submarine cable. Control stations C1 and C2 at far field locations are for comparison. Control stations C1A and C2A are relocated for C1 and C2 respectively as equivalent far field locations for comparison.

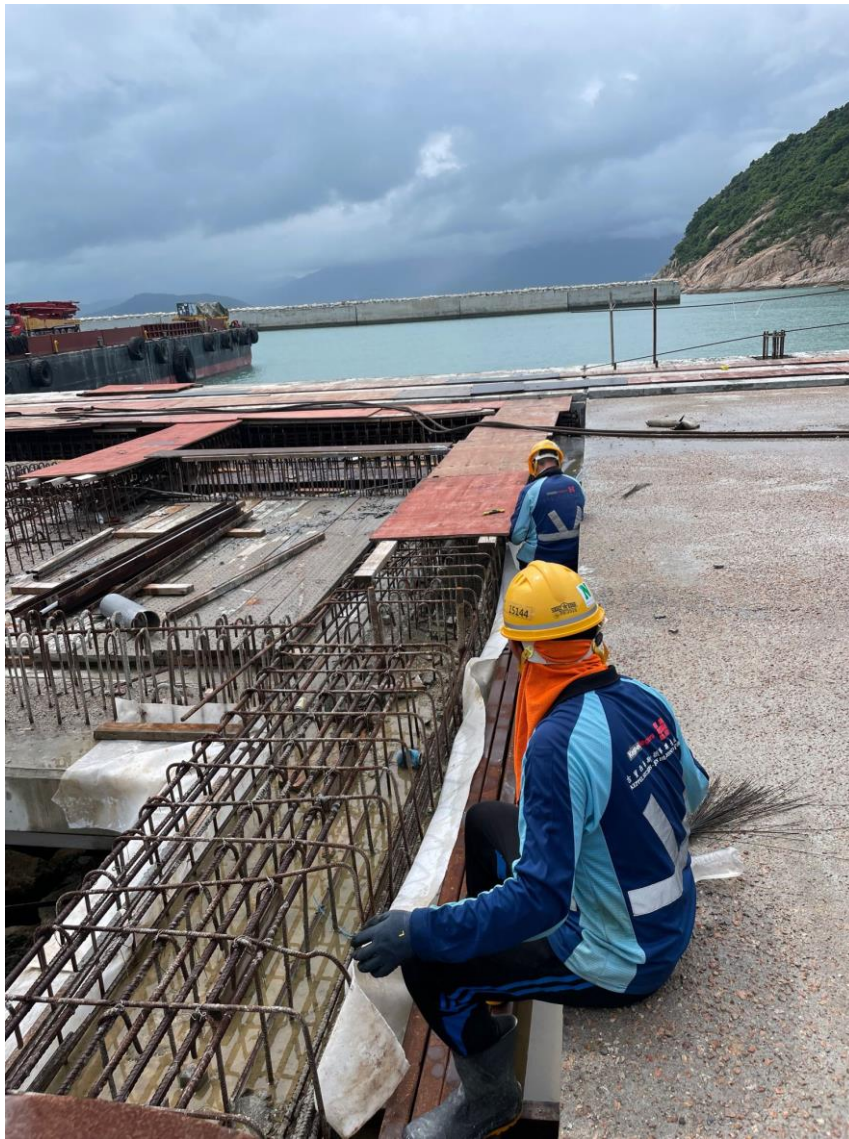
**Figure 1** Replacement of Damaged Geotextile on 05 September 2023

Date Received	05 September 2023 From: Environmental Protection Department (Compliance Division)
Parameter	* <del>Air / Noise /</del> Water / <del>Waste / Landscape and Visual /</del> Chemical Spillage
Reference No.	IWMF_EC04_20230905
<b>Enquirer’s Details:</b>	
Name	Not disclosed
Contact Tel No.	Not disclosed
Address	Not disclosed
Source	* <del>Telephone / Site Visit /</del> Referred from Environmental Protection Department
<b>Details of a Complaint:</b>	
<p>A complaint was received by the Environmental Protection Department on 05 September 2023 and referred to the Environmental Team (ET), Independent Environmental Checker (IEC) and Supervising Officer (SO) on 06 September 2023. The complaint was related to alleged discharge of effluent near the shore of artificial island. Details of the complaint are as below:</p> <p><i>From Notification of Environmental Complaint</i></p> <ul style="list-style-type: none"> <li>- The complainant alleged that discharge of effluent was observed near the shore of artificial island.</li> <li>- The complainant reported that discharged effluent was suspected to be cement water.</li> </ul>

<b>Actions taken / to be taken:</b>	
<ul style="list-style-type: none"> <li>- ET notified the Contractor and requested for more information on 06 September 2023.</li> <li>- Information had been provided by Contractor on 06 September 2023.</li> <li>- Field investigations were conducted on 07, 12 and 19 September 2023.</li> <li>- Leakage test with fluorescent dye at pits near the shore of artificial island was conducted on 19 September 2023.</li> </ul>	
<b>Investigation Findings:</b>	
<p>With reference to the information provided by the Contractor, the location of alleged discharge of cement water is in the vicinity of caisson 7. As the land based concrete batching plant was still not in operation and no leakage was reported and observed at the concrete batching barge on 05 September 2023, no cement water shall be generated or observed in the work areas adjacent to caisson 7.</p> <p>In view of impossibility of the existence of cement water at the work areas adjacent to caisson 7, the accidentally discharged effluent claimed in the complaint was suspected to be the surface runoff along haul road near caisson 7. The accidental discharge might be caused by the minor leakage from the damaged geotextile at caisson 7.</p> <p>As reported by the Contractor, damaged geotextile at caisson 7 was observed during the post typhoon inspection on 05 September 2023 and the damaged geotextile had been repaired immediately after the post inspection. The photo record of the replacing the damaged geotextile is given in <b>Figure 1</b>. The damage was possibly due to adverse weather under Super Typhoon “SAOLA”<sup>[1]</sup>.</p>

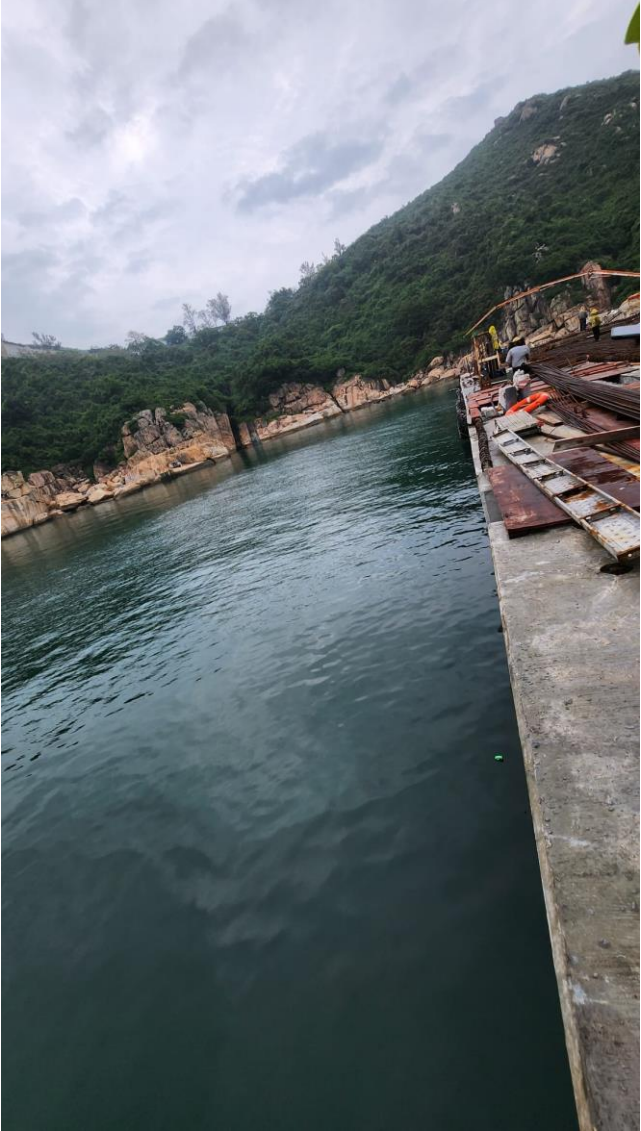
<p data-bbox="376 1547 1458 1615"><b>Figure 2</b> Shore Condition along Seawall B during Site Inspection on 07 September 2023</p>

Date	Status / Observation
07, 12 and 19 September 2023  (Weekly site inspection)	<p data-bbox="341 232 1493 376">No silt plume was observed on the sea surface along the seawall B during the site inspection on 07, 12 and 19 September 2023. The site photo records of seawall B during site inspection on 07, 12 and 19 September 2023 are given in <b>Figure 2</b>, <b>Figure 3</b> and <b>Figure 4</b> respectively.</p>
