Contract No. EP/SP/66/12
Integrated Waste Management Facilities, Phase 1
Monthly EM&A Report No.69

Monthly EM&A Report No.69 (Period from 1 March to 31 March 2024)

(Clause 3.3, Further Environmental Permit FEP-01/429/2012/A)

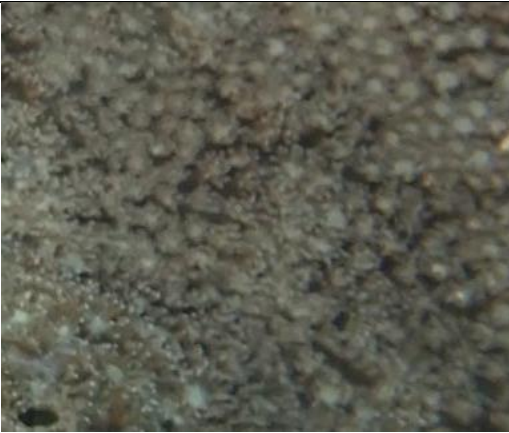
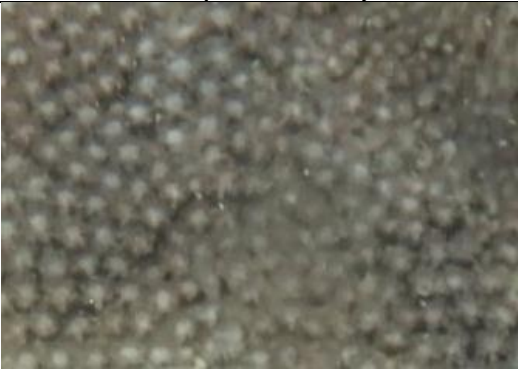
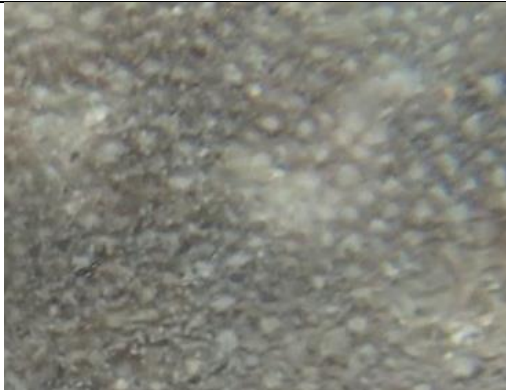
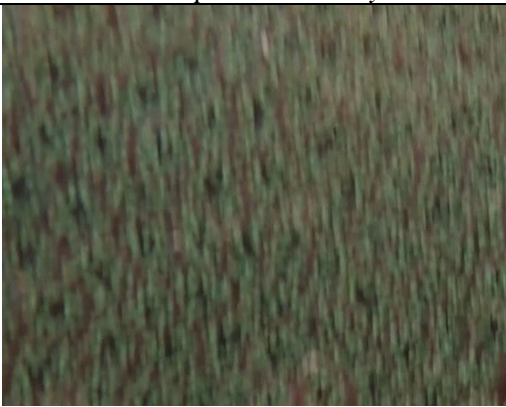
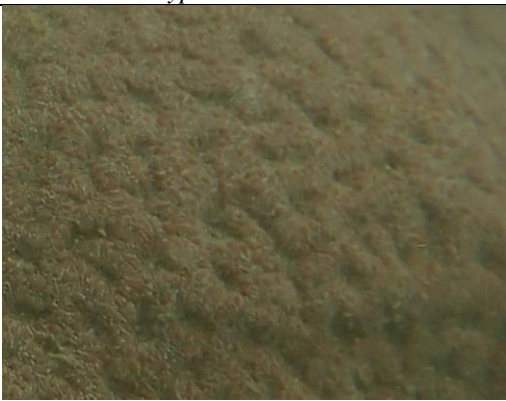
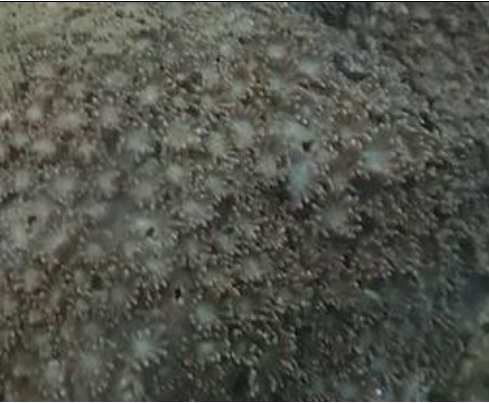
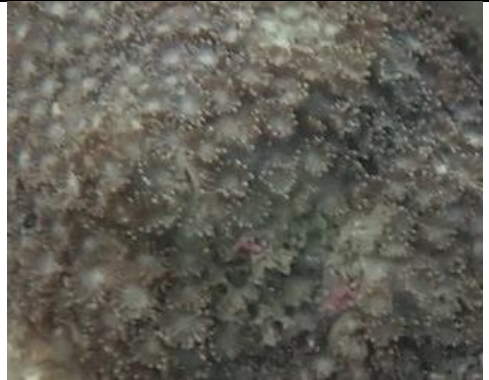
Photo Plate 5.1 Ten (10) Monitored Corals at Control Site

5.6.2 Ten (10) hard coral colonies were monitored at each Control site and Indirect Impact Site as suggested in the Construction Phase Monitoring Plan. The general health conditions (size, mortality, bleaching and sediment) were recorded and summarized in **Table 5.8** and **Table 5.9**. Photos of each coral colonies were taken during the monitoring activities shown in **Photo Plate 5.1** and **Photo Plate 5.2**.

- 5.6.4 All tagged and re-tagged coral colonies showed good health condition during the 21st Quarterly Construction Phase Monitoring. There was no increased level of mortality, bleaching and sediment when compared with the baseline results.
