Contract No. EP/SP/66/12  
Integrated Waste Management Facilities, Phase 1  
Monthly EM&A Report No.9

## Monthly EM&A Report No.9 (Period from 1 March to 31 March 2019)

(Clause 3.3, Further Environmental Permit FEP-01/429/2012/A)

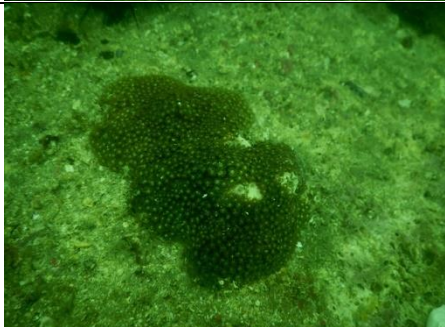
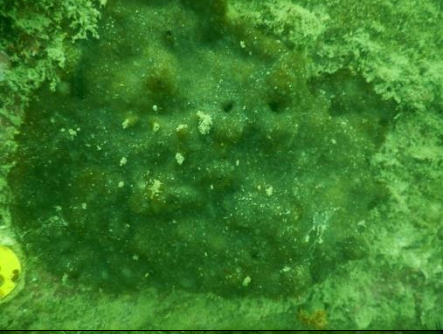
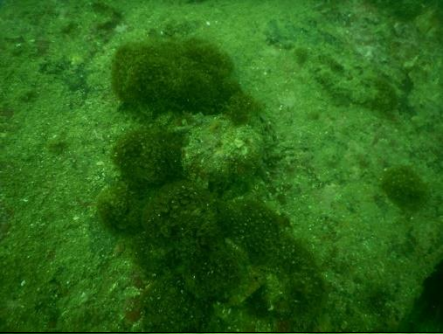
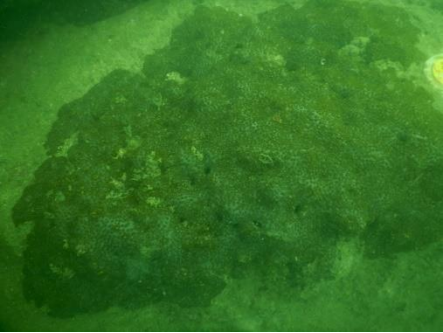
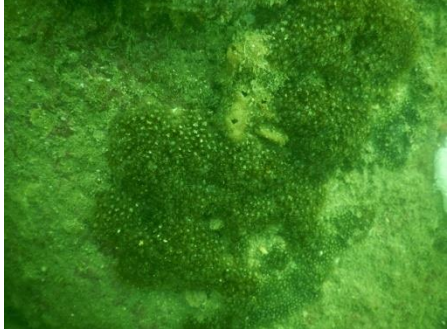
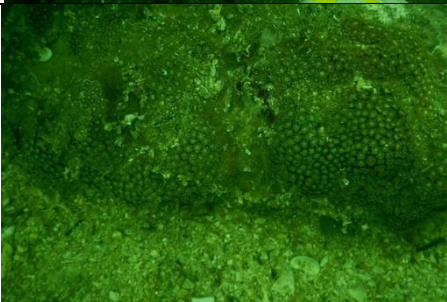
**Photo Plate 5.1 Ten (10) Monitored Corals at Control Site**

5.6.2 Ten (10) hard coral colonies were monitored at each Control site and Indirect Impact Site as suggested in the Construction Phase Monitoring Plan. The general health conditions (size, mortality, bleaching and sediment) were recorded and summarized in **Table 5.8** and **Table 5.9**. Photos of each coral colonies were taken during the monitoring activities shown in **Photo Plate 5.1** and **5.2**.

- 5.6.6 No sediment, bleaching or increased mortality in the general condition of coral colonies were observed during the first construction phase monitoring period. No deterioration of the coral community was observed in the ecological monitoring results when compared with the baseline ecological monitoring results. There is no AL/LL exceedance during the monitoring period. Photos of each tagged coral colonies were taken and shown in **Photo Plates 5.1** and **5.2**.

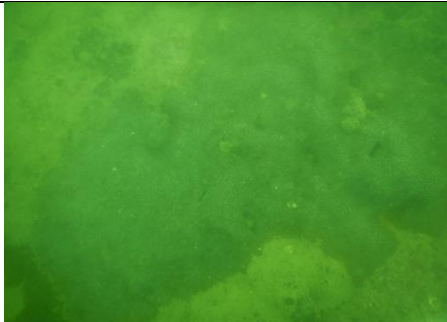
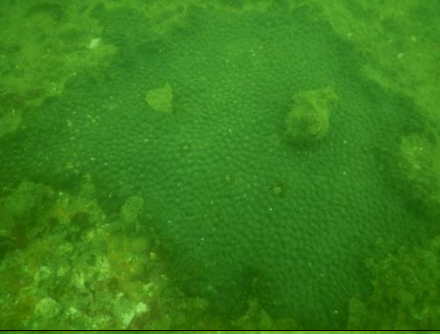
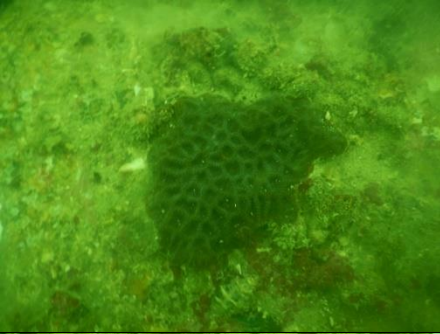
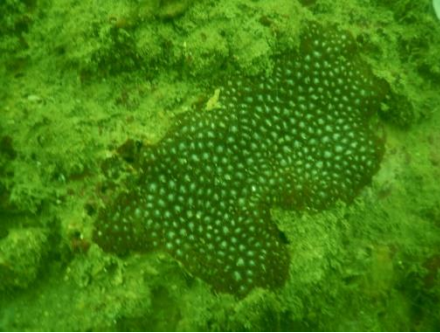
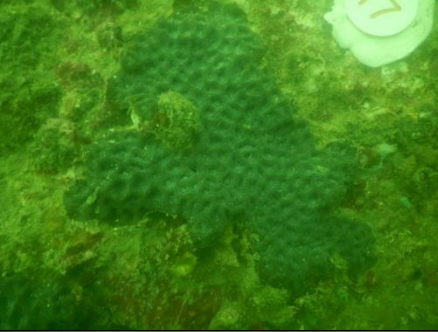
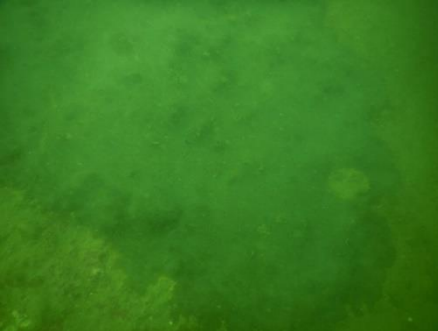
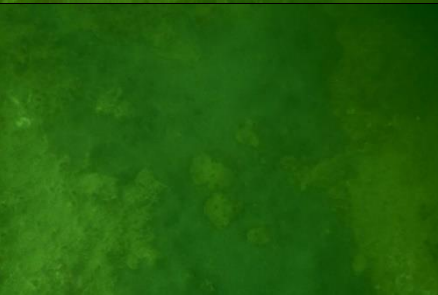
**Photo Plate 5.2 Ten (10) Monitored Corals at Indirect Impact Site**

- 5.6.5 The 1<sup>st</sup> quarterly coral monitoring during construction phase at both Indirect Impact Site and Control Site was carried out on 28 March 2019. A total of 20 tagged coral colonies (10 at control site and 10 at indirect impact site including the re-tagged coral colonies) were monitored. Similar to the baseline result, the health condition of all tagged coral colonies were good in general. No increased mortality was recorded during the survey.

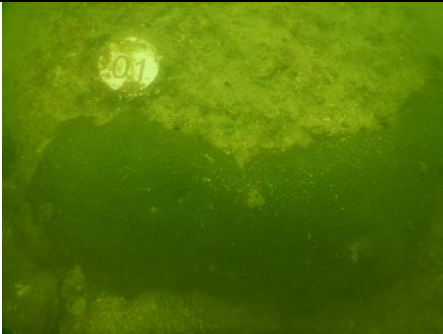
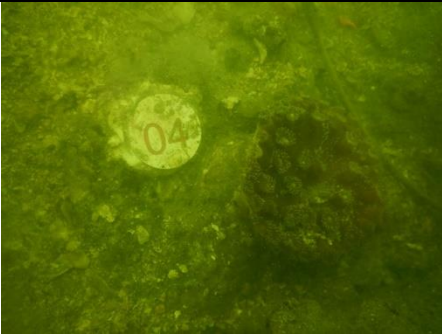
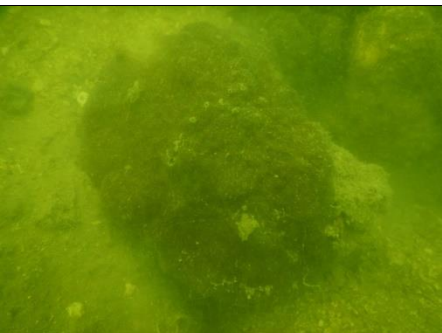
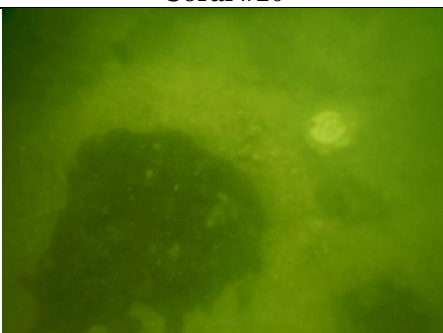
**Photo Plate 5.3 Seven (7) Translocated Corals at Recipient Site R3**

5.6.3 The 4<sup>th</sup> Post-Translocation Monitoring was conducted on 28 March 2019 for the Recipient Site R3 (Figure 5.3) and the weather conditions were summarized in **Table 5.10**. Seven (7) translocated and nine (9) natural hard coral colonies were remained to monitor after the typhoon Mangkhut in mid-September 2018. The general health conditions (size, condition, mortality, bleaching and sediment) at Recipient Site were recorded and summarized in **Table 5.11** and **Table 5.12** respectively. Photos of each tagged corals colonies were taken and shown in **Photo Plates 5.3** and **5.4**.

- 5.6.10 No sediment, bleaching or increased mortality in the general condition of coral colonies were observed during the monitoring period. No deterioration of the coral community was observed in the ecological monitoring results when compared with the baseline ecological monitoring results. There is no AL/LL exceedance during the monitoring period. Photos of each tagged translocated and natural corals were taken and shown in **Photo Plates 5.3** and **5.4**.

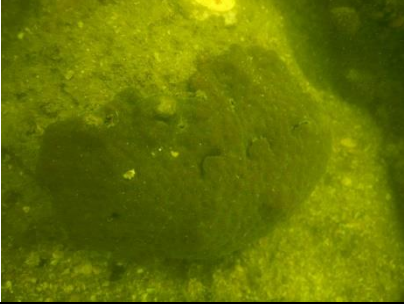
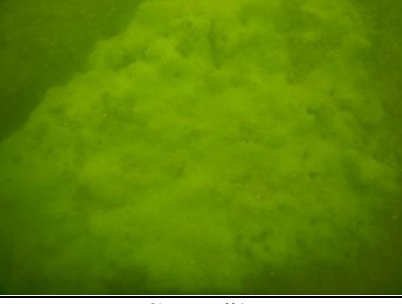
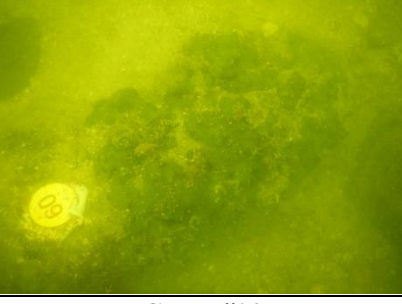
**Photo Plate 5.4      Nine (9) Nautral Control Corals at Recipient Site R3**

- 5.6.9 Remaining nine (9) natural hard coral colonies were also monitored at the recipient site as control and similar to the baseline result, all the natural coral colonies are all in good condition. No increased mortality was recorded during the survey.

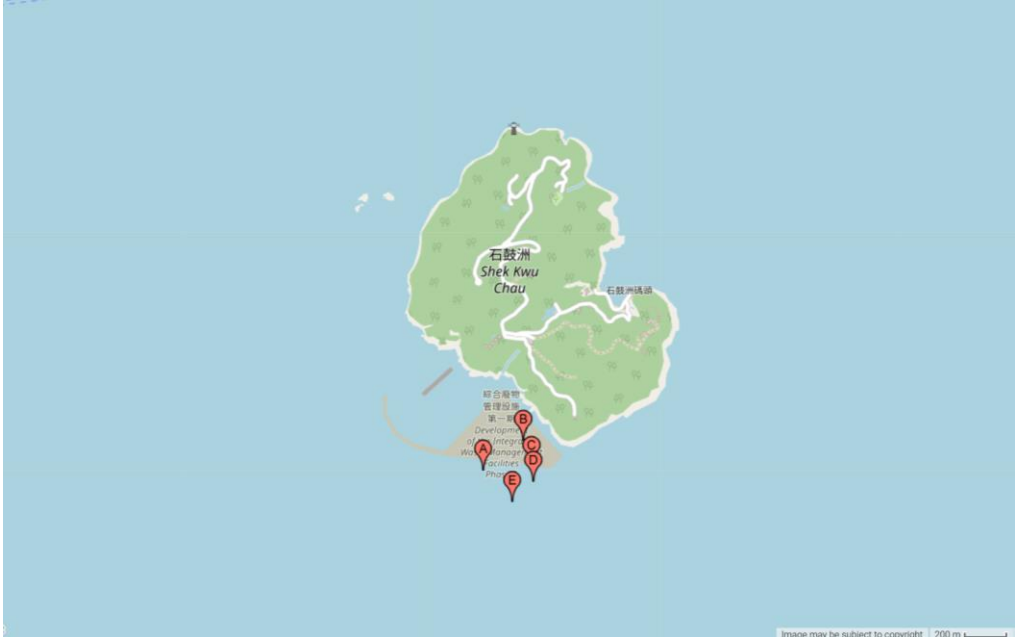
Project	Integrated Waste Management Facilities, Phase 1
Date	2 March 2019 (Lab result received on 6 March 2019)
Time	09:16 – 11:40 (Mid-Ebb)
Monitoring Location	Mid-Ebb I5 : A (N22°11.241 E113° 59.154) I6 : B (N22°11.318 E113° 59.264) I7 : C (N22°11.252 E113° 59.287) I9 : D (N22°11.213 E113° 59.292) I10 : E (N22°11.16 E113° 59.235)

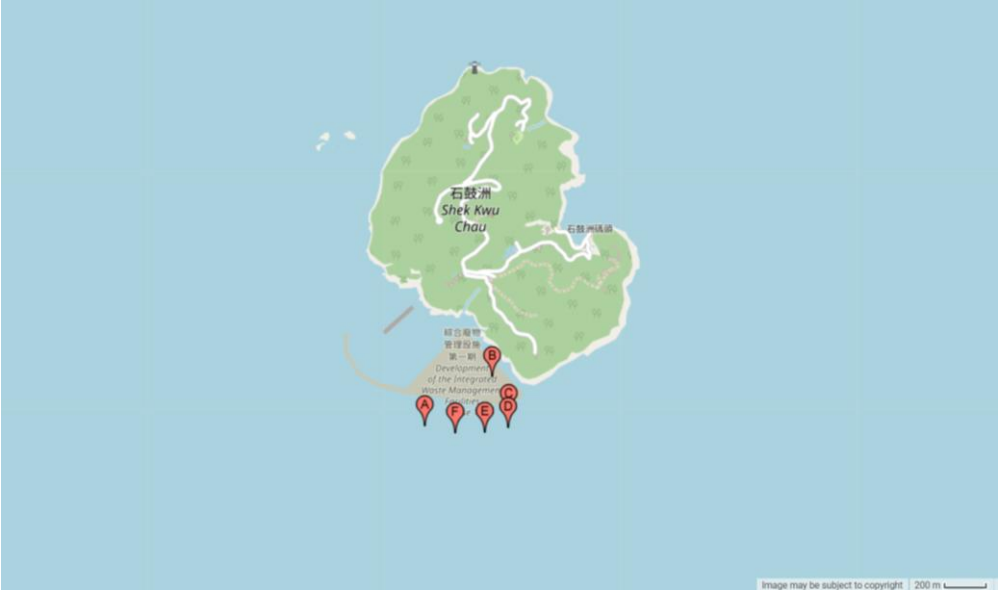
Project	Integrated Waste Management Facilities, Phase 1
Date	4 March 2019 (Lab result received on 7 March 2019)
Time	10:03 – 13:33 (Mid-Ebb) 15:07 – 18:37 (Mid-Flood)
Mid-Ebb	
Monitoring Location	<p>I5 : A (N22°11.197 E113° 59.101)                  I6 : B (N22°11.324 E113° 59.288)                  I7 : C (N22°11.225 E113° 59.334)                  I8 : D (N22°11.191 E113° 59.332)                  I9 : E (N22°11.180 E113° 59.266)                  I10 : F (N22°11.178 E113° 59.184)</p>

Parameter	Suspended Solid (SS)
Action & Limit Levels	Action Level
	Limit Level
	<p>≥ 6.1 mg/L (120% of average of UC1 &amp; UC2)</p> <p>≥ 6.6 mg/L (130% of average of UC1 &amp; UC2)</p>
Measurement Level	Impact Station(s) of Exceedance
	Control Stations
	<p>Impact Station(s) without Exceedance</p> <p>10.8 mg/L (I5) 7.3 mg/L (I6) 7.5 mg/L (I7) 10.0 mg/L (I8) 13.7 mg/L (I9) 9.5 mg/L (I10)</p> <p>5.5 mg/L (UC1) 4.7 mg/L (UC2)</p> <p>4.5 mg/L (I1) 5.8 mg/L (I2) 4.7 mg/L (I3) 3.8 mg/L (I4)</p>
Possible reason for Action or Limit Level Non-compliance	<p>Works schedule on site on 04/03 include laying of geotextile at caisson seawall area, laying of sand blanket at caisson seawall area, post cone penetration test works, DCM sample coring for DCM main works, DCM main works, laying of rocks material at static loading test area and levelling the formation of rubble mound of static loading test.</p> <p>Dominating sea current direction was found to be from Northwest to Southeast at waters around Shek Kwu Chau.</p> <p>From MMO monitoring records on 04/03, MMO teams were arranged to two DCM barges (ESC-61 &amp; ESC-62) and four derrick barges (Shun Tat D12, FTB-19, DL-5 &amp; GD-851) on that day while no deficiency of silt curtain was found before the start of construction activity.</p> <p>I5, I6, I7, I8, I9 &amp; I10 are located close to the work location within the Project site while silt curtain checking was implemented on DL-5 (10:30), GD-851 (13:15), FTB19 (09:00), ESC-62 (07:30) and ESC-61 (09:00) by the Contractor and checking results showed that no deficiency of silt curtain was found on that day. No sand blanket laying works scheduled on Shun Tat D12, Cheung Kee No.7 &amp; Kam Ying No.8 were carried out with referring to site diary on that day. It might suggest that the SS exceedance at I5, I6, I7, I8, I9 &amp; I10 are deemed to be unrelated to the Project.</p> <p>Site tidiness in the present barges in the Project site were checked during weekly site inspection on 04/03, where no major observation of improper site practice that might contribute to the increase in SS level was observed during the inspection.</p>

Actions taken / to be taken	Examination of environmental performance of the Project will be continued during the weekly inspection, and the Contractor is remained to implement all applicable mitigation measures as per the Updated EM&A Manual.
Mid-Flood	
Monitoring Location	<p>I1 : A (N22°11.340 E113° 58.979)</p> <p>I2 : B (N22°11.348 E113° 59.024)</p> <p>I3 : C (N22°11.394 E113° 59.043)</p> <p>I4 : D (N22°11.420 E113° 59.082)</p> <p>I5 : E (N22°11.454 E113° 59.068)</p> <p>I6 : F (N22°11.373 E113° 58.886)</p> <p>I7 : G (N22°11.394 E113° 58.958)</p> <p>I8 : H (N22°11.452 E113° 58.938)</p> <p>I9 : I (N22°11.472 E113° 58.926)</p> <p>I10 : J (N22°11.508 E113° 58.995)</p>

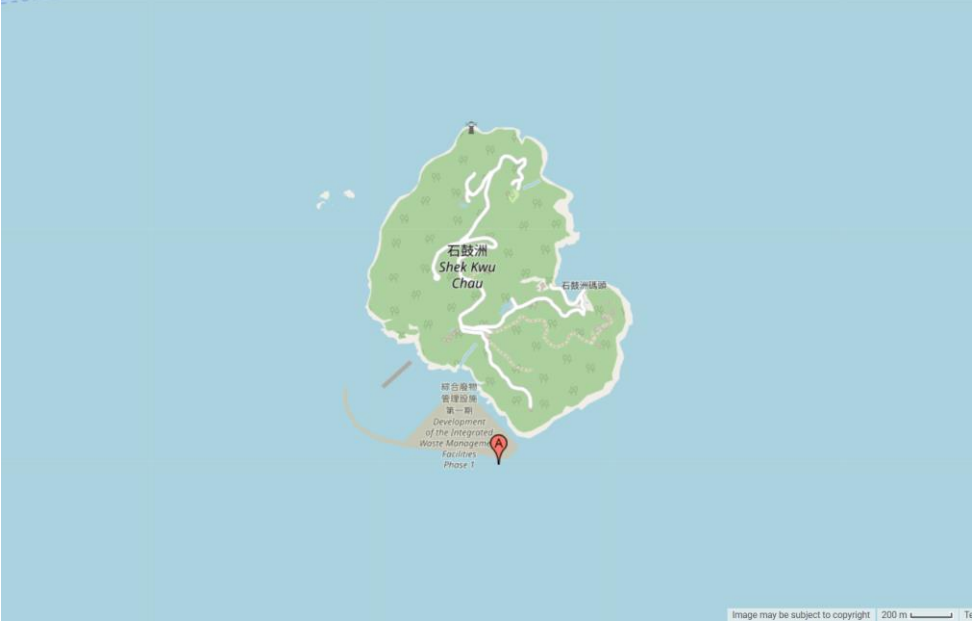
Project	Integrated Waste Management Facilities, Phase 1	
Date	6 March 2019 (Lab result received on 11 March 2019)	
Time	11:02 – 14:32 (Mid-Ebb) 16:37 – 19:00 (Mid-Flood)	
Mid-Ebb		
Monitoring Location	I8 : A (N22°11.232 E113°59.137)

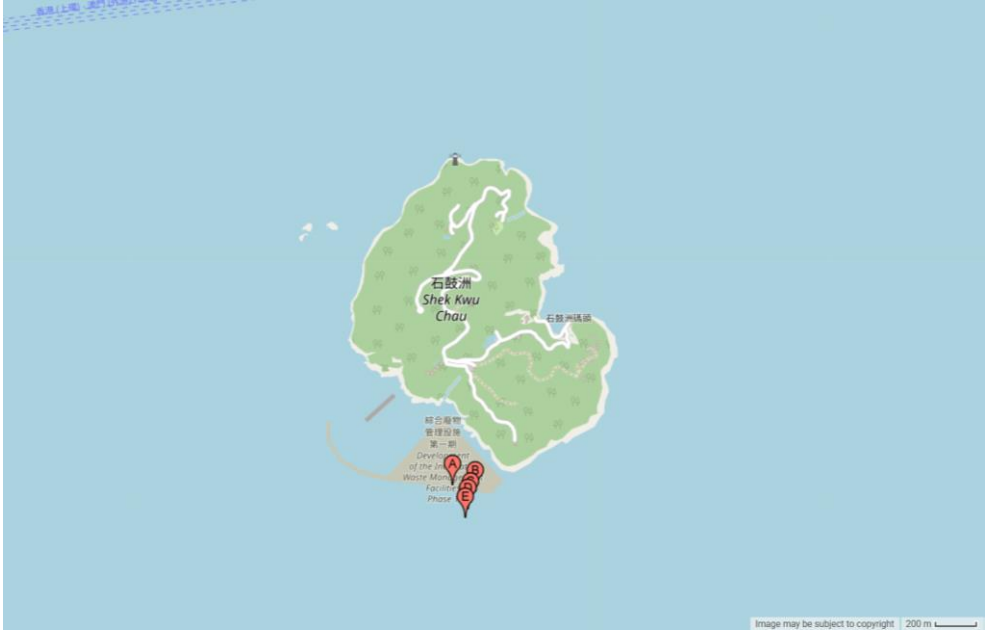
Project	Integrated Waste Management Facilities, Phase 1
Date	10 March 2019 (Lab result received on 13 March 2019)
Time	12:51 – 16:21 (Mid-Ebb)
Monitoring Location	<p style="text-align: center;">Mid-Ebb</p> <p>I2 : A (N22°11.241 E113° 59.154)                  I7 : B (N22°11.318 E113° 59.264)                  I8 : C (N22°11.252 E113° 59.287)                  I9 : D (N22°11.213 E113° 59.292)                  I10 : E (N22°11.16 E113° 59.235)</p>
