Contract No. EP/SP/66/12 Integrated Waste Management Facilities, Phase 1 17th Quarterly EM&A Report

Quarterly EM&A Report No.17 (Period from 1 July to 30 September 2022)

(Clause 3.3, Further Environmental Permit FEP-01/429/2012/A)

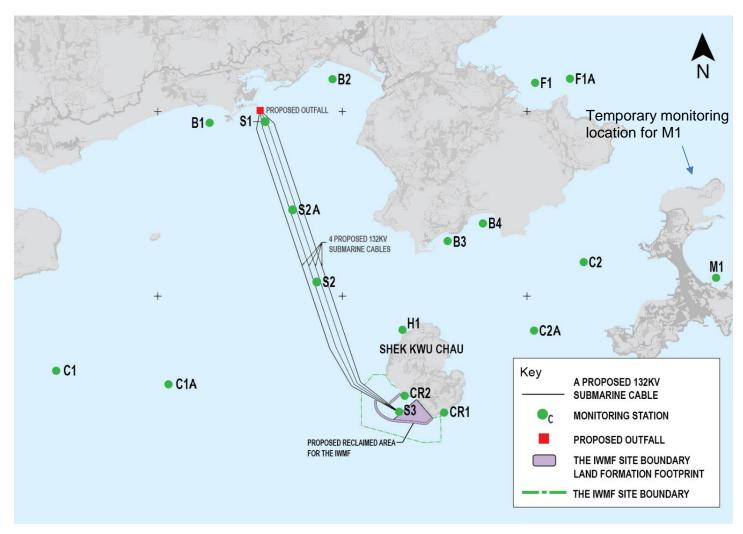
Figure 2.1 Water monitoring locations at Artificial Island near SKC

2.2.1 Impact water quality monitoring was conducted at eleven monitoring locations (i.e. B1-B4, H1, C1A, C2A, F1A, CR1, CR2 and M1) during general water quality monitoring as shown in **Figure 2.1**.

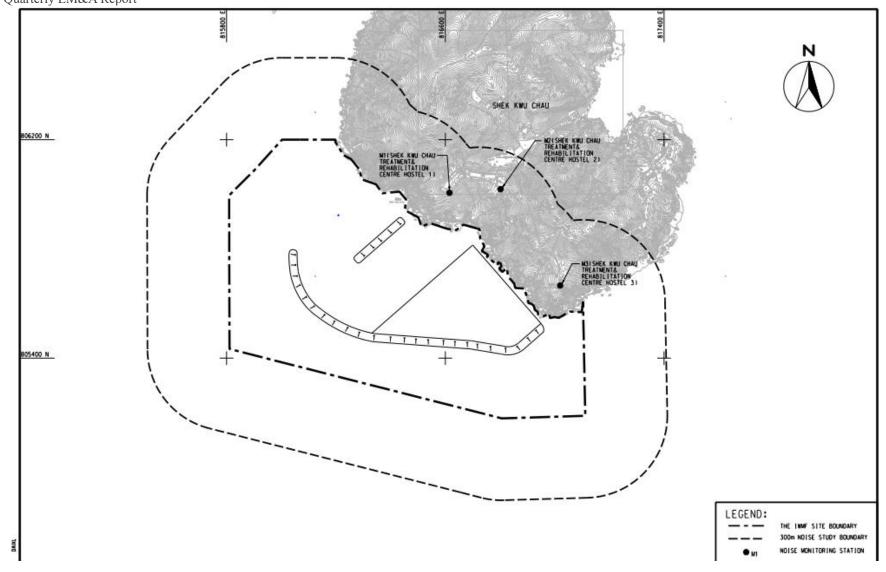
Figure 3.1 Noise monitoring locations at SKC

- 3.2 Noise Monitoring Locations
- 3.2.1 Three noise monitoring locations for impact monitoring and additional impact monitoring at the nearby sensitive receivers are shown in **Figure 3.1**

- 3.2.2 M1, M2 and M3 are Shek Kwu Chau Treatment and Rehabilitation Centre Hostel 1, 2 and 3 respectively of The Society for the Aid and Rehabilitation of Drug Abusers (SARDA) located at southern part of Shek Kwu Chau.

- 3.2.3 Measurements at M1 & M3 were conducted at a point 1m from the exterior of the sensitive receivers building façade and at a position 1.2m above the ground. Measurement setup at M3 has been varying with minor adjustment to minimize the disturbance to the users of Treatment Centre. Measurement at M2 was conducted at a point 1m from building façade of the ceiling of 1st floor level for avoidance of mutual disturbance with users of Treatment Centre. The minor adjustment of monitoring locations, which were in favour to mutual convenience with the users of Treatment Centre, were found with no effect on monitoring result based on on-site observation and experience from the Baseline monitoring of the Project.

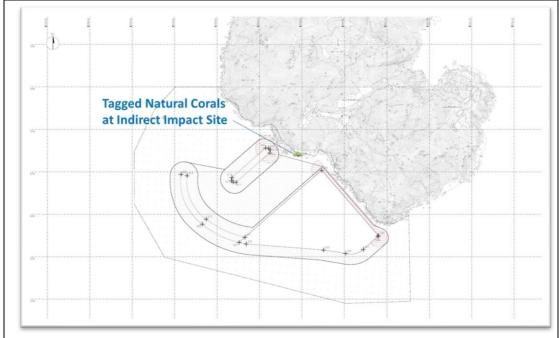
Figure 5.1 Tagged Natural Corals at Indirect Impact Site Near SKC for re-tagging after typhoon Mangkhut

Location of the ten tagged coral colonies at each of the proposed indirect impact site, control site, the recipient site R3 and REA transect at proposed indirect impact site are shown in **Figure 5.1**, **Figure 5.2** and **Figure 5.3** respectively:

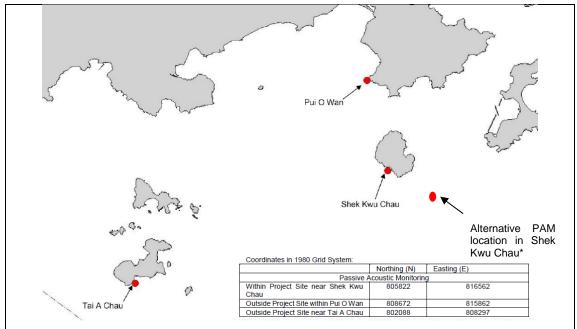
Figure 6.2 Locations of Passive Acoustic Monitoring

Finless Porpoise. During the construction period, the PAM survey will be conducted including placement of two passive porpoise detectors outside the Project Area as control site (i.e. within Pui O Wan and to the south of Tai A Chau) and one porpoise detector within the Project Area (i.e. near Shek Kwu Chau) as shown in **Figure 6.2** below.

Note*: The alternative PAM device adjacent to the Project site was deployed from 5 Mar to 11 Apr 2019, which contained a full 37 days acoustic monitoring data set. After the confirmation of loss of the original PAM within the Project site, this data set was proposed to replace that of the original one, as consulted with AFCD accordingly.

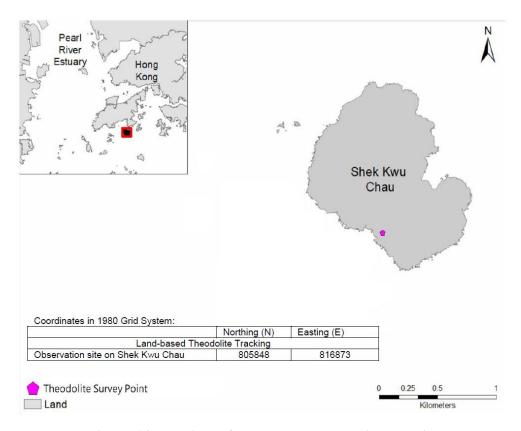
Figure 6.3 Locations of Land-based Theodolite Tracking

6.1.3.1 The Land-based Theodolite Tracking study would use the same station as in the AFCD monitoring study(same as the baseline monitoring location), which is situated at the southwest side of Shek Kwu Chau (GPS position: 22°11.47' N and 113°59.33' E) as shown in below **Figure 6.3**. The station was selected based on its height above sea level (at least 20 metres), close proximity to shore, and relatively unobstructed views of the entire Project Area to the southwest of Shek Kwu Chau. The height of the Shek Kwu Chau Station established by the HKCRP team is 74.6 m high at mean low water, and only a few hundred metres to the IWMF reclamation site, which is ideal for the purpose for the present behavioural and movement monitoring of finless porpoises as well during construction phase considering there as an un-obstructed vantage point at a height above the Project Site.

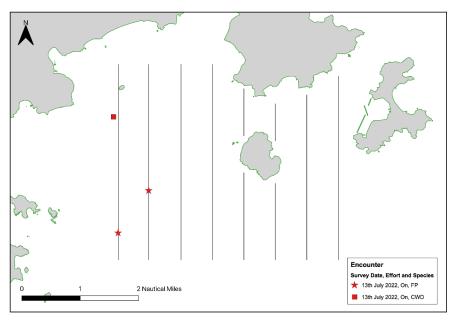
Figure 6.4 Location of sightings recorded during July to September 2022 Vesselbased Line-transect Survey

Date	Species	Sighting No.	Time	Group Size	PSD	Behaviour	Lat.	Long.	Area	Effort	Season
13 July 2022	Finless Porpoise	127	12:58	1	211	Unknow	22.18536	113.9543	SEL	On	Summer
13 July 2022	Chinese White Dolphin	128	13:24	1	157	Other	22.20642	113.9435	SEL	On	Summer
13 July 2022	Finless Porpoise	129	13:42	10	193	Other	22.17325	113.9449	SEL	On	Summer

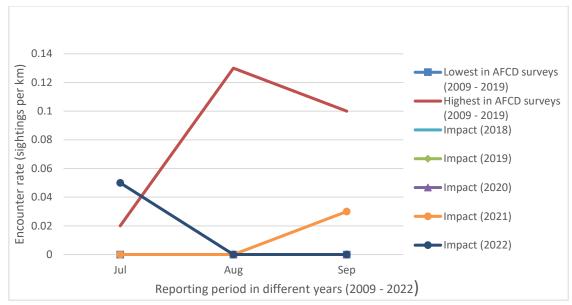
Figure 6.5 Plot of encounter rate during July to September in 2009 – 2022 from different surveys

- 6.3.1.2 A review of all the porpoise sightings in the survey area for July to September between 2009 and 2017 indicates that there are fluctuations between the number of sightings usually recorded in July while sighting was rarely recorded in August and September. Given the similar survey conditions and the encounter rate recorded for porpoise in the project area during the reporting period, the encounter rate for July to September 2022 were between 0.00km⁻¹ and 0.13km⁻¹ (see Figure 6.5), it is noted that the encounter rates of impact survey in July 2022 was higher when compared to other years. The encounter rate of impact survey in August 2022 was the same as the impact monitoring in 2018, 2019, 2020, 2021 and 2022. The encounter rate of impact survey in September 2022 was lower when compared to 2021. It is noted that the impact survey focuses on a relatively small populations of highly mobile individuals and the survey area conducted for this monitoring is very small. It is also noted that works for other projects in the area adjacent to this Project site have been intensified, therefore, they are likely impacting porpoise presence and behaviour.

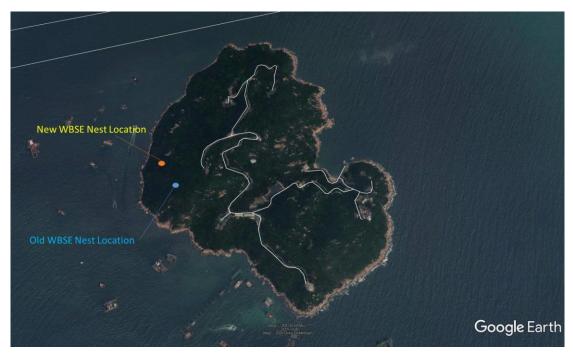
Figure 7.1 Location of WBSE Nest on SKC

- 7.2.2 Two adult WBSEs and one juvenile were recorded near Shek Kwu Chau area in the July and August 2022 and two adult WBSE were recorded near Shek Kwu Chau area in the September 2022. No abnormal behavior of the recorded adults and juvenile during the July and September 2022 construction phase monitoring. All marine works during the monitoring period did not show any impact to the WBSE.
- 7.2.3 No disturbances from anthropogenic activities on the island were recorded during the monitoring survey. No invasion of other fauna species was recorded as well.
