Contract No. EP/SP/66/12
Integrated Waste Management Facilities, Phase 1
19th Quarterly EM&A Report

Quarterly EM&A Report No.19 (Period from 1 January to 31 March 2023)

(Clause 3.3, Further Environmental Permit FEP-01/429/2012/A)

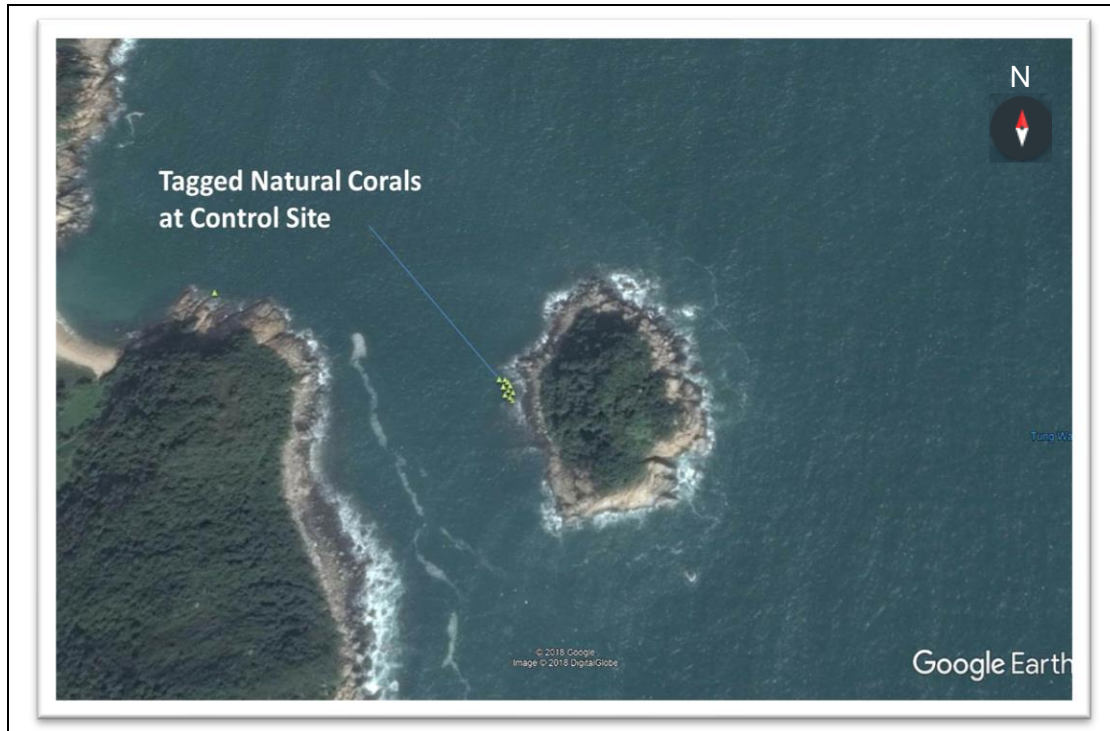
Figure 5.2 Tagged Natural Corals at Control Site Near Yuen Kong Chau for re-tagging after typhoon Mangkhut

Location of the ten tagged coral colonies at each of the proposed indirect impact site, control site, the recipient site R3 and REA transect at proposed indirect impact site are shown in **Figure 5.1**, **Figure 5.2** and **Figure 5.3** respectively:
