Contract No. EP/SP/66/12
Integrated Waste Management Facilities, Phase 1
4th Quarterly EM&A Report

Quarterly EM&A Report No.4 (Period from 1 April to 30 June 2019)

(Clause 3.3, Further Environmental Permit FEP-01/429/2012/A)

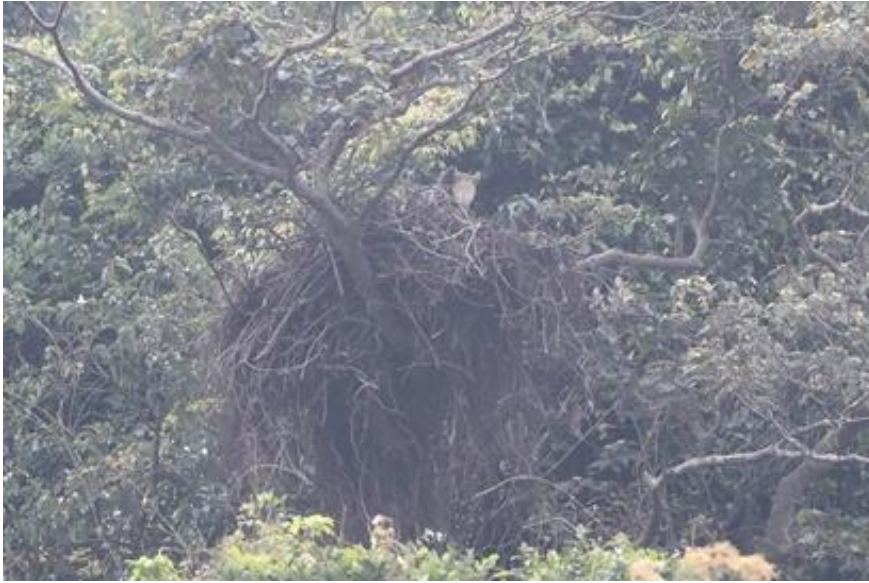
WBSE adult staying on the tree

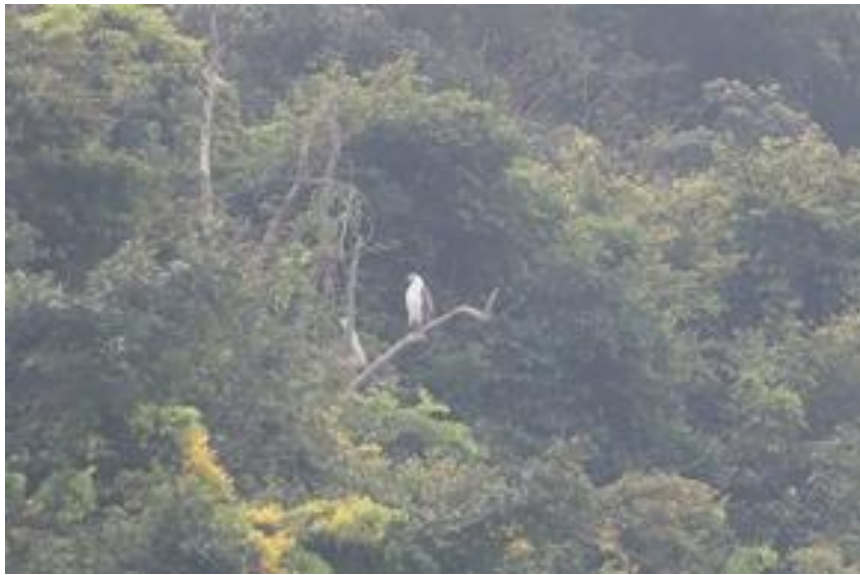
Adult WBSE Staying at the Area next to its Nest

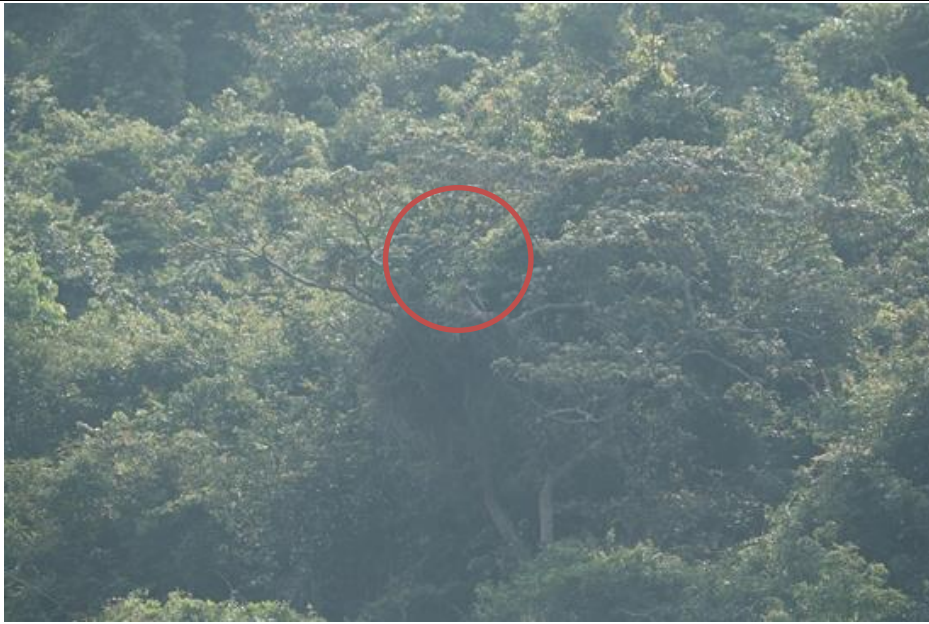
WBSE Chick Staying in the Nest

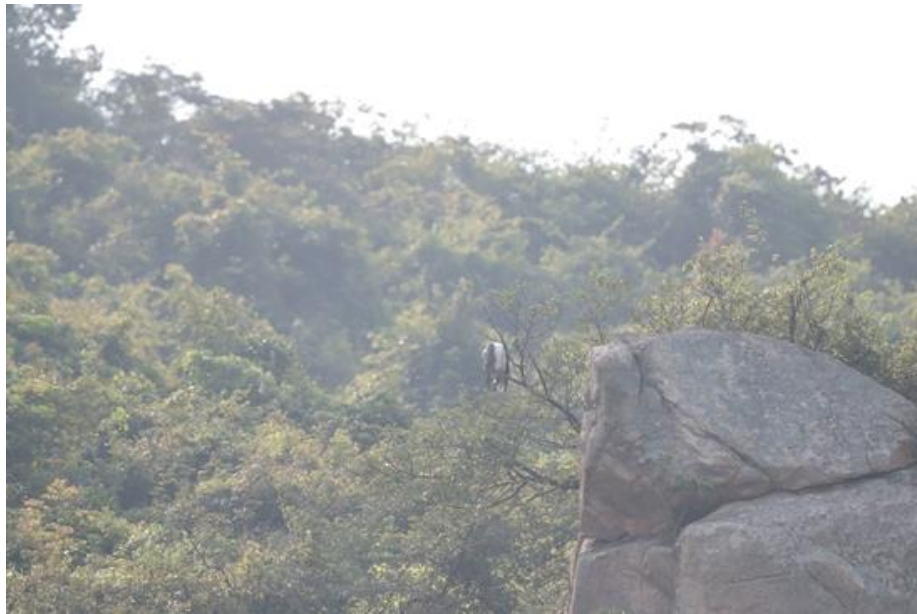
Adult WBSE staying at the Area next to its nest

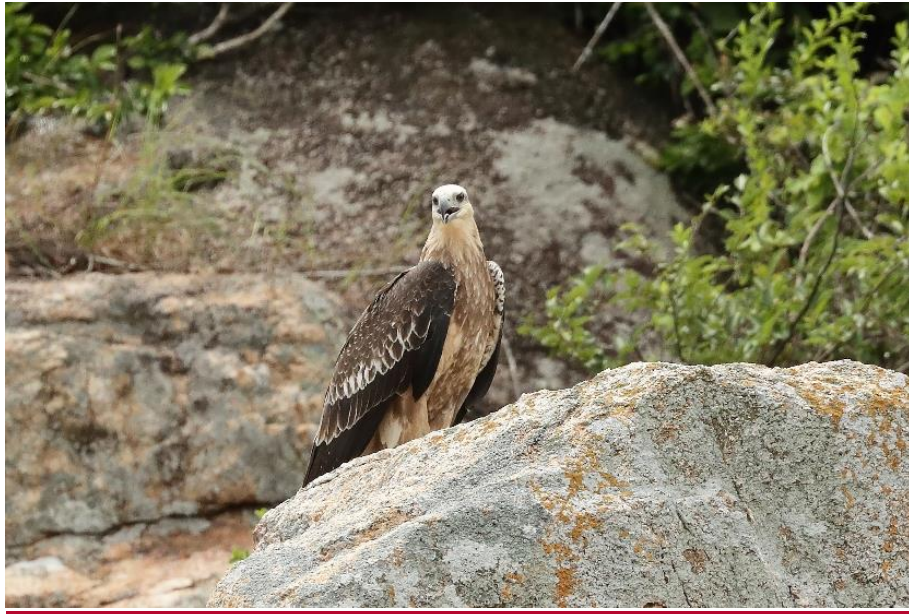
BSE chick staying on a big rock next to the nest

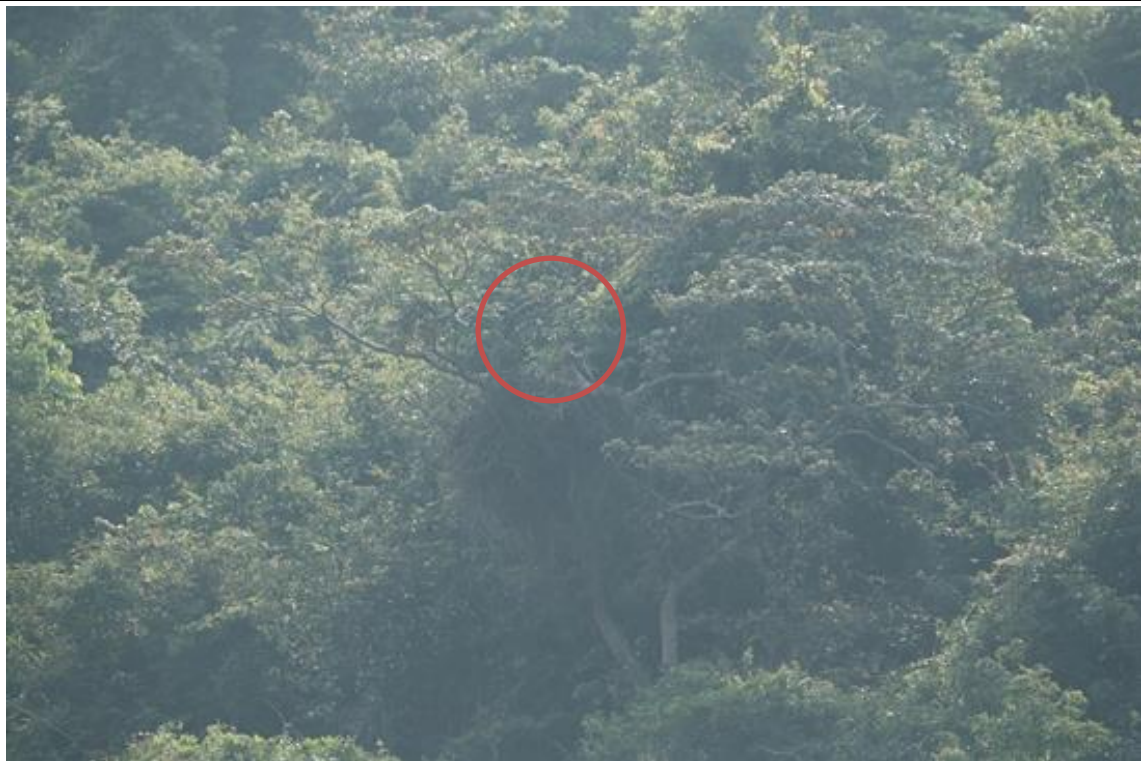
WBSE Chick Staying in the Nest
