Contract No. EP/SP/66/12  
Integrated Waste Management Facilities, Phase 1  
4<sup>th</sup> Quarterly EM&A Report

## Quarterly EM&A Report No.4 (Period from 1 April to 30 June 2019)

(Clause 3.3, Further Environmental Permit FEP-01/429/2012/A)

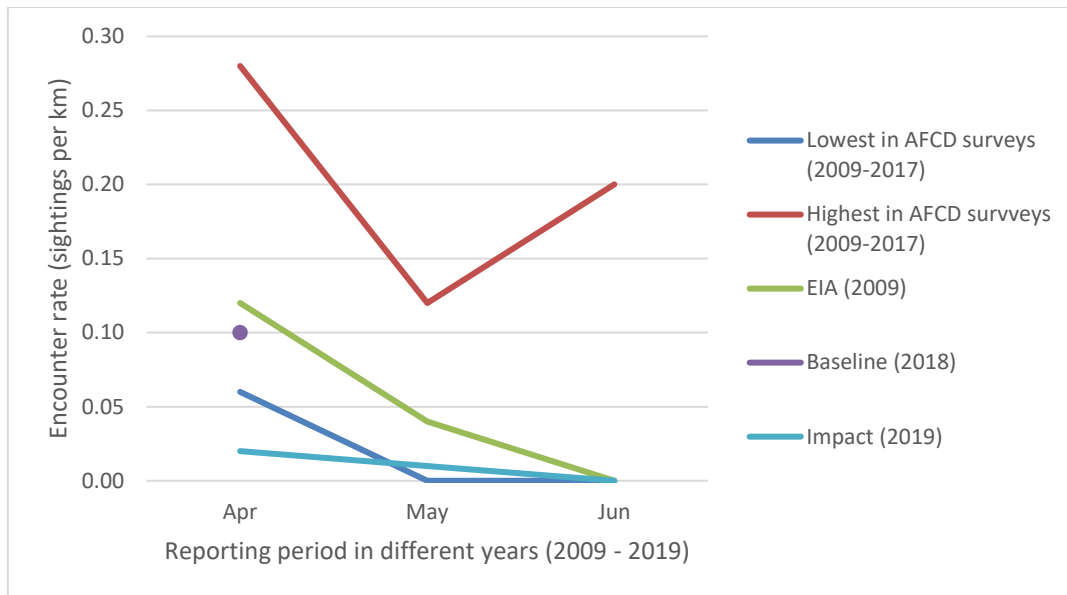
**Figure 6.5 Plot of encounter rate during April to June in 2009 – 2019 from different surveys**

6.3.1.4 A review of all the porpoise sightings in the survey area for April to June between 2009-2018 indicates that there are fluctuations between the number of sightings usually recorded in April to June. Given the similar survey conditions and the encounter rate recorded for porpoise in the project area during the reporting period, the encounter rate for April to June 2019 were  $0.02\text{km}^{-1}$ ,  $0.01\text{km}^{-1}$  and  $0\text{km}^{-1}$  respectively (see **Figure 6.5**), it is noted that the encounter rate of impact survey is low when compared to other years and other survey types April survey. It is noted that the peak season of finless porpoise is coming to an end and that works at IWMF are increasing, both which may impact encounter rates. It is also noted that the impact survey focuses on a relatively small populations of highly mobile individuals and the survey area conducted for this monitoring is very small. For June 2019, there were no recorded sightings, as was the case in 2013, 2016 and 2017 of AFCD long term monitoring data.
