翠谷工程有限公司 Green Valley Landfill, Limited

### South East New Territories (SENT) Landfill Extension

Monthly Environmental Monitoring & Audit Report No.13 for January 2020

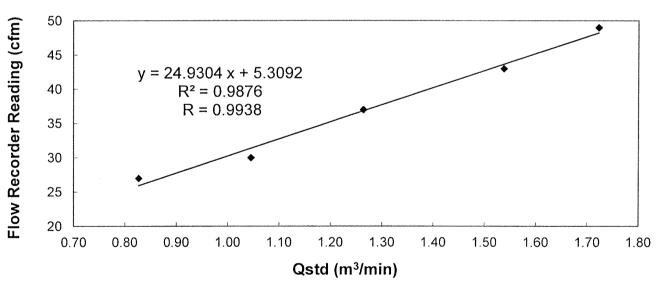
### Sampler 9795 Calibration Curve Site: Tseung Kwan O 137 (TKO-A1)

Manufacturer	:	Graseby 105	Date of Calibrati			20 De	ecember 20	19
Serial No.	÷	9795 (ET/EA/003/18)	Calibration Du	e Date	:	19 Fe	bruary 2020	)
Method	:	Five-point calibration by using standard Operations Manual	Five-point calibration by using standard calibration kit Tisch TE-5025A refer to the Operations Manual					
Results		Flow recorder reading (cfm)	49	43		37	30	27
		Qstd (Actual flow rate, m <sup>3</sup> /min)	1.72	1.54	1	.26	1.05	0.83
		Pressure : 765.81 mm H	⊣g	Temp. :	2	92	к

Acceptance Criteria : Correlation coefficient (r) of the calibration curve greater than 0.990 after a 5-point calibration

The high volume sampler complies\* / does not comply\* with the specified requirements and is deemed acceptable\*/ unacceptable\* for use.

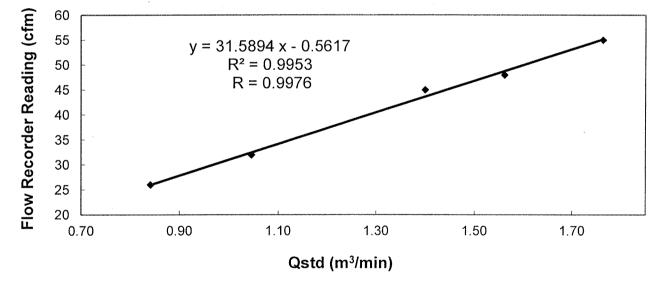
### Sampler 1176 Calibration Curve Site: Tseung Kwan O 137 (TKO-A2a)

High Volume Air Sampler											
Manufacturer	:	Andersen G1051	Date of Calib	ration	•	20 De	ecember 20	19			
Serial No.	:	1176 (ET / EA / 003 / 05) Calibration Due Date : 19 February 2020									
Method	:	Based on Operations Manual for the 5- manufactured by Tisch TE-5025 A	-point calibratio	on using st	and	ard ca	libration kit				
Results	:	Flow recorder reading (cfm)	55	48		45	32	26			
		Qstd (Actual flow rate, m <sup>3</sup> /min)	1.76	1.56		1.40	1.05	0.84			
		Pressure : 765.81 mm	Hg	Temp. :		292	К

Acceptance Criteria : Correlation coefficient (r) of the calibration curve greater than 0.990 after a 5-point calibration

The high volume sampler complies\* / does not comply\* with the specified requirements and is deemed acceptable\* / unacceptable \* for use.

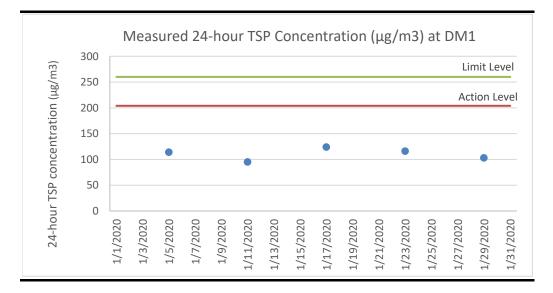
Figure D2.1 Graphical Presentation for 24-hr TSP Monitoring at DM1

According to the updated EM&A Manual of the Project, impact air quality monitoring (dust, in term of Total Suspended Particulates (TSP)) was carried out at the two designated monitoring locations (i.e. DM1 and DM2) at a 6-day interval. As there are two existing TSP monitoring stations (i.e. TKO-A1 and TKO-A2a) currently operating by the Civil Engineering and Development Department (CEDD) to monitor the 24-hour TSP levels at the proposed dust monitoring stations for the SENTX, it is considered that the CEDD monitoring data can represent the dust condition of the SENTX during the construction phase.

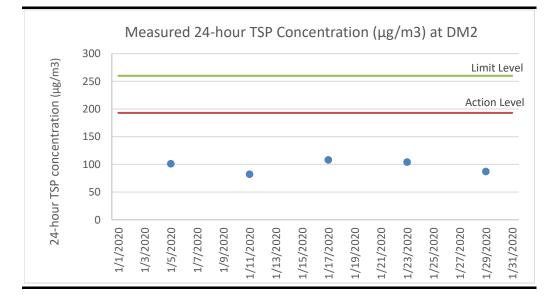
### Figure D2.2 Graphical Presentation for 24-hr TSP Monitoring at DM2

Start Date	Start Time	Finish Date	Finish Time	Weather	24-hour TSP (µg/m3)
5 Jan 20	8:30	6 Jan 20	8:30	Cloudy	101
11 Jan 20	8:00	12 Jan 20	8:00	Fine	82
17 Jan 20	15:30	18 Jan 20	15:30	Cloudy	108
23 Jan 20	8:00	24 Jan 20	8:00	Fine	104
29 Jan 20	9:45	30 Jan 20	9:45	Fine	87
				Average	96
				Min	82
				Max	108
Note:					
	mondo to the	wisting TCD a	anitaring stati	on TKO Ala	urrently operating

DM2 corresponds to the existing TSP monitoring station TKO-A2a currently operating by CEDD.

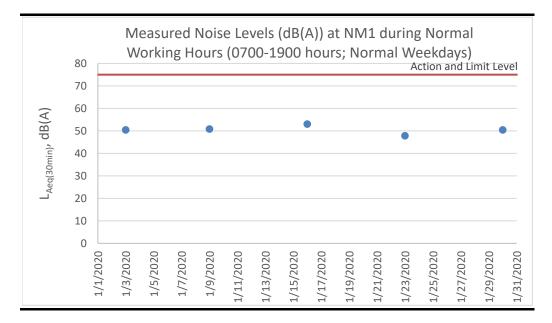
Figure E2.1 Graphical Presentation for Noise Monitoring at NM1

Table E2.1Measured Noise Levels (dB(A)) at NM1 during Normal Working Hours (0700-<br/>1900 hours; Normal Weekdays)
