South East New Territories (SENT) Landfill Extension

Monthly Environmental Monitoring & Audit Report No.43

for July 2022

Monthly Environmental Monitoring & Audit Report for July 2022

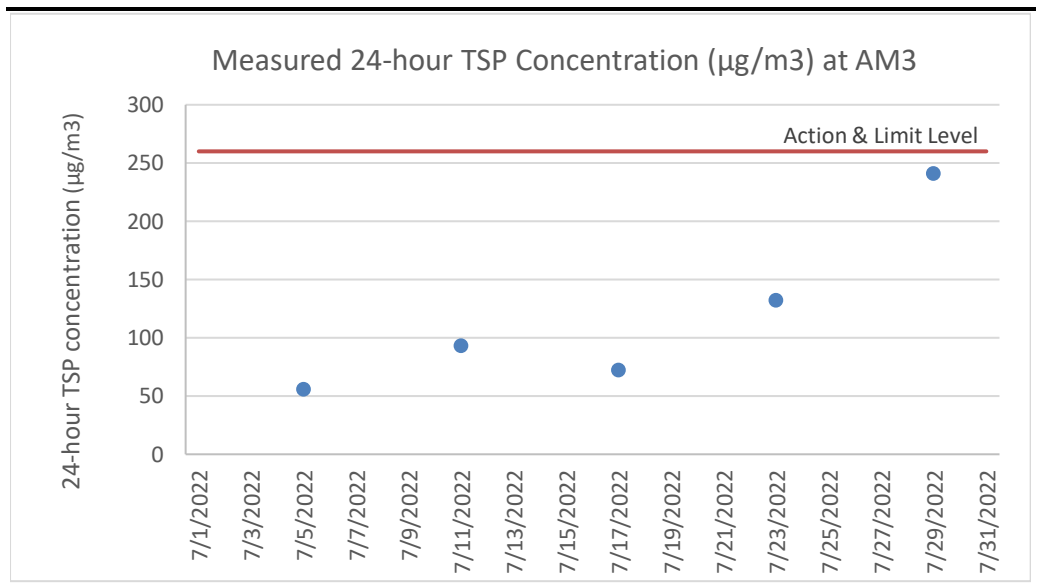
Figure D2.3 Graphical Presentation for 24-hr TSP Monitoring at AM3

Start Date	Start Time	Finish Date	Finish Time	Weather	24-hour TSP ($\mu\text{g}/\text{m}^3$)
5 Jul 22	9:00	6 Jul 22	8:43	Fine	56
11 Jul 22	9:00	12 Jul 22	8:14	Fine	93
17 Jul 22	9:00	18 Jul 22	9:32	Fine	72
23 Jul 22	9:00	24 Jul 22	8:33	Sunny	132
29 Jul 22	9:00	30 Jul 22	9:34	Sunny	241
Average					119
Min					56
Max					241
