## South East New Territories (SENT) Landfill Extension

Monthly Environmental Monitoring & Audit Report No.45  
for September 2022

# South East New Territories (SENT) Landfill Extension

## Monthly Environmental Monitoring & Audit Report for September 2022

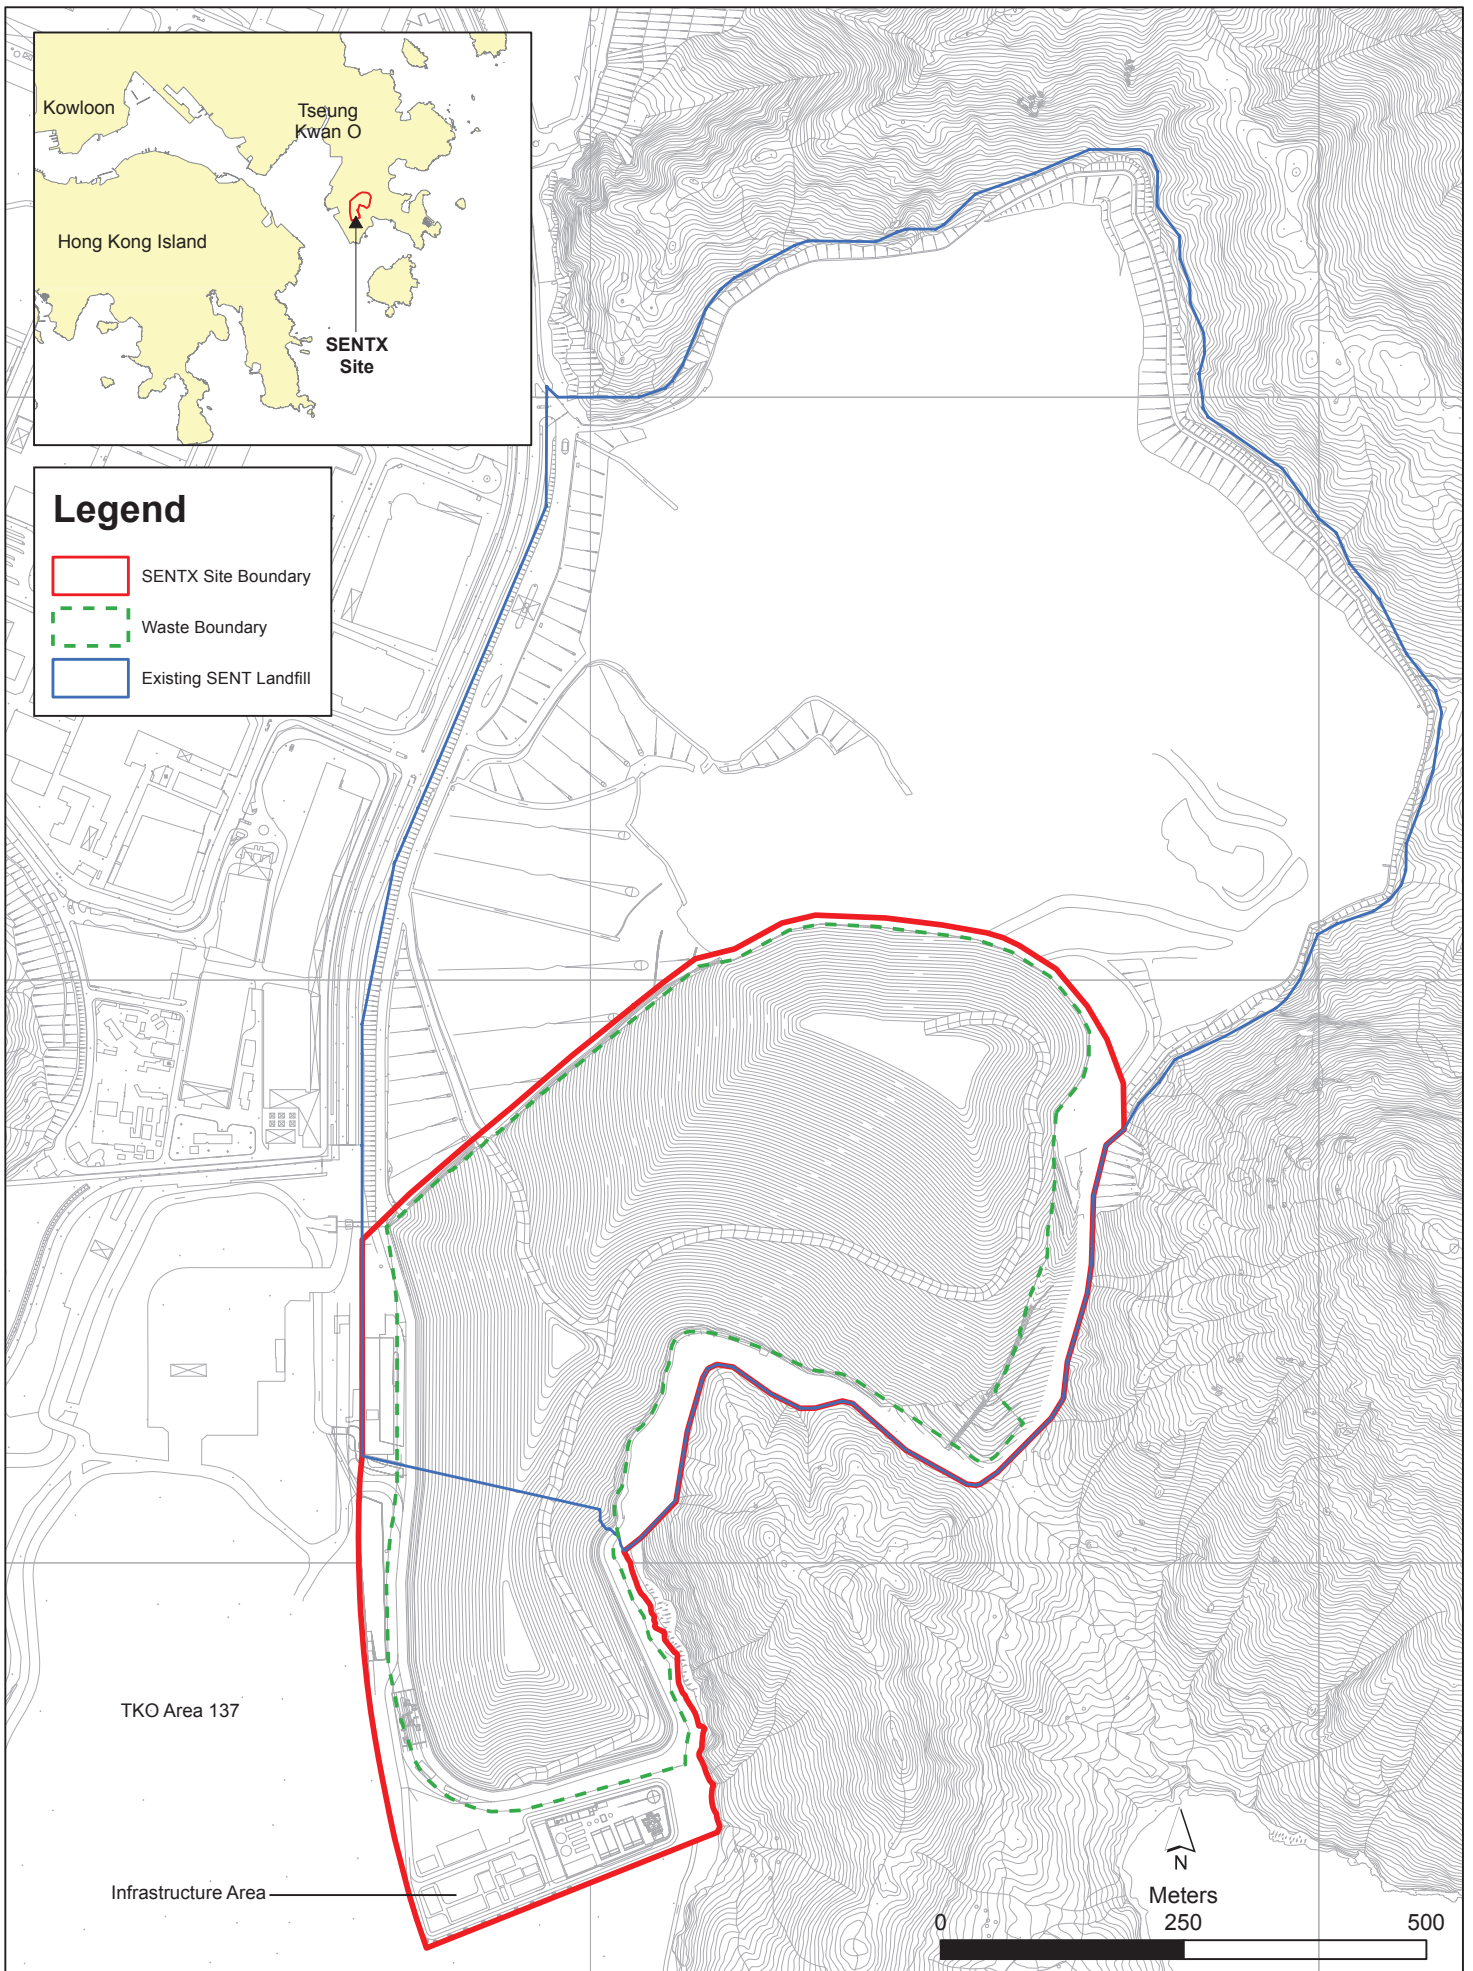
Figure 1.1

Layout Plan of SENTX
