South East New Territories (SENT) Landfill Extension

Monthly Environmental Monitoring & Audit Report No.49
for January 2023

May 2023

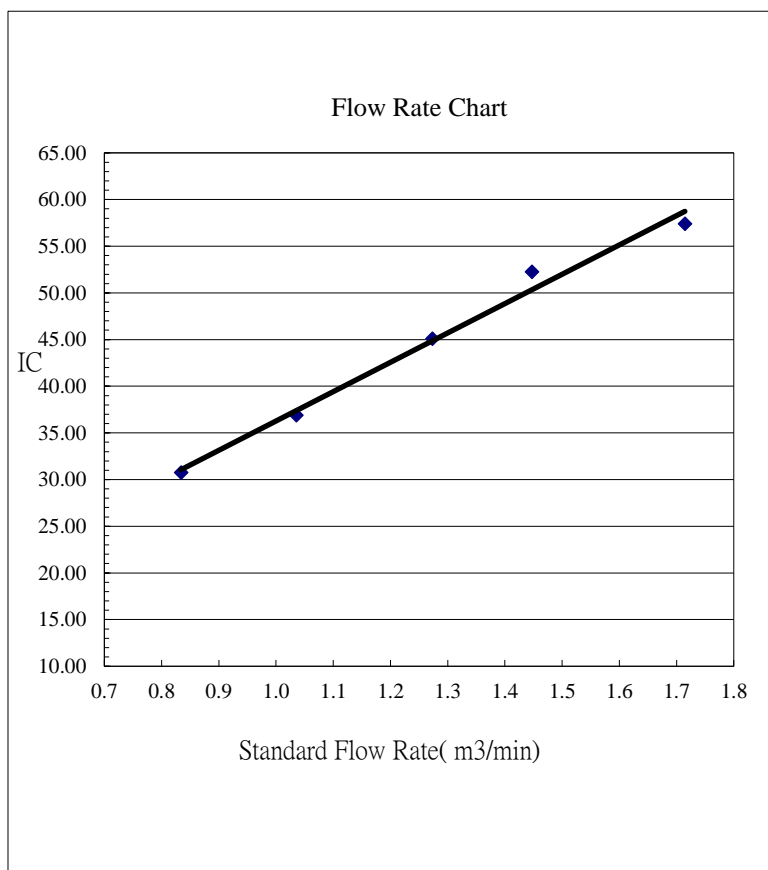
TSP SAMPLER CALIBRATION CALCULATION SPREADSHEET

Location ID: AM2	Date of Calibration:	30-Dec-22
Name and Model : TISCH HVS Model TE-5170	Next Calibration Date:	30-Mar-23
	Operator:	P.F.Yeung

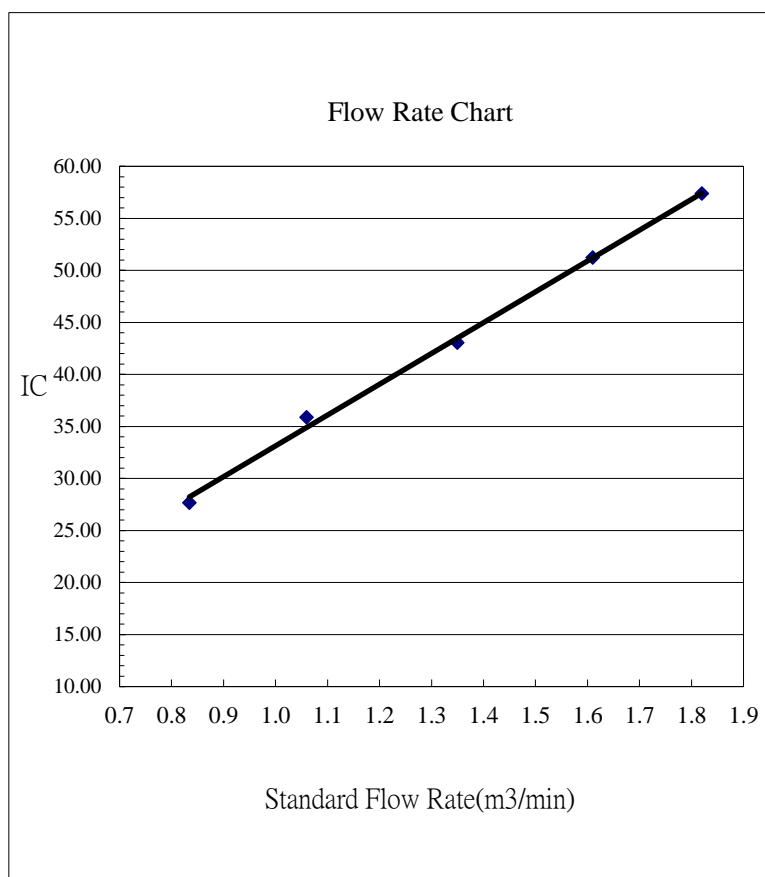
TSP SAMPLER CALIBRATION CALCULATION SPREADSHEET

Location ID: AM3	Date of Calibration:	30-Dec-22
Name and Model : TISCH HVS Model TE-5170	Next Calibration Date:	30-Mar-23
	Operator:	P.F.Yeung

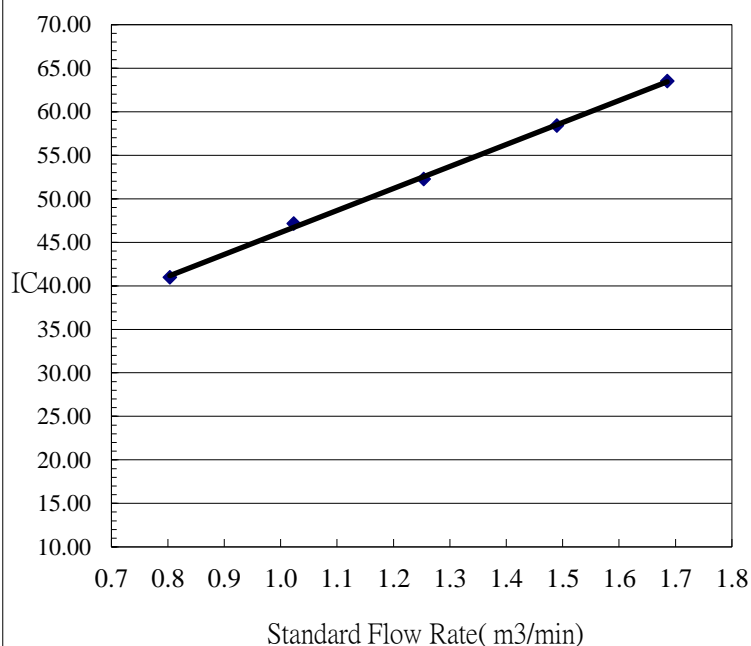
TSP SAMPLER CALIBRATION CALCULATION SPREADSHEET

Location ID: AM4	Date of Calibration:	30-Dec-22
Name and Model : TISCH HVS Model TE-5170	Next Calibration Date:	30-Mar-23
	Operator:	P.F.Yeung

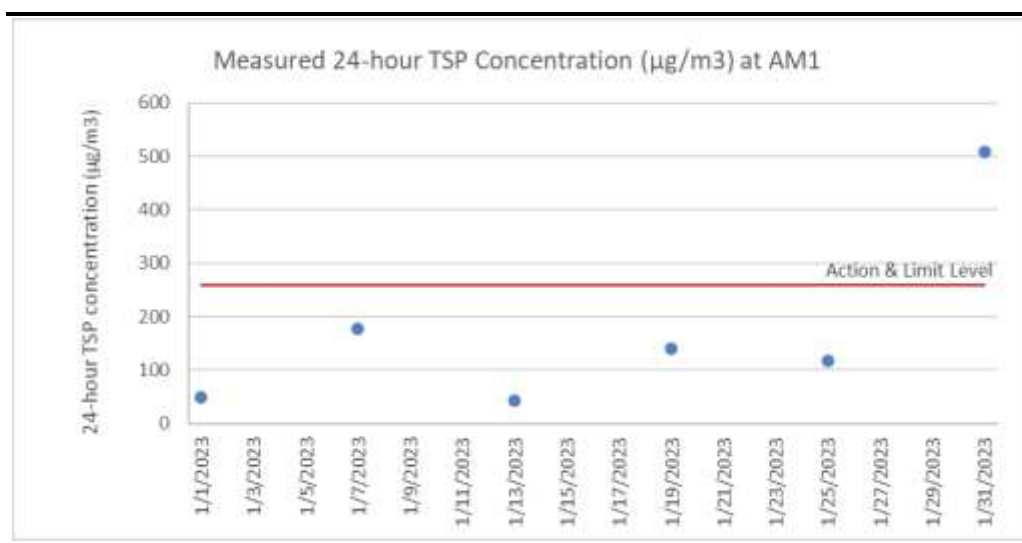
Start Date	Start Time	Finish Date	Finish Time	Weather	24-hour TSP ($\mu\text{g}/\text{m}^3$)
1 Jan 23	8:00	2 Jan 23	7:33	Sunny	50
7 Jan 23	8:00	8 Jan 23	7:37	Cloudy	178
13 Jan 23	8:00	14 Jan 23	7:48	Cloudy	43
19 Jan 23	8:00	20 Jan 23	7:36	Cloudy	140
25 Jan 23	8:00	26 Jan 23	8:06	Cloudy	118
31 Jan 23	8:00	1 Feb 23	7:48	Sunny	509
Average					173
Min					43
Max					509

Figure D2.1 Graphical Presentation for 24-hr TSP Monitoring at AM1

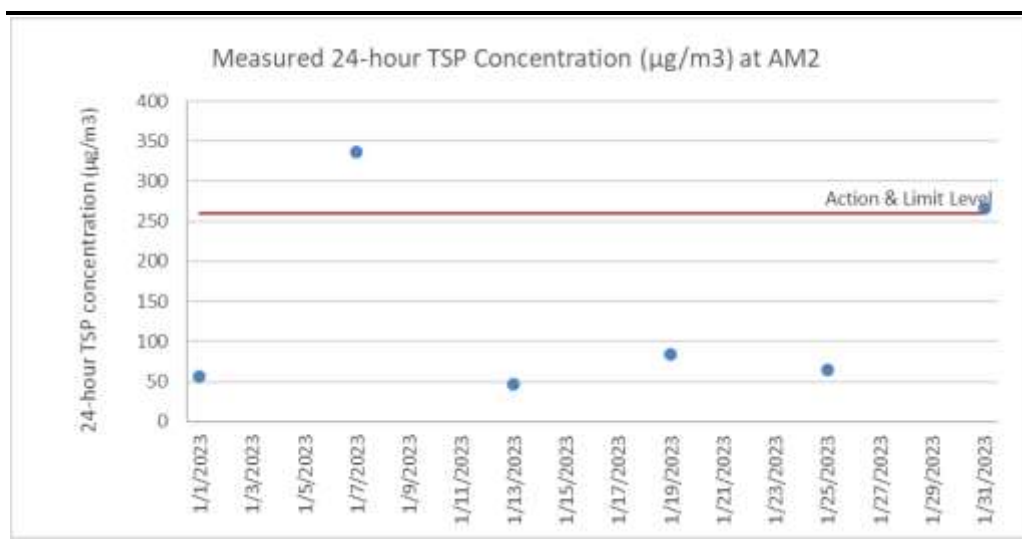
Start Date	Start Time	Finish Date	Finish Time	Weather	24-hour TSP ($\mu\text{g}/\text{m}^3$)
1 Jan 23	8:00	2 Jan 23	7:42	Sunny	56
7 Jan 23	8:00	8 Jan 23	7:38	Cloudy	337
13 Jan 23	8:00	14 Jan 23	7:58	Cloudy	47
19 Jan 23	8:00	20 Jan 23	7:33	Cloudy	84
25 Jan 23	8:00	26 Jan 23	7:39	Cloudy	64
31 Jan 23	8:00	1 Feb 23	7:33	Sunny	266
Average					142
Min					47
Max					337

Figure D2.2 Graphical Presentation for 24-hr TSP Monitoring at AM2

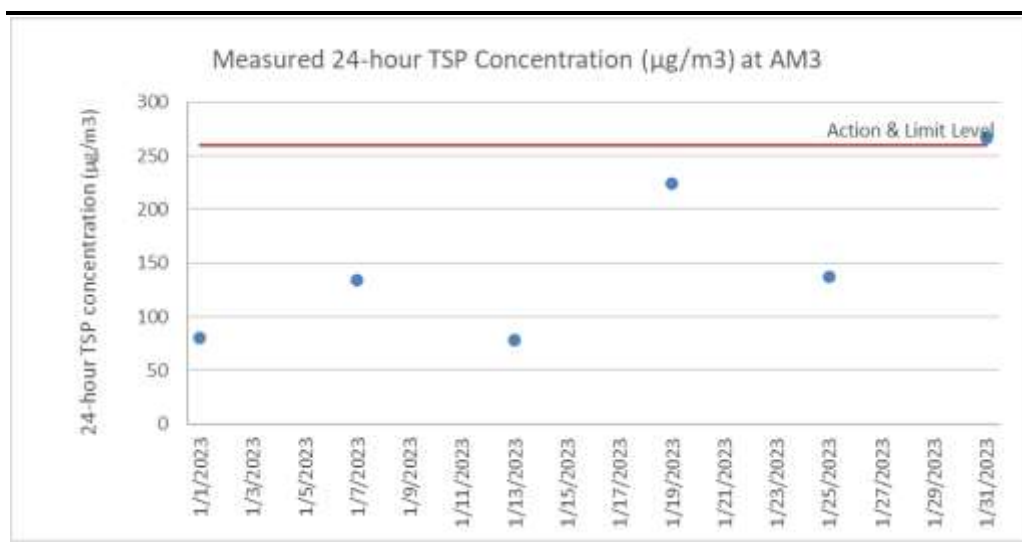
Start Date	Start Time	Finish Date	Finish Time	Weather	24-hour TSP ($\mu\text{g}/\text{m}^3$)
1 Jan 23	8:00	2 Jan 23	7:44	Sunny	80
7 Jan 23	8:00	8 Jan 23	7:52	Cloudy	134
13 Jan 23	8:00	14 Jan 23	7:55	Cloudy	78
19 Jan 23	8:00	20 Jan 23	7:33	Cloudy	224
25 Jan 23	8:00	26 Jan 23	7:42	Cloudy	137
31 Jan 23	8:00	1 Feb 23	7:45	Sunny	267
Average					153
Min					78
Max					267

Figure D2.3 Graphical Presentation for 24-hr TSP Monitoring at AM3

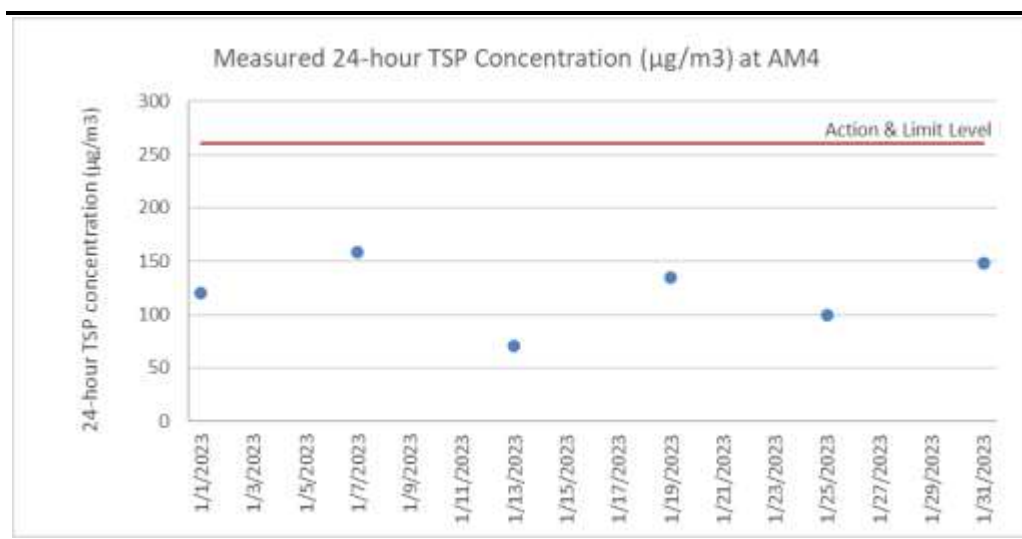
Start Date	Start Time	Finish Date	Finish Time	Weather	24-hour TSP ($\mu\text{g}/\text{m}^3$)
1 Jan 23	8:00	2 Jan 23	7:38	Sunny	120
7 Jan 23	8:00	8 Jan 23	7:52	Cloudy	158
13 Jan 23	8:00	14 Jan 23	7:37	Cloudy	71
19 Jan 23	8:00	20 Jan 23	7:41	Cloudy	135
25 Jan 23	8:00	26 Jan 23	7:51	Cloudy	100
31 Jan 23	8:00	1 Feb 23	7:36	Sunny	148
Average					122
Min					71
Max					158

Figure D2.4 Graphical Presentation for 24-hr TSP Monitoring at AM4

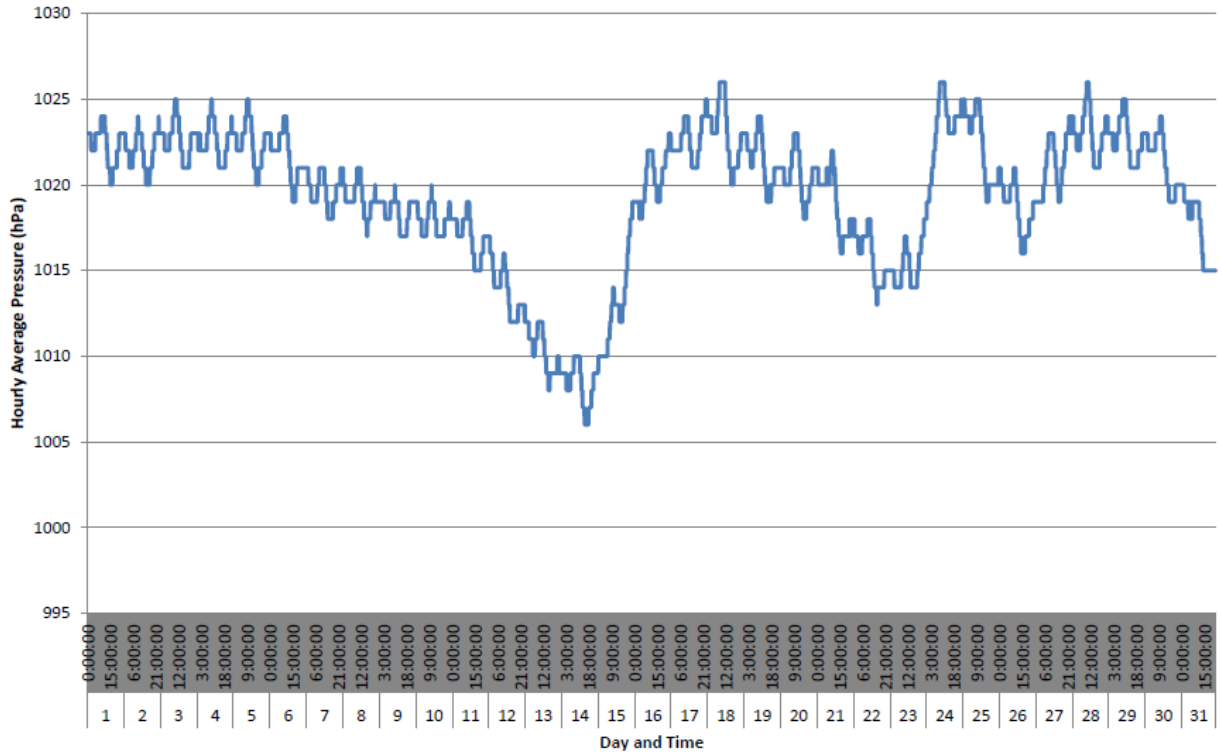
Hourly Average Pressure (hPa) for Jan 2023

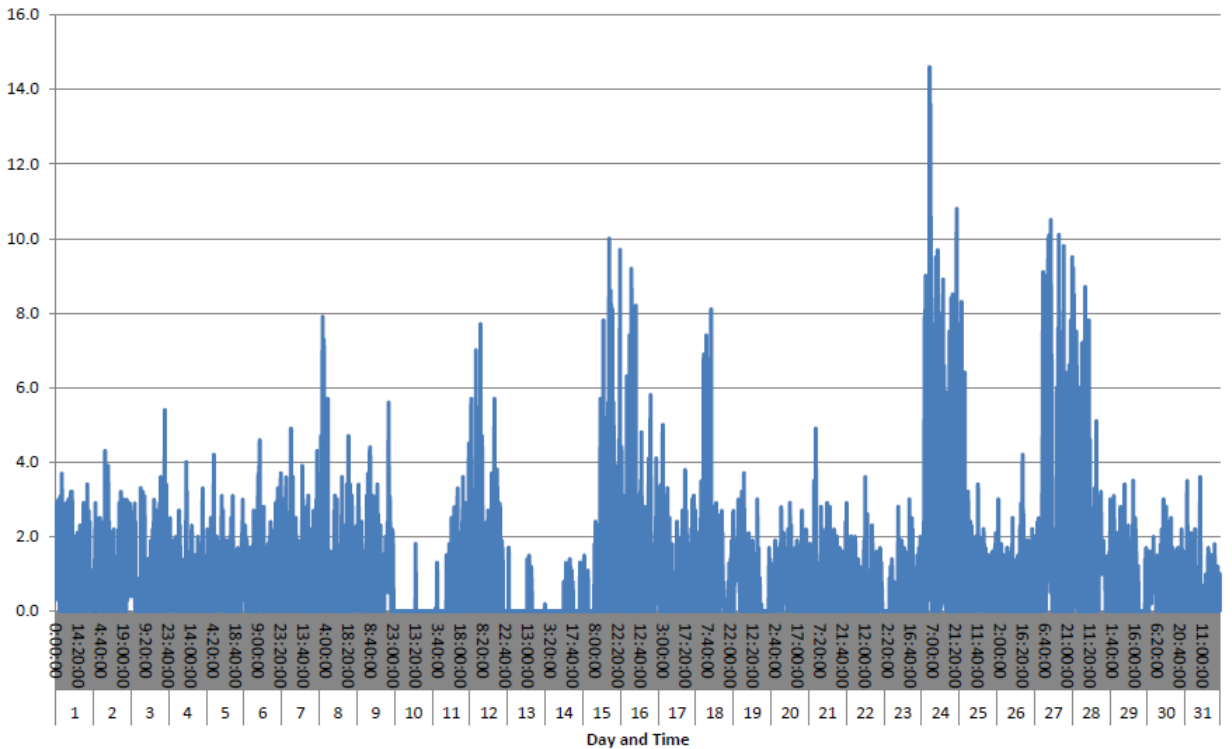
Hourly Average Wind Speed (m/s) for Jan 2023

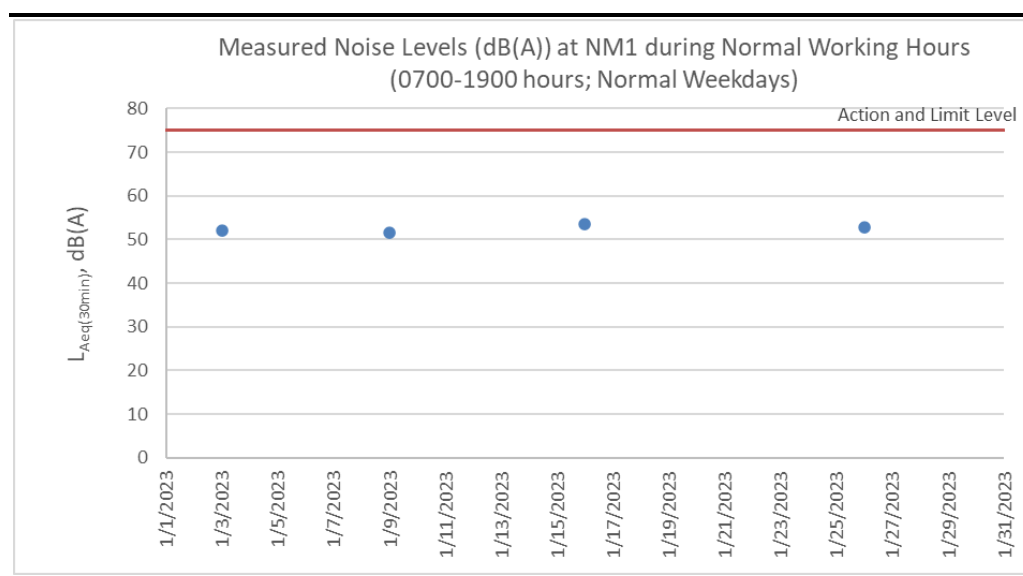
Date	Start Time	Finish Time	Weather	L ₁₀ (30min)	L ₉₀ (30min)	L _{eq} (30min)
3 Jan 23	10:32	11:02	Cloudy	54.1	49.5	52.2
9 Jan 23	9:02	9:32	Cloudy	54.0	48.1	51.5
16 Jan 23	9:40	10:10	Cloudy	55.0	51.5	53.5
26 Jan 23	10:20	10:50	Cloudy	55.2	46.4	52.9
Average						52.5
Min						51.5
Max						53.5

Figure E2.1 Graphical Presentation for Noise Monitoring at NM1
