South East New Territories (SENT) Landfill Extension

Monthly Environmental Monitoring & Audit Report No.50 for February 2023

March 2023

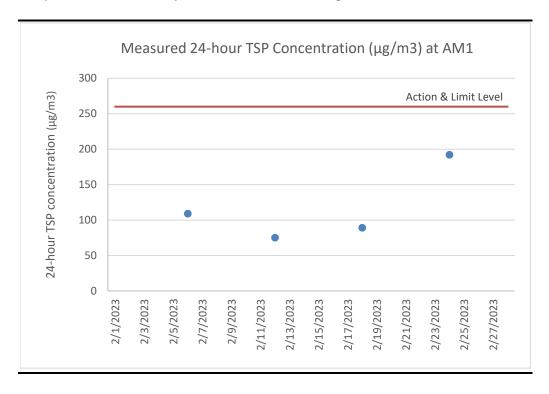
Figure D2.1 Graphical Presentation for 24-hr TSP Monitoring at AM1

Start Date	Start Time	Finish Date	Finish Time	Weather	24-hour TSP (μg/m3)
6 Feb 23	8:00	7 Feb 23	7:36	Sunny	109
12 Feb 23	8:00	13 Feb 23	7:45	Fine	75
18 Feb 23	8:00	19 Feb 23	8:11	Fine	89
24 Feb 23	8:00	25 Feb 23	8:11	Sunny	192
				Average	116
				Min	75
				Max	192

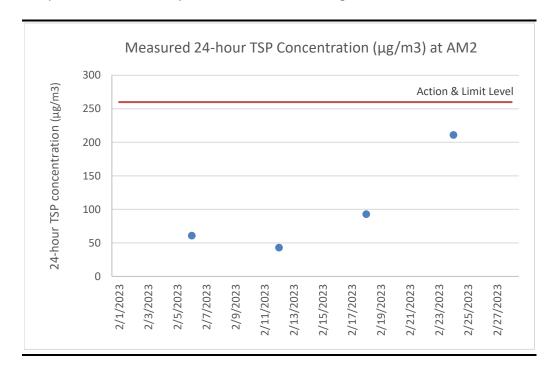
Figure D2.2 Graphical Presentation for 24-hr TSP Monitoring at AM2

Start Date	Start Time	Finish Date	Finish Time	Weather	24-hour TSP (μg/m3)
6 Feb 23	8:00	7 Feb 23	7:33	Sunny	61
12 Feb 23	8:00	13 Feb 23	8:07	Fine	43
18 Feb 23	8:00	19 Feb 23	7:43	Fine	93
24 Feb 23	8:00	25 Feb 23	7:56	Sunny	211
Average 102			102		
				Min	43
				Max	211

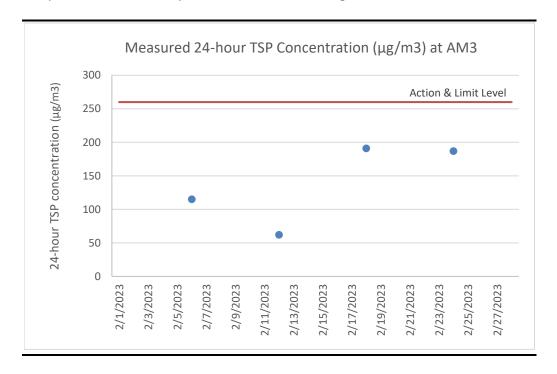
Figure D2.3 Graphical Presentation for 24-hr TSP Monitoring at AM3

Start Date	Start Time	Finish Date	Finish Time	Weather	24-hour TSP (μg/m3)
6 Feb 23	8:00	7 Feb 23	8:05	Sunny	115
12 Feb 23	8:00	13 Feb 23	7:32	Fine	62
18 Feb 23	8:00	19 Feb 23	7:56	Fine	191
24 Feb 23	8:00	25 Feb 23	8:01	Sunny	187
Average			139		
				Min	62
				Max	191

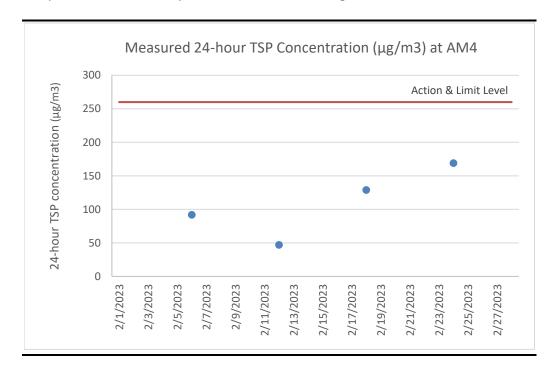
Figure D2.4 Graphical Presentation for 24-hr TSP Monitoring at AM4

Start Date	Start Time	Finish Date	Finish Time	Weather	24-hour TSP (μg/m3)
6 Feb 23	8:00	7 Feb 23	7:33	Sunny	92
12 Feb 23	8:00	13 Feb 23	7:40	Fine	47
18 Feb 23	8:00	19 Feb 23	7:59	Fine	129
24 Feb 23	8:00	25 Feb 23	7:45	Sunny	169
	Average 109			109	
				Min	47
				Max	169

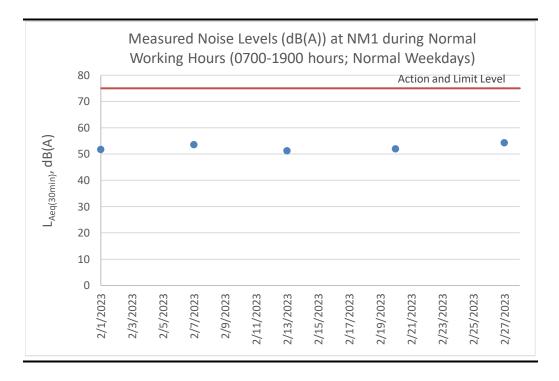
Figure E2.1 Graphical Presentation for Noise Monitoring at NM1

Date	Start Time	Finish Time	Weather	L _{10 (30min)}	L _{90 (30min)}	Leq (30min)
1 Feb 23	9:22	9:52	Cloudy	53.9	48.4	51.8
7 Feb 23	9:43	10:13	Cloudy	55.4	50.3	53.6
13 Feb 23	10:50	11:20	Cloudy	53.7	48.0	51.3
20 Feb 23	9:36	10:06	Sunny	53.7	49.8	52.0
27 Feb 23	10:16	10:46	Sunny	56.3	50.5	54.3
					Average	e 52.6
					Mir	n 51.3
					Max	x 54.3
