翠谷工程有限公司
Green Valley Landfill, Limited

South East New Territories (SENT) Landfill Extension

Monthly Environmental Monitoring & Audit Report No.51
for March 2023

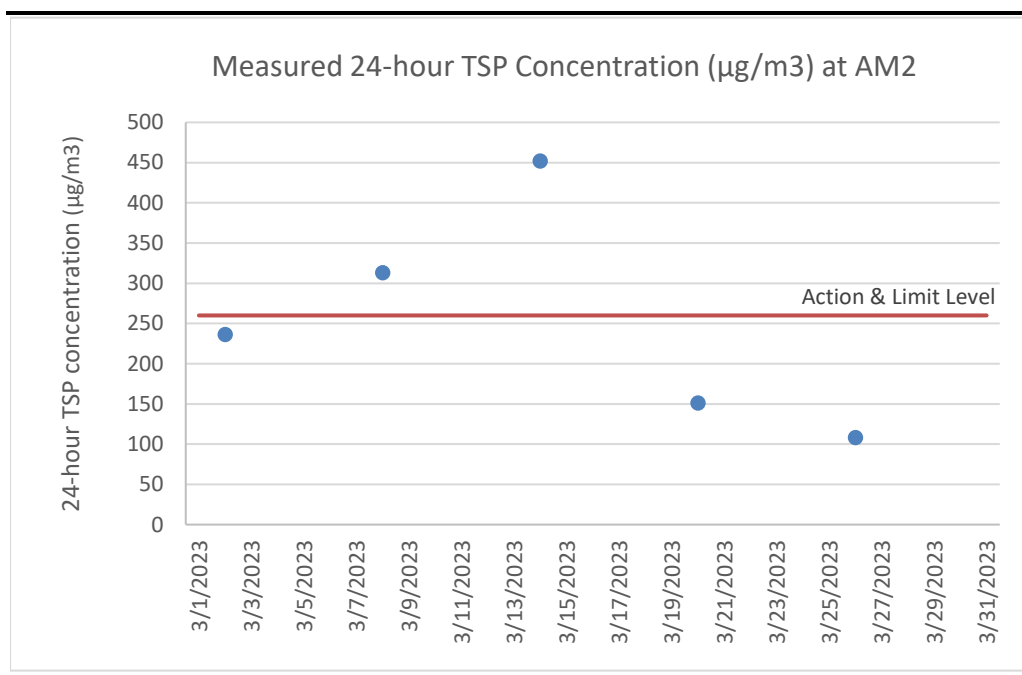
Start Date	Start Time	Finish Date	Finish Time	Weather	24-hour TSP ($\mu\text{g}/\text{m}^3$)
2 Mar 23	8:00	3 Mar 23	7:53	Sunny	236
8 Mar 23	8:00	9 Mar 23	8:13	Sunny	313
14 Mar 23	8:00	15 Mar 23	7:39	Cloudy	452
20 Mar 23	8:00	21 Mar 23	7:48	Cloudy	151
26 Mar 23	8:00	27 Mar 23	8:25	Rainy	108
Average					252
Min					108
Max					452

Figure D2.2 Graphical Presentation for 24-hr TSP Monitoring at AM2
